# National Transportation Safety Board

WPR22LA263

## **MATERIALS LABORATORY**

Factual Report 24-020

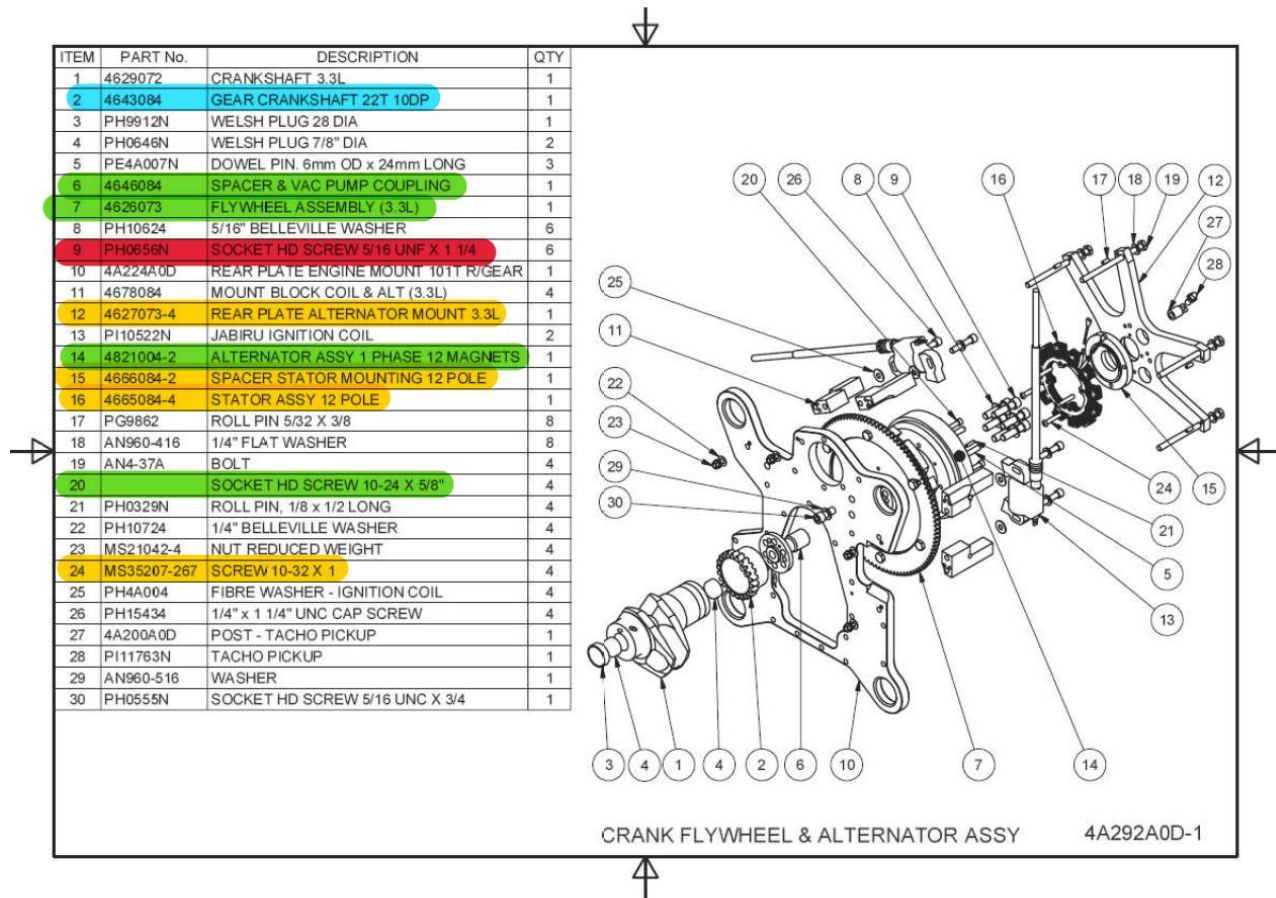
**Figure 2** shows the crankshaft timing gear as received. The bolts would have passed through the six through-holes on the face and then threaded into to the crankshaft, as shown in Jabiru's assembly drawing (**Figure 3**). No significant damage was seen in the timing gear.

**Figure 3.** Drawing of crankshaft, flywheel, and alternator assembly in with similar configuration to accident vehicle. Highlighted text indicates parts in the assembly. Blue is the crankshaft timing gear, green are parts in the flywheel assembly, orange is the stator and bracket assembly, and red are the failed bolts. Note that this image is from a newer design revision than the accident vehicle, as the accident vehicle did not include the three dowel pins and accompanying holes in the crankshaft assembly. Adapted from "Jabiru Engine Parts Book: 3300 Series," p. 19.
