National Transportation Safety Board

WPR23FA153

**INVESTIGATIVE SUPPLEMENTAL MATERIAL**

Location: Cal-Nev-Ari, Nevada  
Date: 04.11.2023  
Time: 0419 Pacific standard time  
Airplane: Glastar GS-1

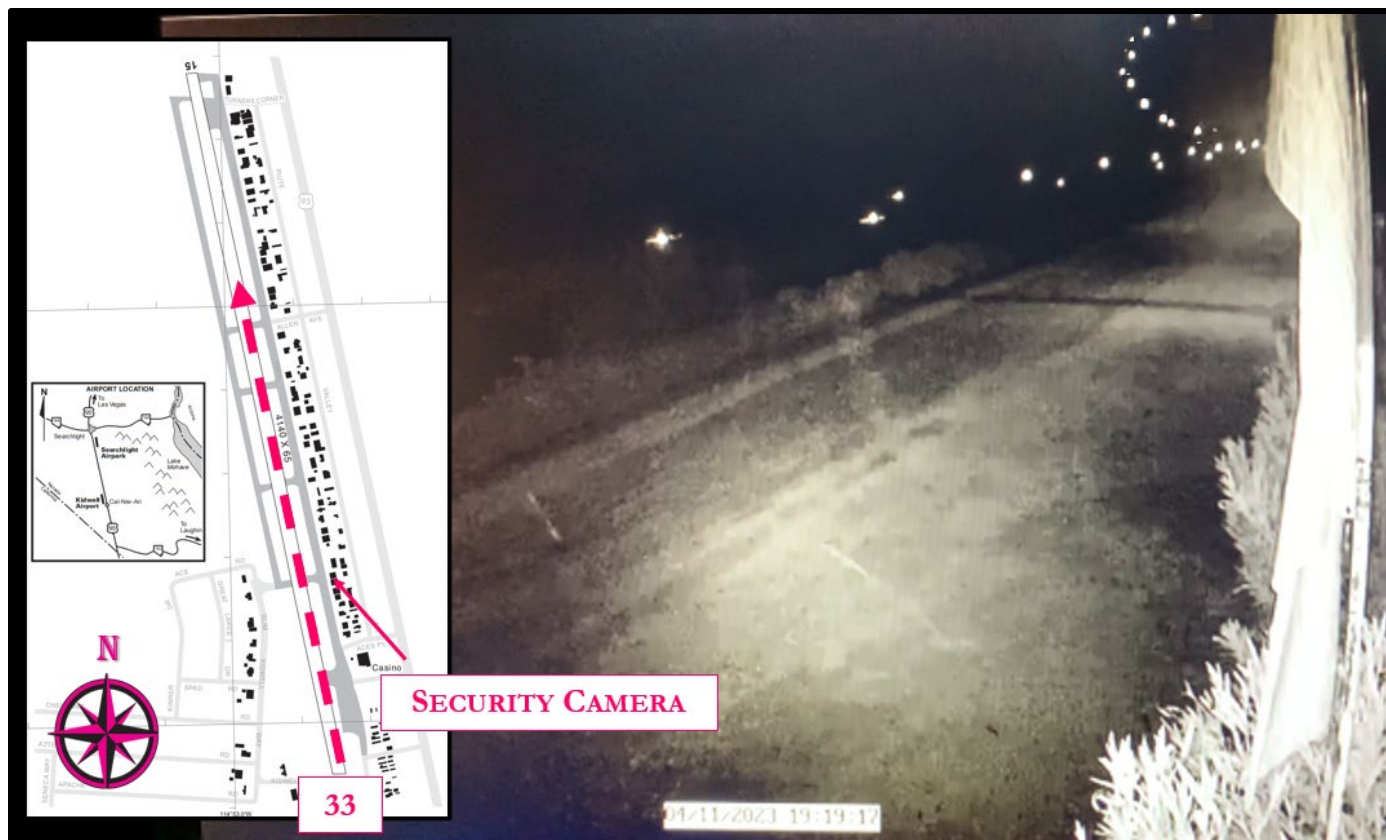
A security camera, located at a private residence at the south side of the airport, recorded grainy footage of the airplane departing and then leaving the frame to the east about one minute later. The airplane then came back into the frame from the east at 0419, equating to about 11 minutes after leaving. The lights appeared higher than when the airplane originally left the frame. The airplane then turned at 0419:17 and rapid descended to the ground presumably crashing at 0419:28.

Figure 2: Security camera composite photo showing runway lights and location.

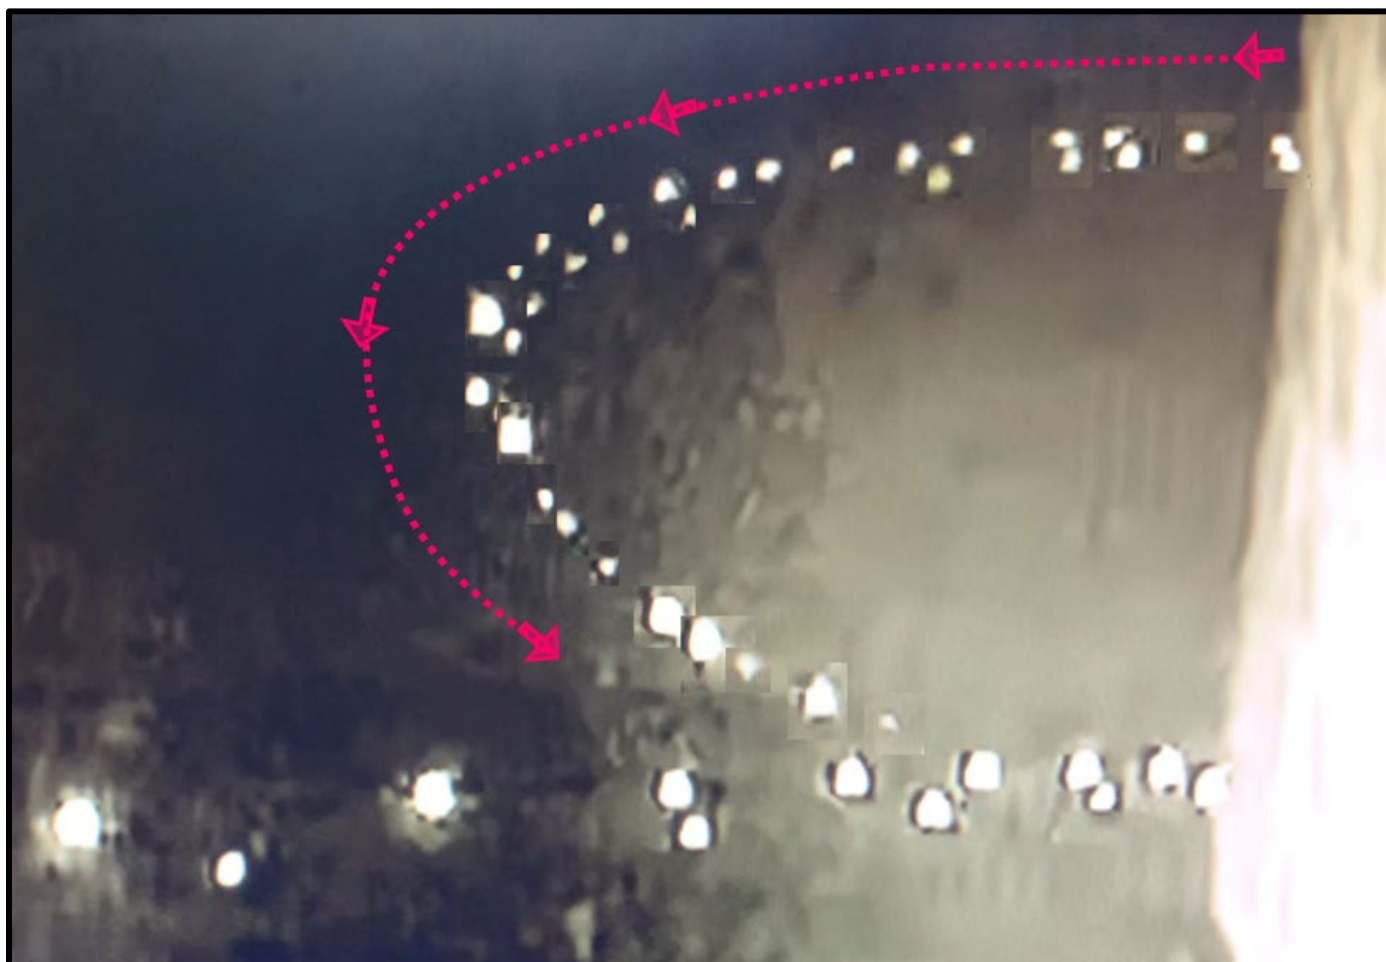
Figure 3: Video images (combined) showing flight path.

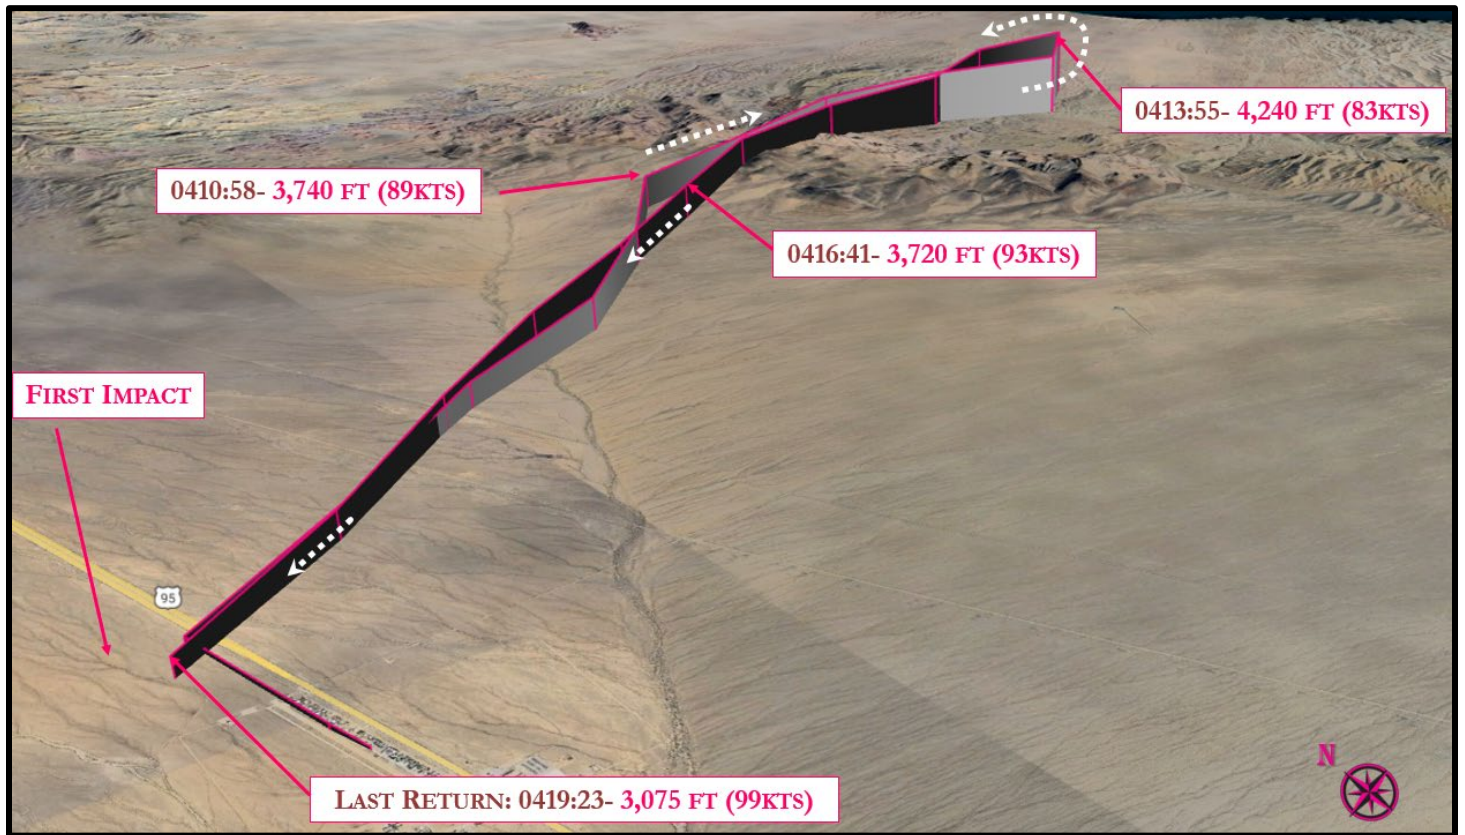
A Garmin GPSMAP 296, portable GPS receiver was located in the wreckage. The unit included a built-in Jeppesen database and was capable of receiving XM satellite radio for flight information. The unit stored date, route-of-flight, and flight-time information; all recorded data were stored in nonvolatile memory. Recorded data plots were recovered for the timeframe that matched the airplane's anticipated flight track after departing from Cal-Nev-Ari. The track indicated that after becoming airborne, the airplane continued on a north-easterly path while making a gradual climb. After about 7 minutes in-flight (about 8 nautical miles) the airplane reached a peak altitude of about 4,240 ft mean sea level (msl), equating to 2,380 ft above ground level (agl) and made a left 180° turn. The airplane then backtracked to the airport on a south-westerly course.

Figure 6: GPS flight path track.

The last recorded position was at 0419:23 and located just west of the runway centerline. The initial impact was 1,560 ft north of the last return.

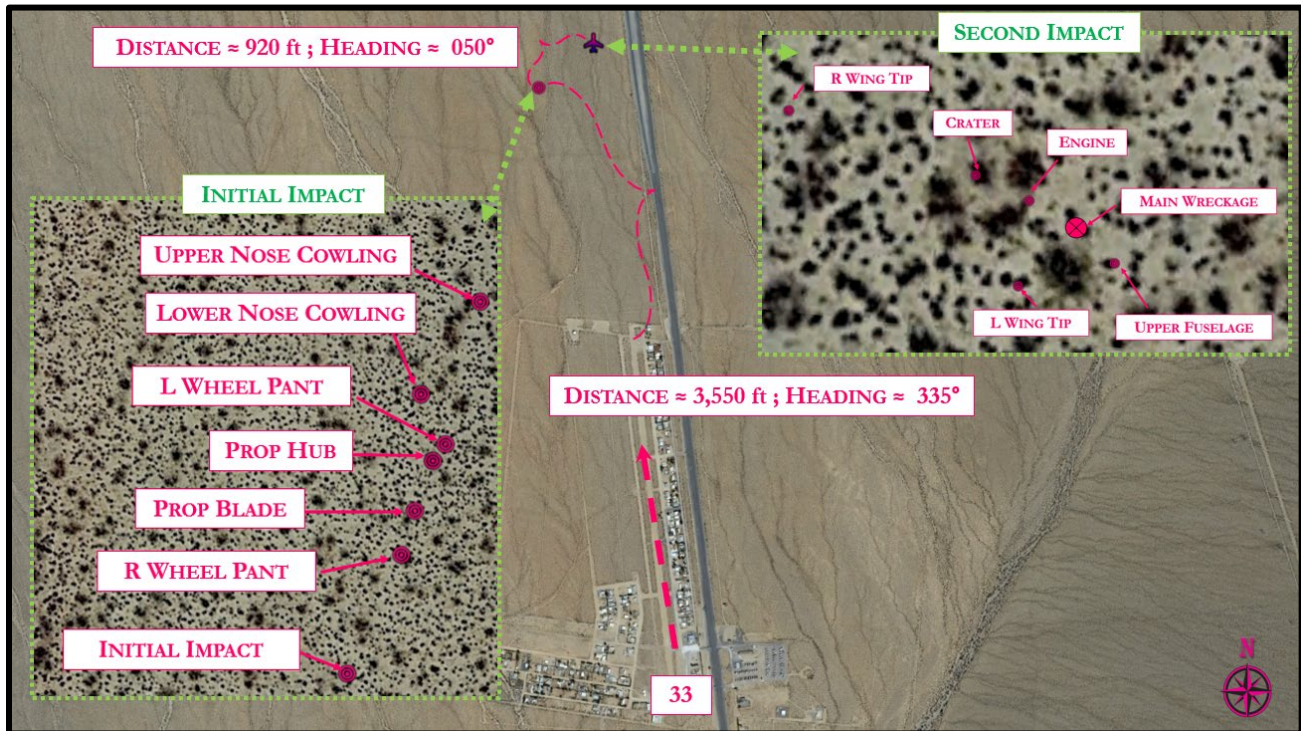
The main wreckage was located in the desert terrain about 3,940 ft north-northwest from the end of runway 33 at the coordinates 35°19'23" N 114°53'12" W and an elevation of 2,660 ft. In character, the terrain was composed of dry, soft dirt and dense brush. The wreckage was found distributed over a 920 ft distance on a median magnetic bearing of about 050°.

Figure 9: Area of impact in reference to the runway.

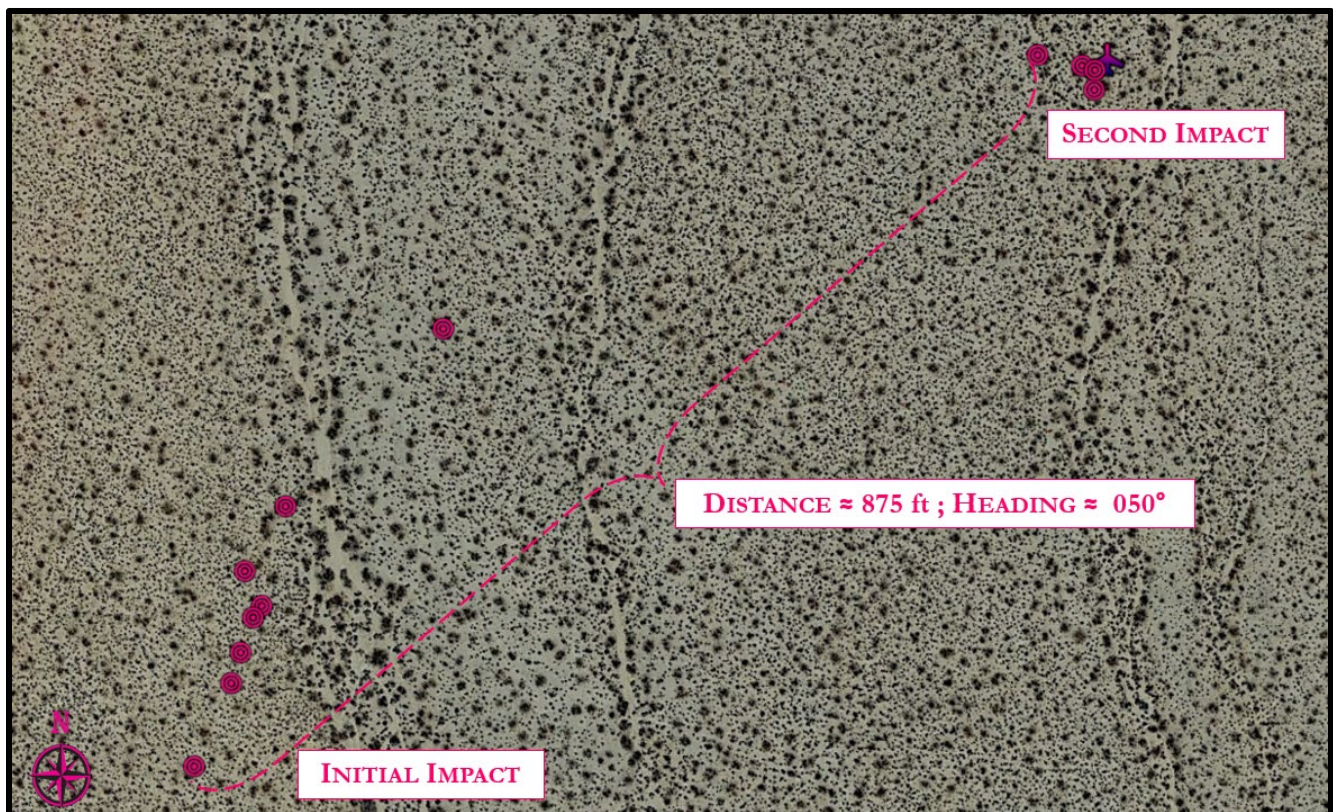
Figure 10: Two impact sites.

The first identified points of contact consisted of disrupted cacti and dirt on the flat desert terrain making up the far southwestern end of the debris field. The markings started as two nearly parallel indentations in the vegetation and dirt spaced about 98 inches apart. The right crater started about 9 ft prior to the left crater and they both continued on a heading of 025°. The indentations were continuous and then merged for 121 ft and at the beginning there were several parallel ground scars located perpendicular to the direction of the center indentation and immediately over it. The size and location was consistent with propeller slashes and fragments of propeller material were found imbedded in the soft dirt.

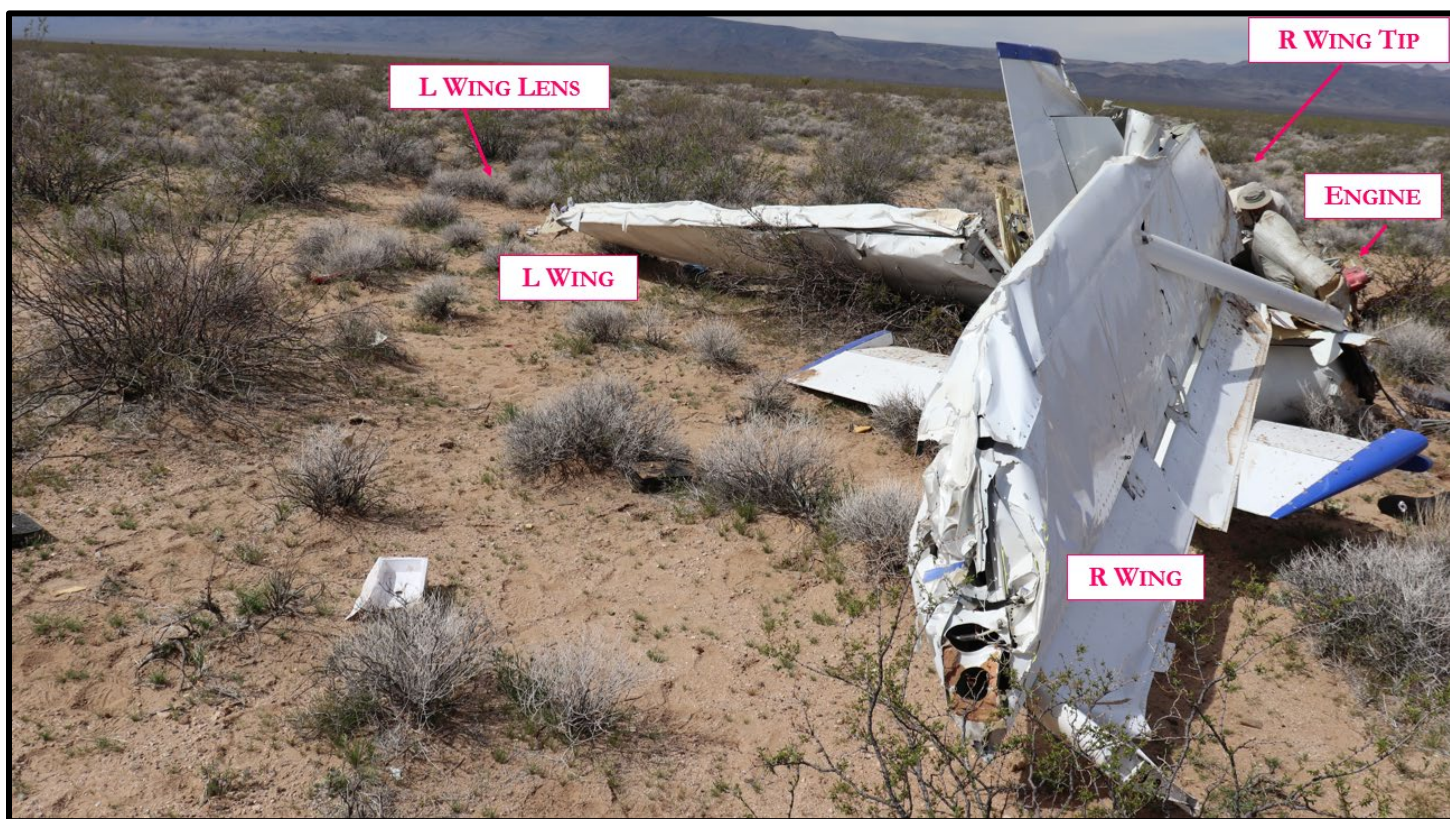
Figure 16: Main wreckage

The fuselage came to rest upright oriented in the direction opposite of the debris path.

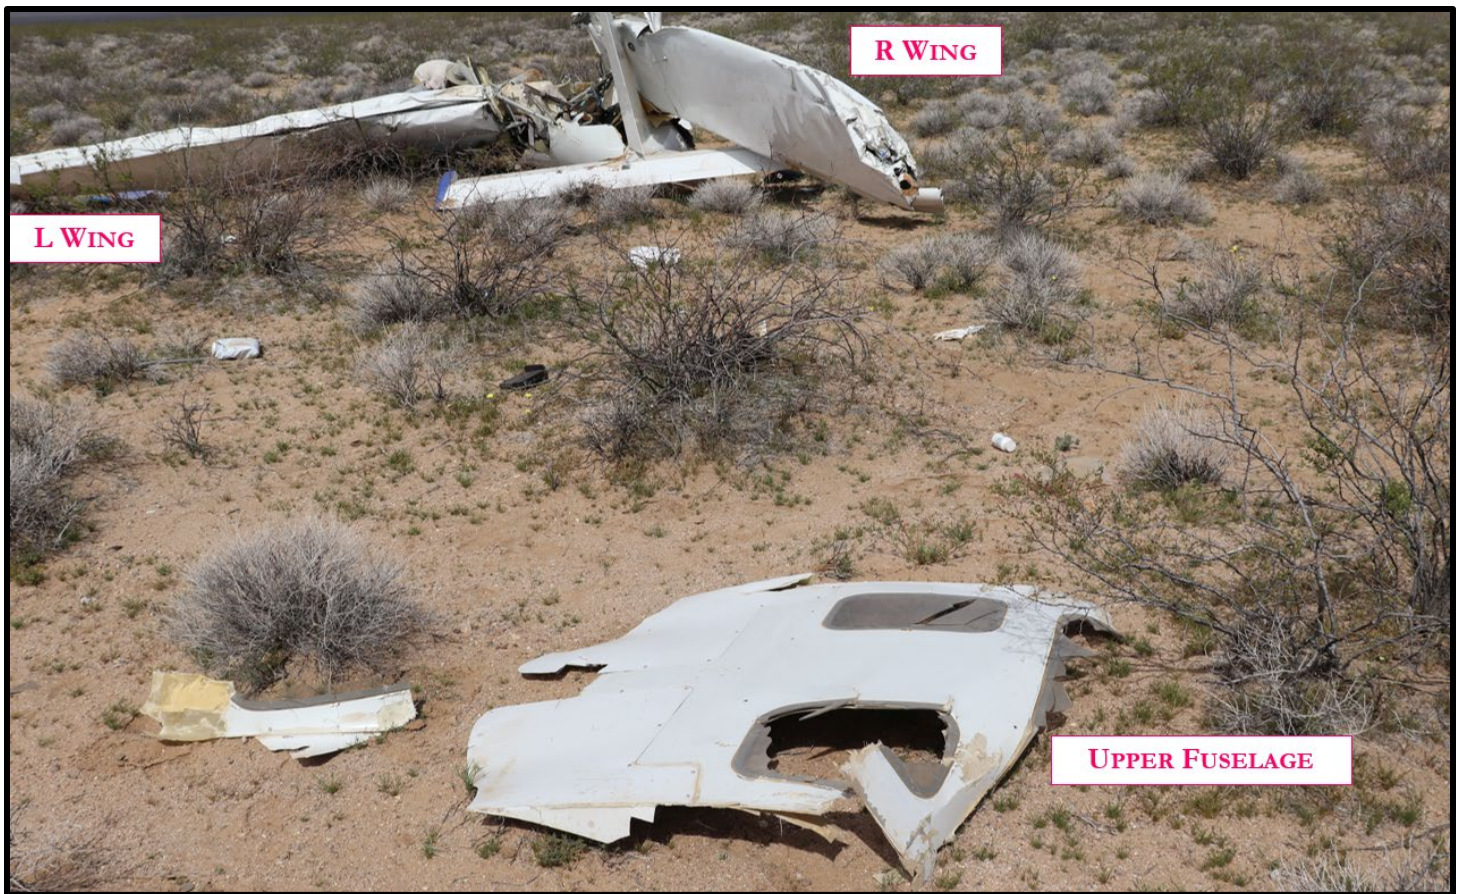
The second debris field consisted of disrupted dirt and vegetation making up northeast end of the debris field. The markings started as an 5 in wide indentation in the vegetation dirt blue/green lens and with almost the entirety of the right wing tip fragments imbedded. The fragmented right wing tip was located immediate adjacent to the initial impact area. There were bushes about 3 ft in height that were on either side of the crater as it extended toward the main wreckage on a heading of 116°. The crater was about 35 feet from the right wing tip and contained the right door and part of the right fuselage just forward of the door.

Figure 17: Second impact area.

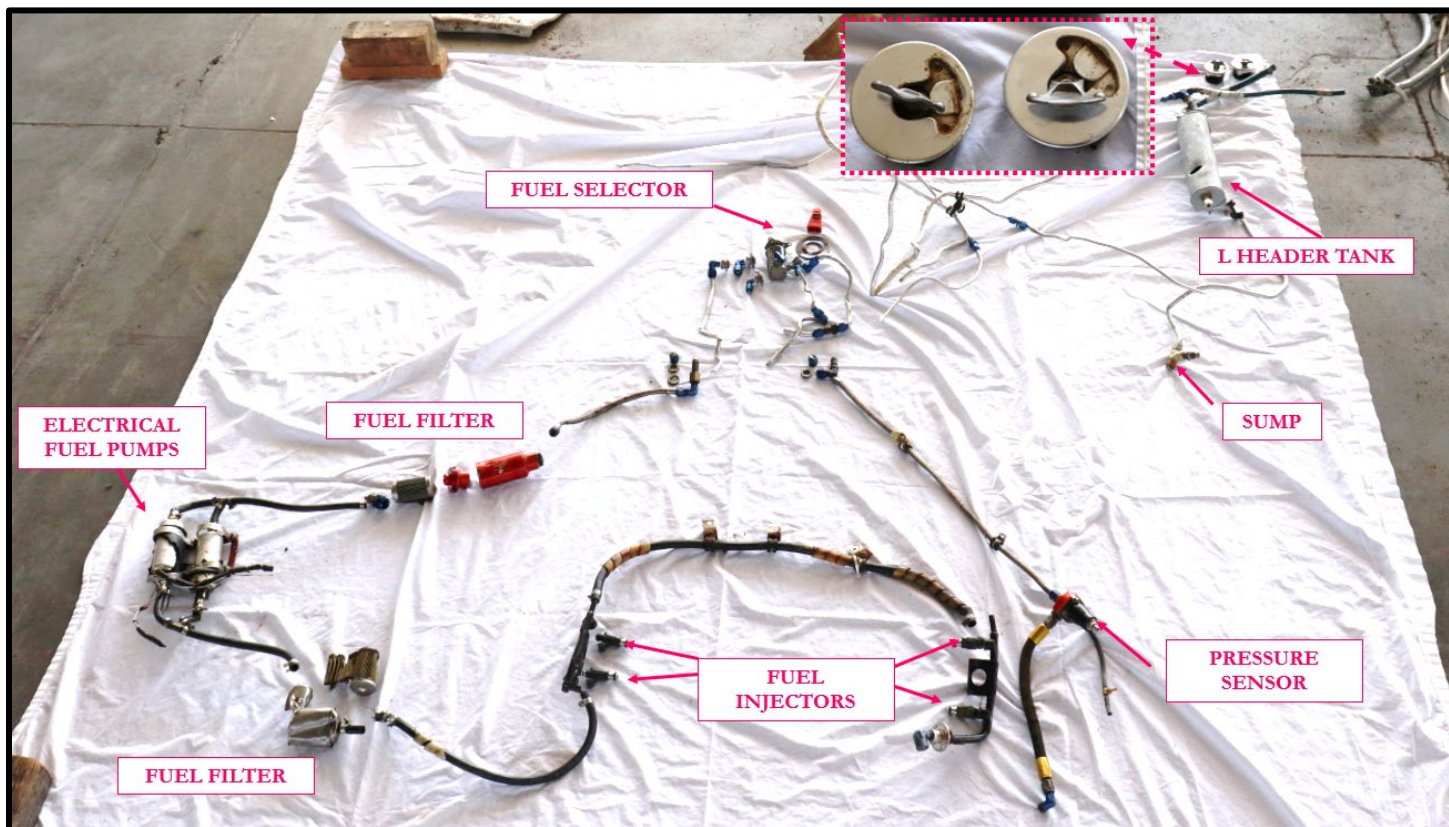
Figure 19: Fuel system examination layout.

There was fluid in both wing tanks consistent in odor and color with that of 100LL Avgas. The fuel selector was in an over-extended position and sustained crush damage with the selector post bent. There were witness marks on the face are consistent with it likely being in the “LEFT” position at the time of impact. There was white

Teflon tape on all the selector fittings that had the appearance of being recently installed. The detents and selector rotated when the post was turned. The fuel lines were all fractured in various places.

The fitting from the selector through the firewall was broken and the b-nut was loose; there were scrapes on the nut. It could not be determined if there was odor or wetness in the area of the firewall.

The Aermotive fuel filter was punctured open. The fluid inside was grainy and dirty and tested positive for containing water. The cooling reservoir was located above the filter and was punctured. The rubber tubing to the lower fuel pump was ruptured. The pumps were hooked up to power and could be felt clicking and having suction on the inlets. The paper filter was cut open and found to be discolored. Numerous lines had fractures and were not attached.

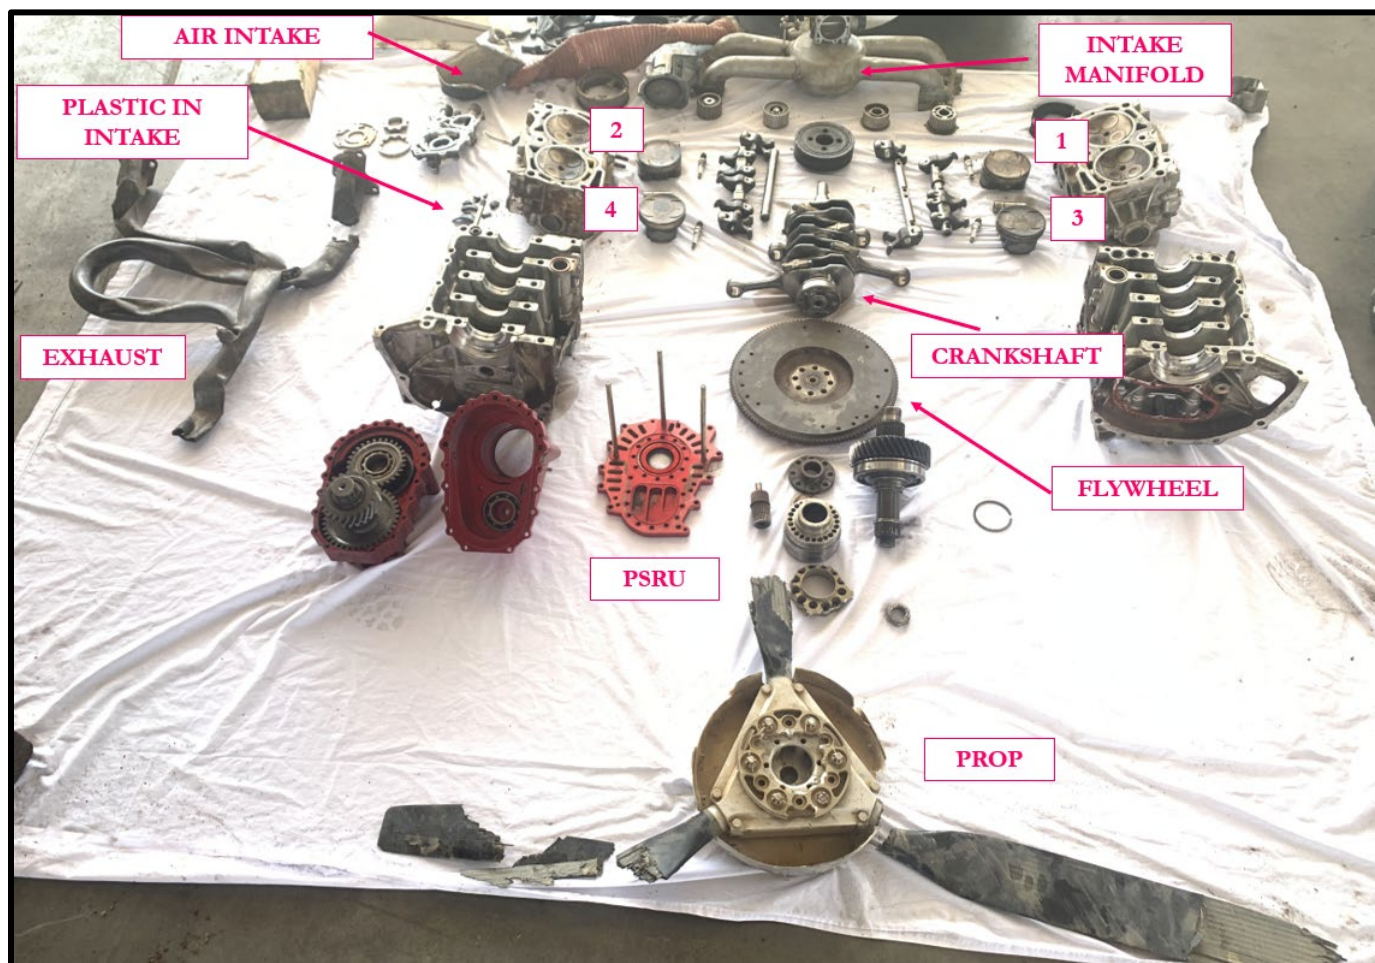
As part of the postaccident examination, a majority of the engine, the PSRU, and the components were completely disassembled. In pertinent part, there were large plastic shards found in the No. 4 intake (entering into the cylinder) and smaller pieces were in the No. 3, consistent with the plastic connection at the air intake fragmenting while the engine was still running at impact. The entire drive train was intact. The deposits on the pistons and spark plugs were all consistent with normal operation. The PSRU splines and bearings were all intact; fine metallic shavings were found in the oil. The examination of the engine and PSRU revealed no obvious evidence of pre impact anomalies or failures that would have precluded normal operation.

Figure 26: Engine layout at examination with propeller.
