# National Transportation Safety Board

WPR23FA185

## **AIRWORTHINESS**

Group Chairman's Factual Report

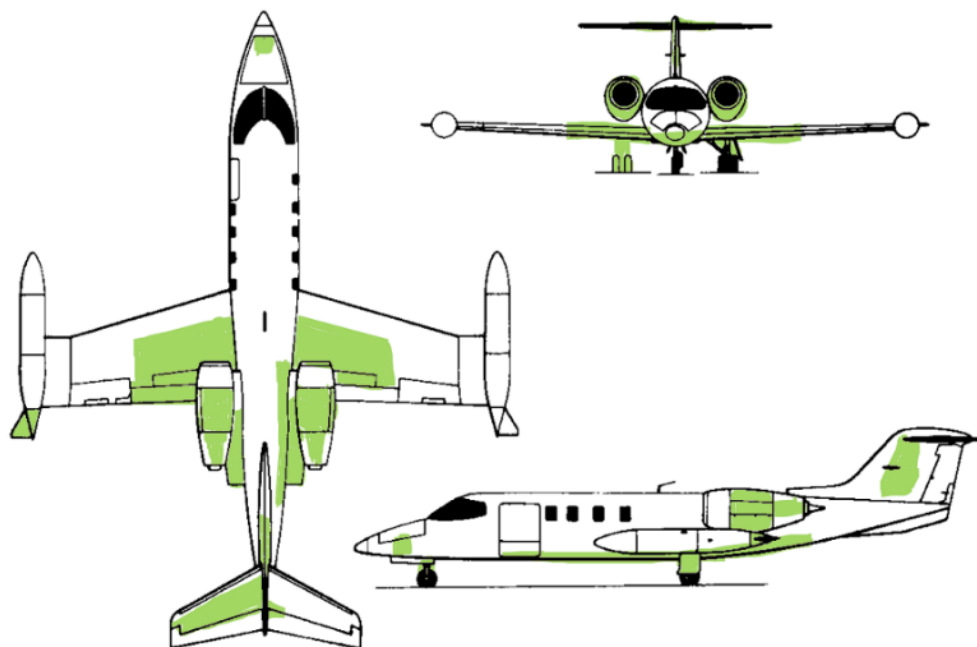
The Airworthiness Group examined the wreckage two times<sup>6</sup>, first on December 6, 2023, and then on October 30-31, 2024. During both examinations the wreckage was entirely laid out. It was estimated that approximately 40% of the airplane had been recovered and was available for examination (Figure 2).

**Figure 2.** A 3-view diagram of the airplane. Areas shaded in green represent the portions of the airplane wreckage that was recovered and examined.

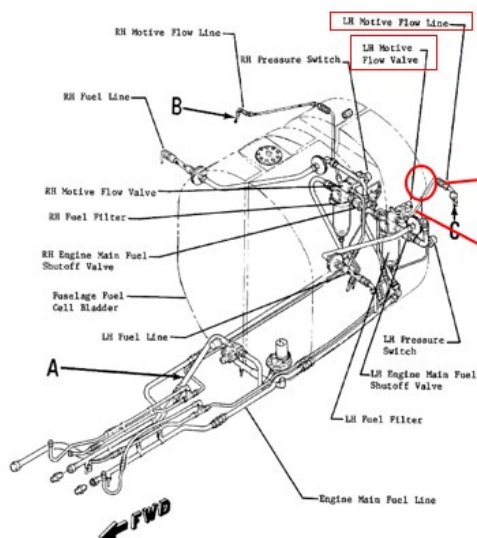
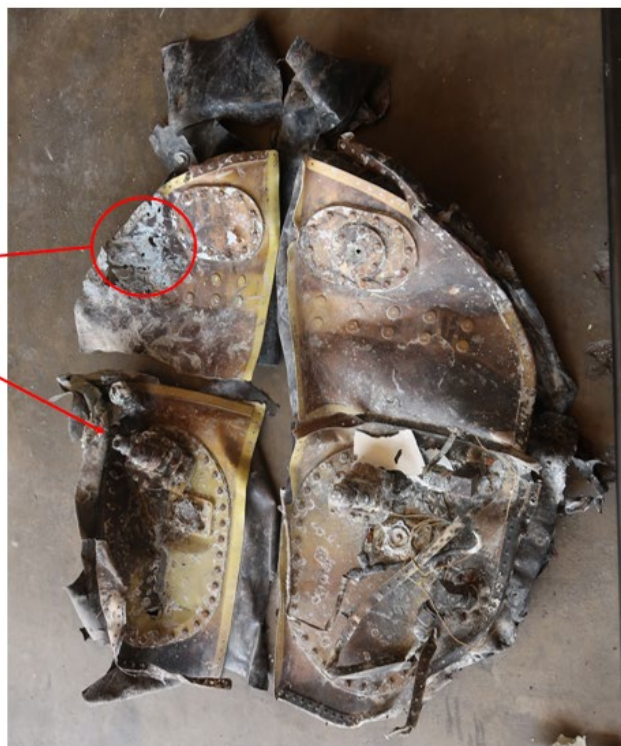
The wreckage consisted of remnants of the cockpit including pilot and copilot seats, various instrumentation, control wheel, and the copilot side rudder pedals. The belly skin from behind the cockpit to the forward wing spar with interior floor and seat track structure was attached. Fuselage structure above the cabin floor was not recovered for examination including the fuselage nose, the cockpit window, and all the upper half of the fuselage structure (crown). One cabin window was recovered. Figure 3 is an exemplar view of the aft equipment bay (tailcone) with the following important features labeled; rear engine mount beam, hydraulic reservoir, left and right motive fuel valves, fire bottles, and the fuselage fuel tank aft bulkhead. Fragments of the forward pressure bulkhead were identified (Figure 4), and the entire rear pressure bulkhead was present. Portions of the fuselage fuel tank structure with fuel bladders were present back to the aft fuel tank bulkhead (Figure 5). Both the left and right fuel motive valves had remained attached to the bulkhead. The upper left corner of the fuselage fuel tank aft bulkhead exhibited damage consistent with extreme sustained localized thermal damage (Figure 5 and 6) which is also in the vicinity of the left motive fuel line (see Section 2.5).

**Figure 6.** Illustration of the fuselage fuel tank and system components relative to the fuel tank aft bulkhead (figure source: Learjet 35A, MM 28-20-00).

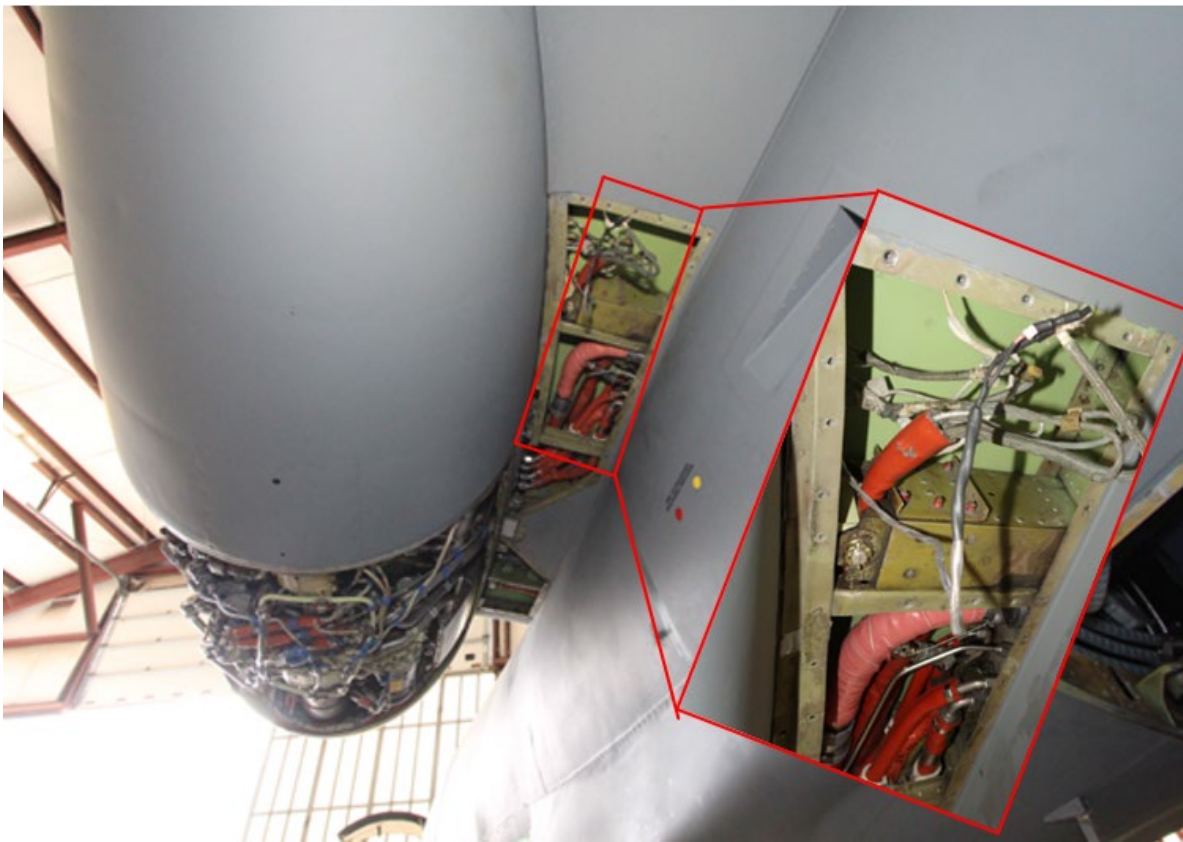
**Figure 12.** Exemplar photo of the left engine pylon and associated engine service connections. See figure 13 for connection details.

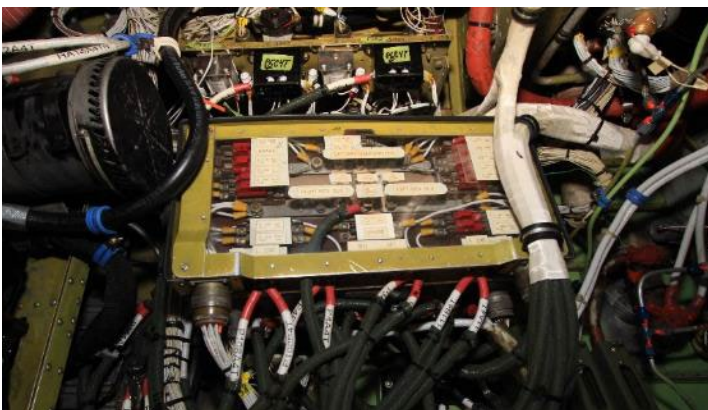
The electrical distribution system was highly fragmented. The generator control panel (Figure 26) was recovered with the wreckage. The panel was deformed

by impact forces and had evidence of exposure to high heat. The generator control panel exhibited thermal damage and charring of the phenolic backer board it was comprised of. On the forward section of the phenolic board the thermal damage was more severe. The power distribution panel would be located on the left side adjacent to the access hatch. Figure 27 depicts the generator control panel as found in the wreckage.

**Figure 26.** Exemplar photo of the generator control box/panel.
