# National Transportation Safety Board

WPR23FA219

## INVESTIGATION MATERIALS SUPPLEMENT

Location: Rio Vista, California  
Date: 06/08/2023  
Time: 1124 Pacific daylight time  
Airplane: Steen Skybolt

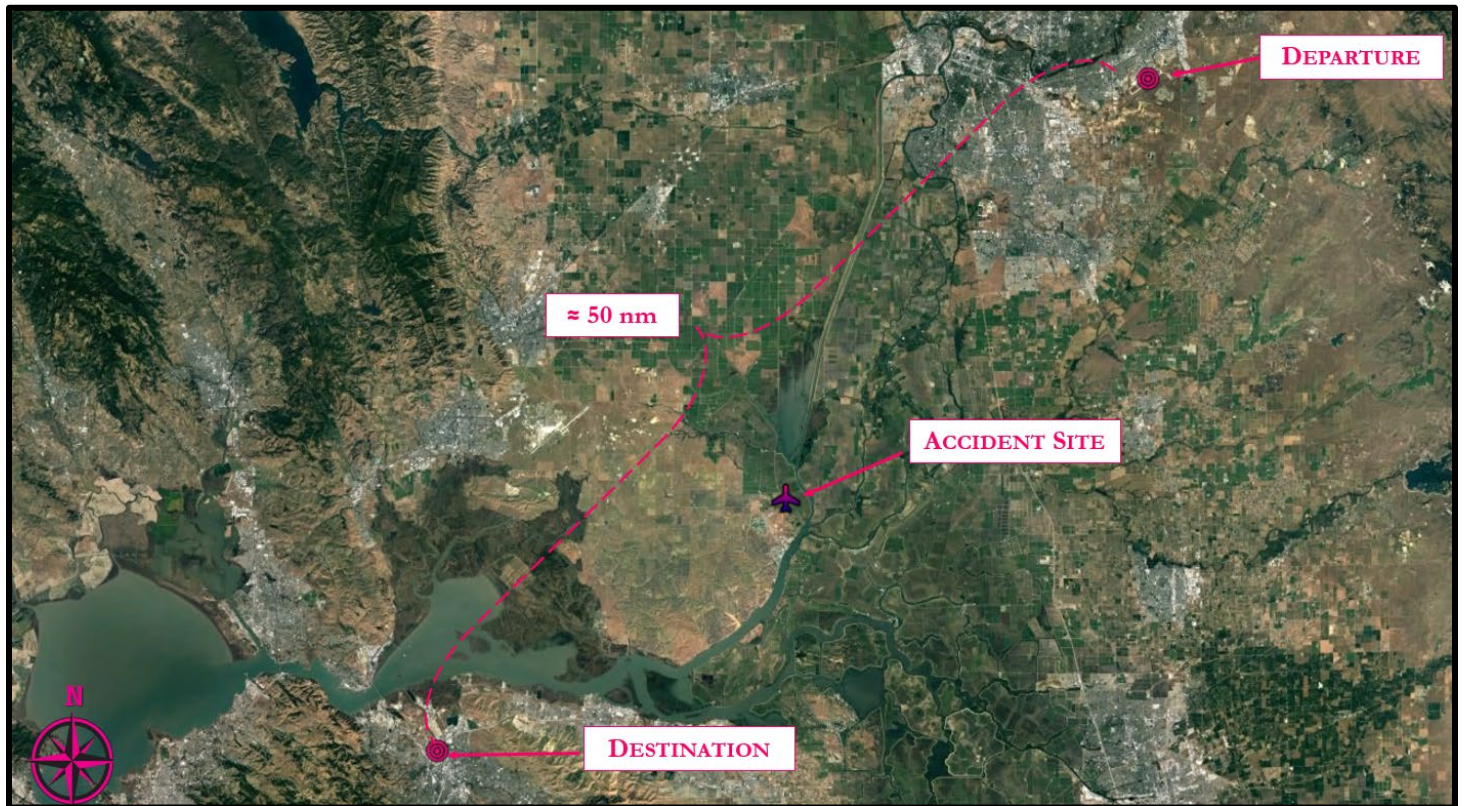
Figure 1: The planned accident flight

On the morning of the accident, the front-seated pilot asked the aft-seated pilot to pick him up at Sacramento Mather Airport, Sacramento, California. The aft-seated pilot departed about 1000 from Concord, California, where the airplane was based. The front-seated pilot had dropped off a jet earlier and needed to get back to Concord.

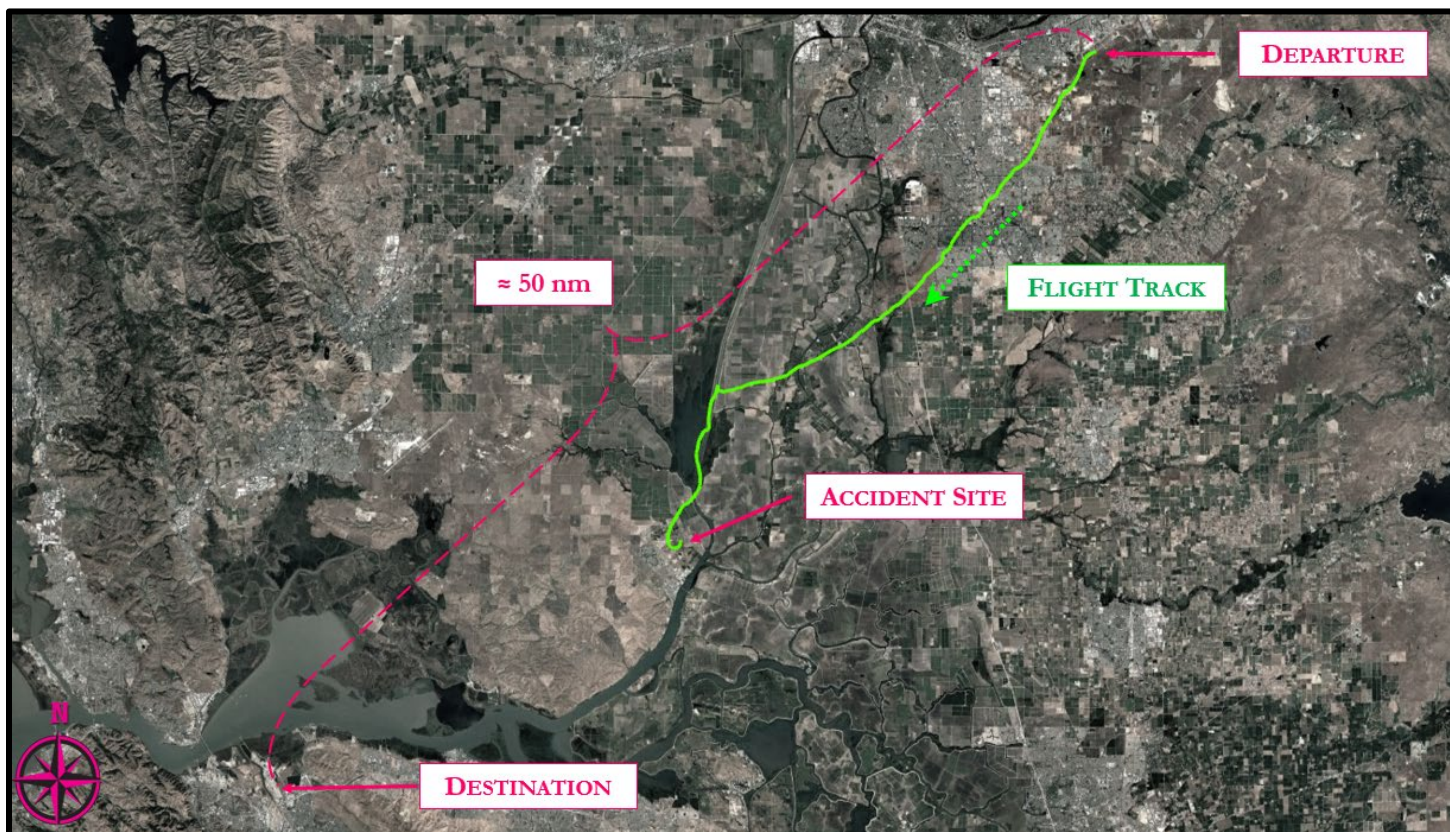
Figure 3: Flight track with reference to the destination

Recorded radar data was obtained and reviewed by a National Transportation Safety Board investigator. Recorded radar data covering the area of the accident was examined for the time frame, and a primary beacon code target was observed that terminated near the accident site and started near the airplane's known departure. The radar data consisted of about 25 minutes of returns from 1059:09 to 1124:20. The returns were consistent with the airplane flying in a southwesterly direction. At 1115:30, the returns are clumped together, consistent with the airplane making a 360° turn or maneuvering. At 1116:15, the returns begin to follow a more southerly path along the Sacramento River Deep Water Ship Channel. The returns then became sparse and continued on a flight path over the middle of the airport. The returns make a left bank consistent with adjoining the downwind and then the left base leg of the traffic pattern to runway 25. The returns then make a left hook-shape at the end of the track, consistent with a spiral.

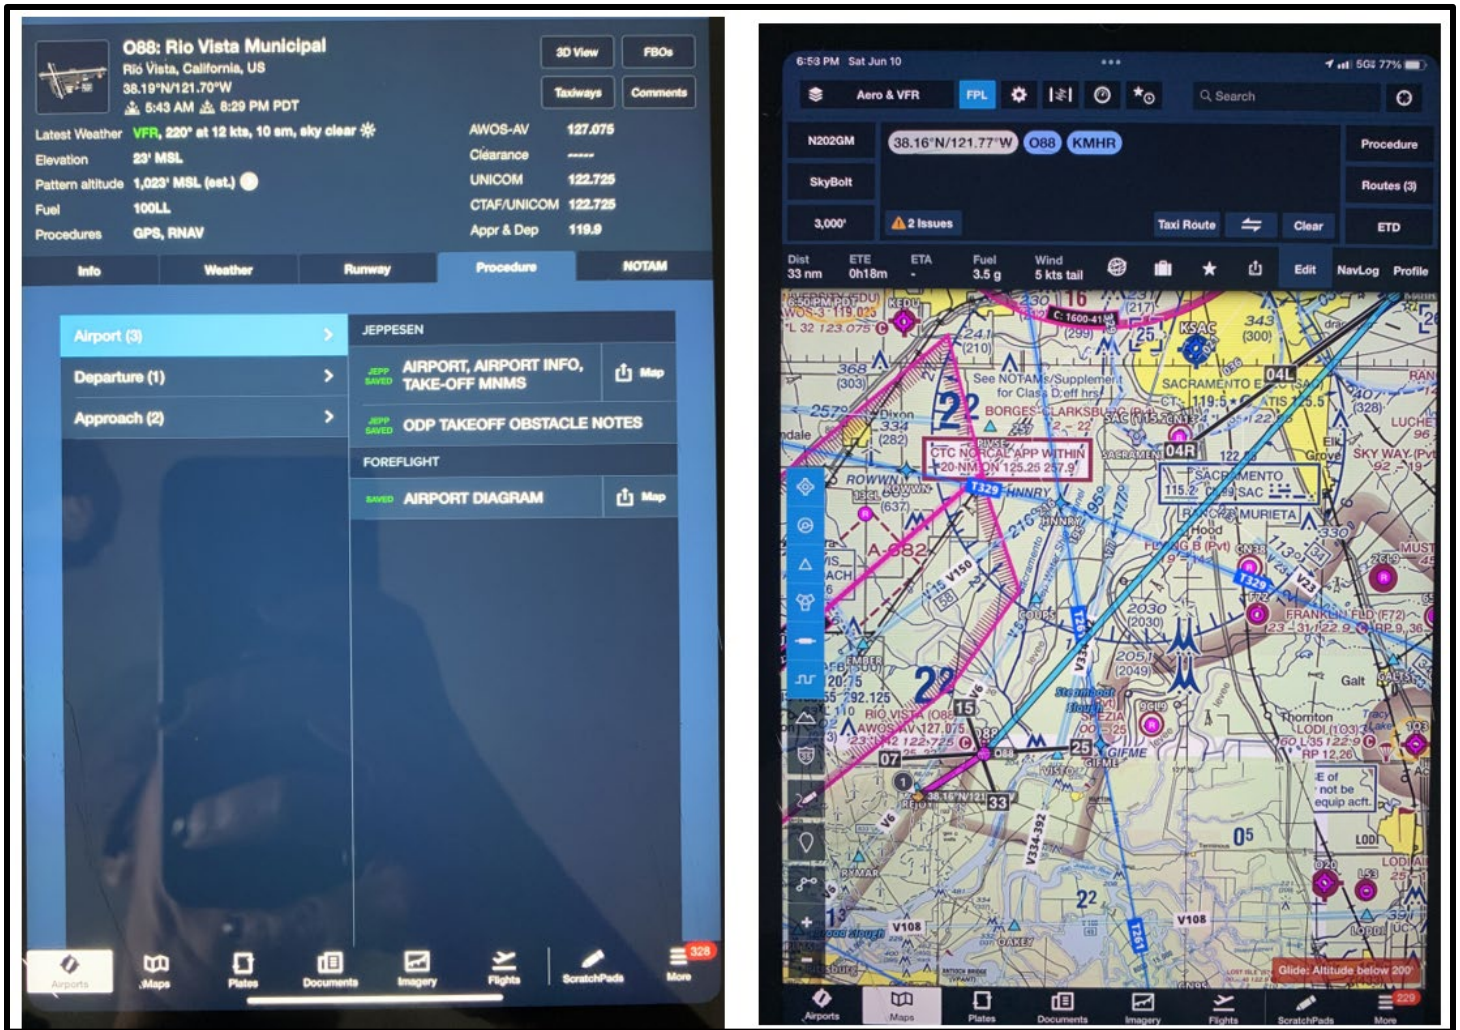
Figure 7: iPad screenshots

A pilot's iPad was located in the wreckage. It revealed that the pilot was using Foreflight and had entered the destination of Rio Vista on the way to Sacramento Mather Airport, Sacramento, California.

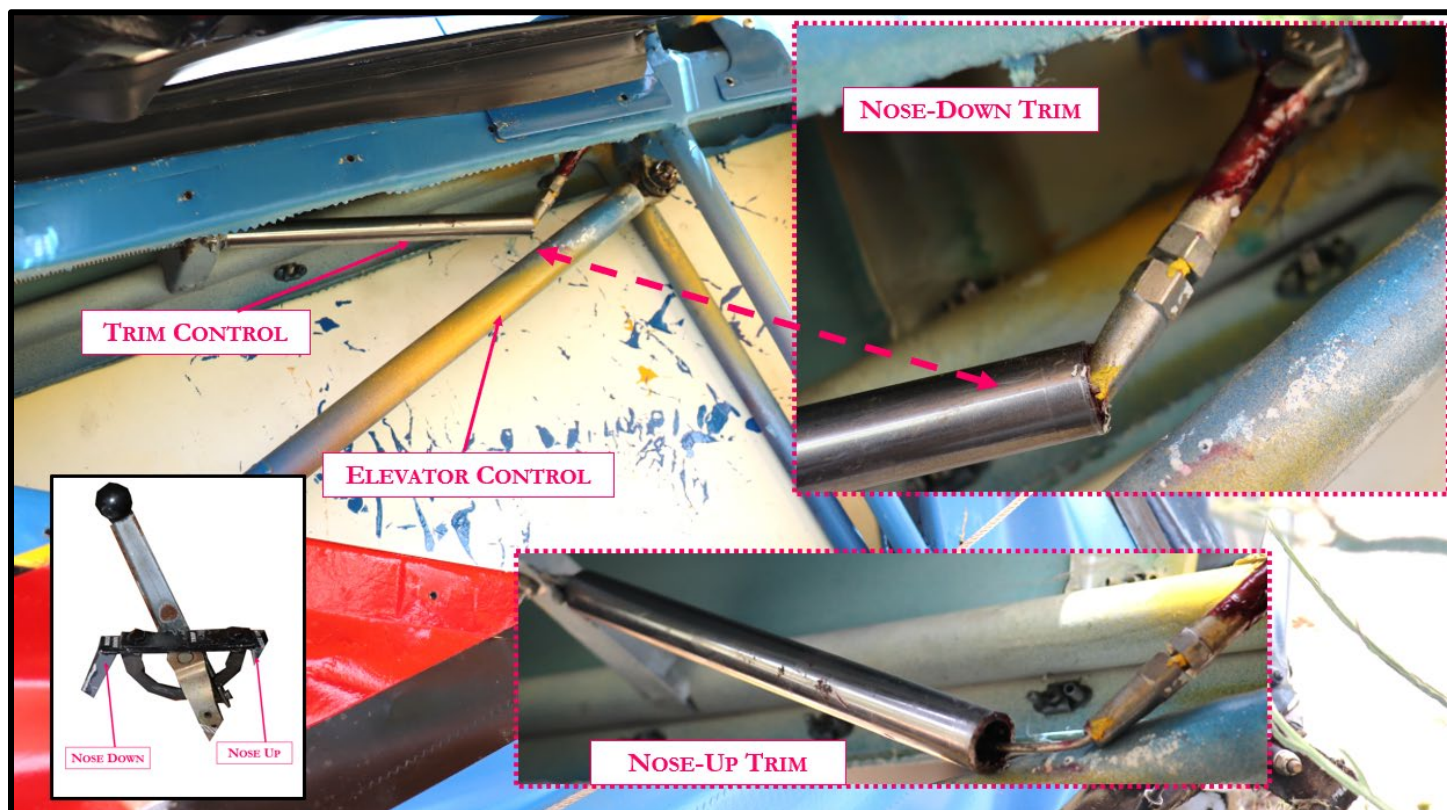
Figure 14: Trim tab function

The left trim tab stayed attached at its surfaces, and the control rod was continuous from the fuselage bellcrank. The right trim tab sheared off the piano hinge and lay under the elevator yet remained connected to the bellcranks and continuous to the fuselage bellcrank. Neither trim tab moved freely. The cockpit trim control, folded into the cabin, was still attached to the deformed frame, with its selector found in the neutral position. Moving the control to nose-down shifted the surface upward, but the control would not move toward nose-up, indicating binding. When attempting to move the control aft, the wires remained continuous to the aft bellcrank; however, a sleeve on the end attachment floated loosely and caused additional binding.
