ZOË KELIHER  
Sr. Air Safety Investigator  
Office of Aviation Safety – Western Pacific Region

The following is a summary of conversation:

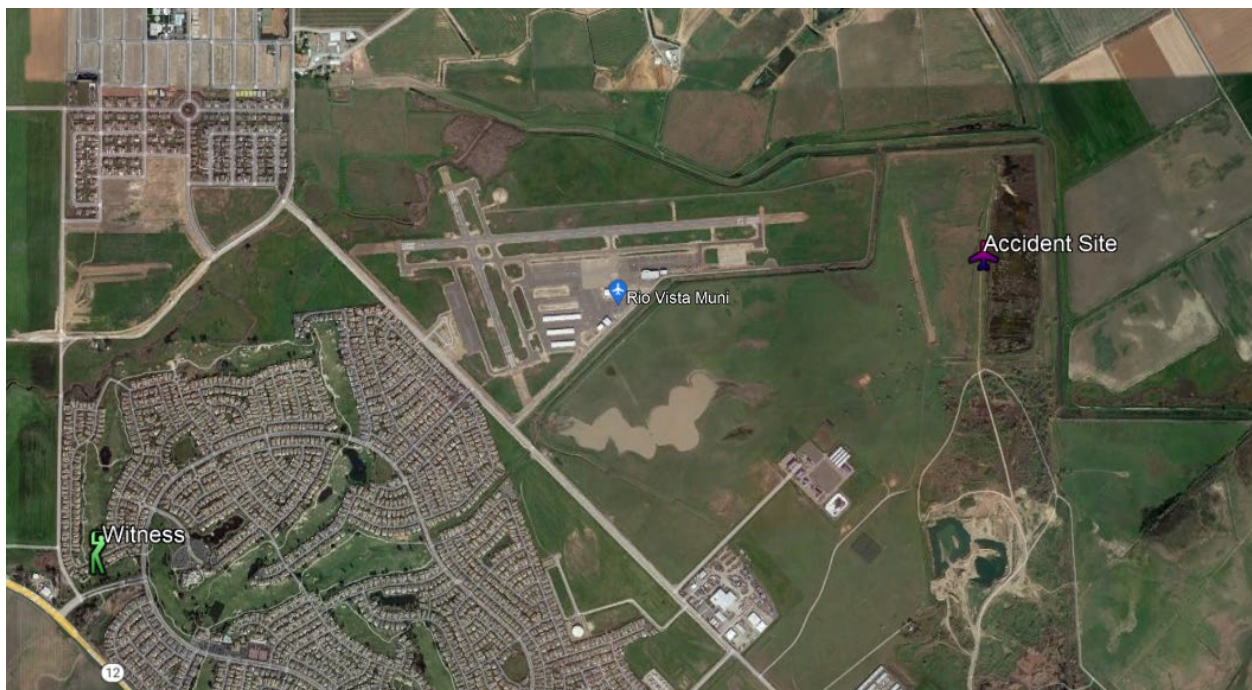
I witnessed the aircraft going down from the tee box 8th hole of the Trilogy golf course (looking east). Best I can tell the airplane was about 1000-1500 in altitude and began to spiral about 7-8 times before what I saw was trying to pull up then disappeared behind the trees.
