# National Transportation Safety Board

WPR23FA299

## INVESTIGATION MATERIALS SUPPLEMENT

Location: Van Nuys, California  
Date: 08/02/2023  
Time: 1036 Pacific daylight time  
Airplane: Czech Sportcruiser

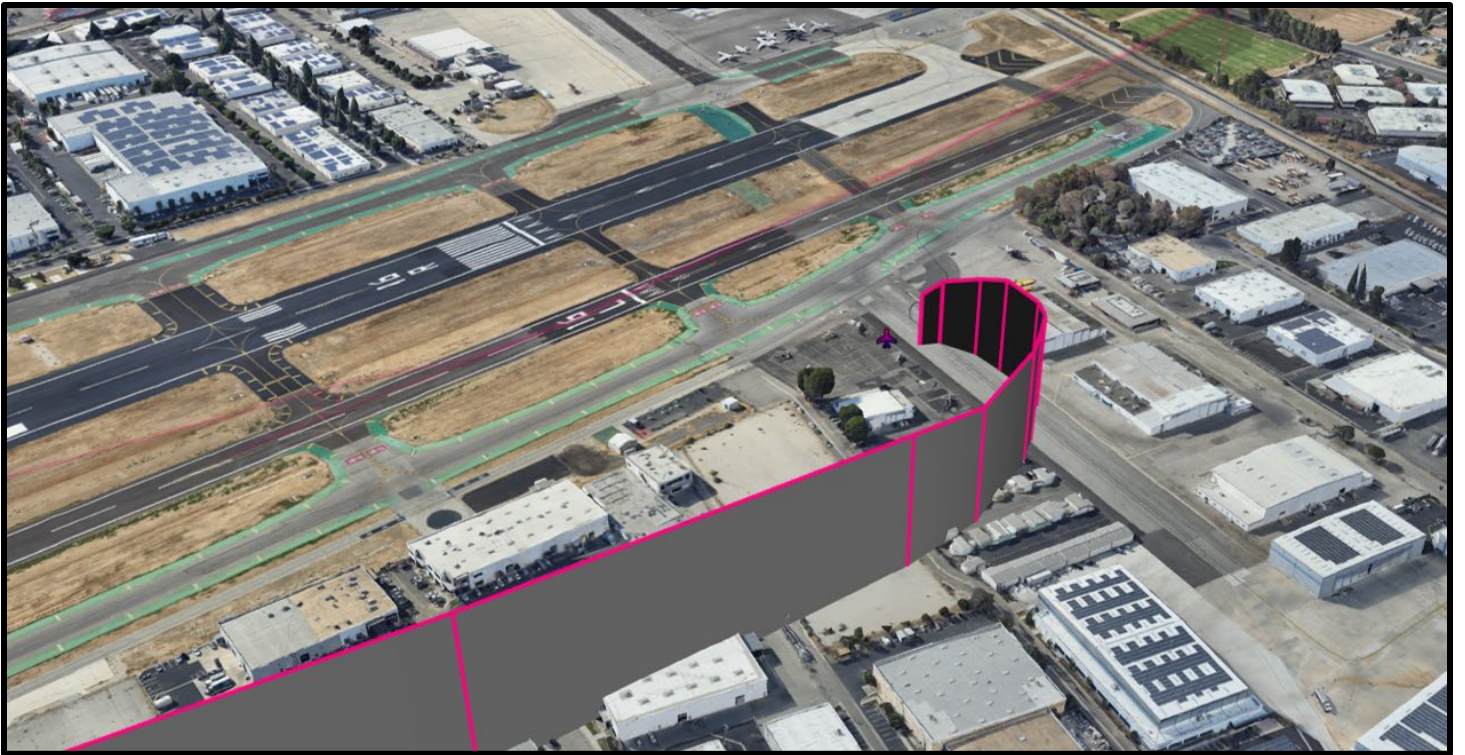
*Figure 3: End of Flight Path*

The controller asked again if the pilot required assistance and the instructor replied “negative, we are landing right now.” Approximately one minute following the transmission indicating a “power loss,” the controller issued a clearance that the airplane could land on any runway. About 10 seconds later, the controller asked what was the nature of their emergency, to which the instructor responded “we are having exhaust gas temperature issues.”

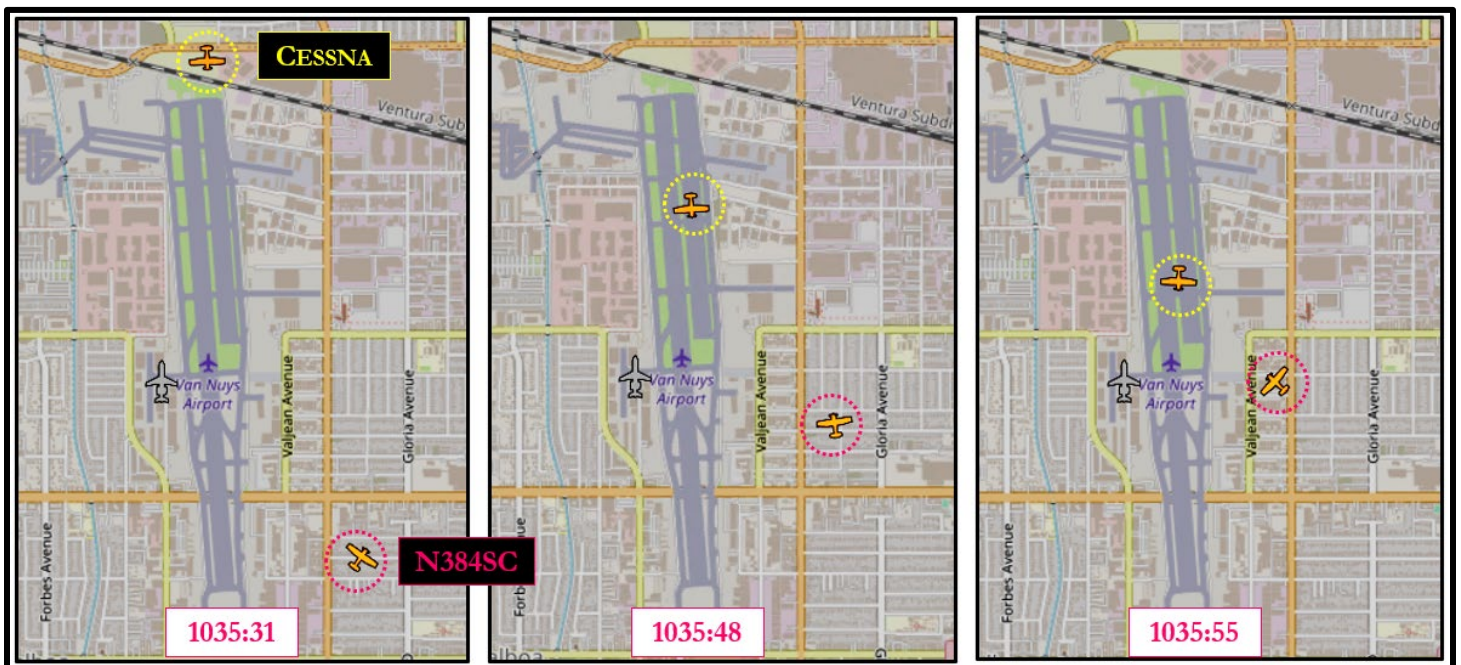
Figure 7: Traffic in the Pattern Part 1 (provided by A-DSB)

A Cessna 172 performed a touch-and-go practice takeoff and landing on runway 16L around the time of the accident. The Cessna touched down about 1035:40 and the controller gave instructions to “go-around” after the accident airplane requested a priority landing.

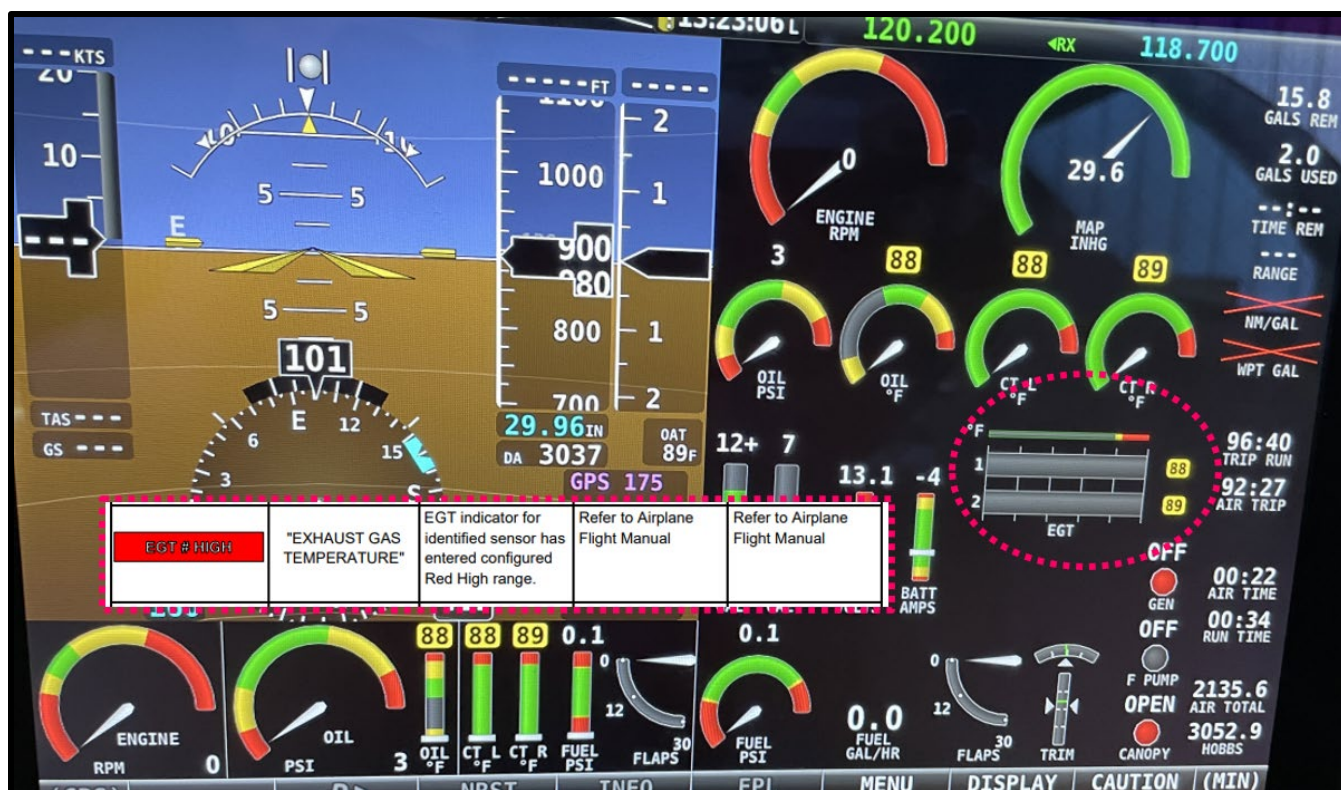
Figure 9: Dynon Screen

The airplane was equipped with a Dynon Skyview system and one Dynon SV-D1000 screen, both of which were burned beyond the possibility of recovering any non-volatile memory. The Dynon alert system provides non-flightpath alerts through a flashing Alert Notification Indicator. This indicator flashes red for warnings, yellow for cautions, and gray for messages. When an alert is triggered, an aural voice will announce either "WARNING," "CAUTION," or "MESSAGE" depending on the alert type.

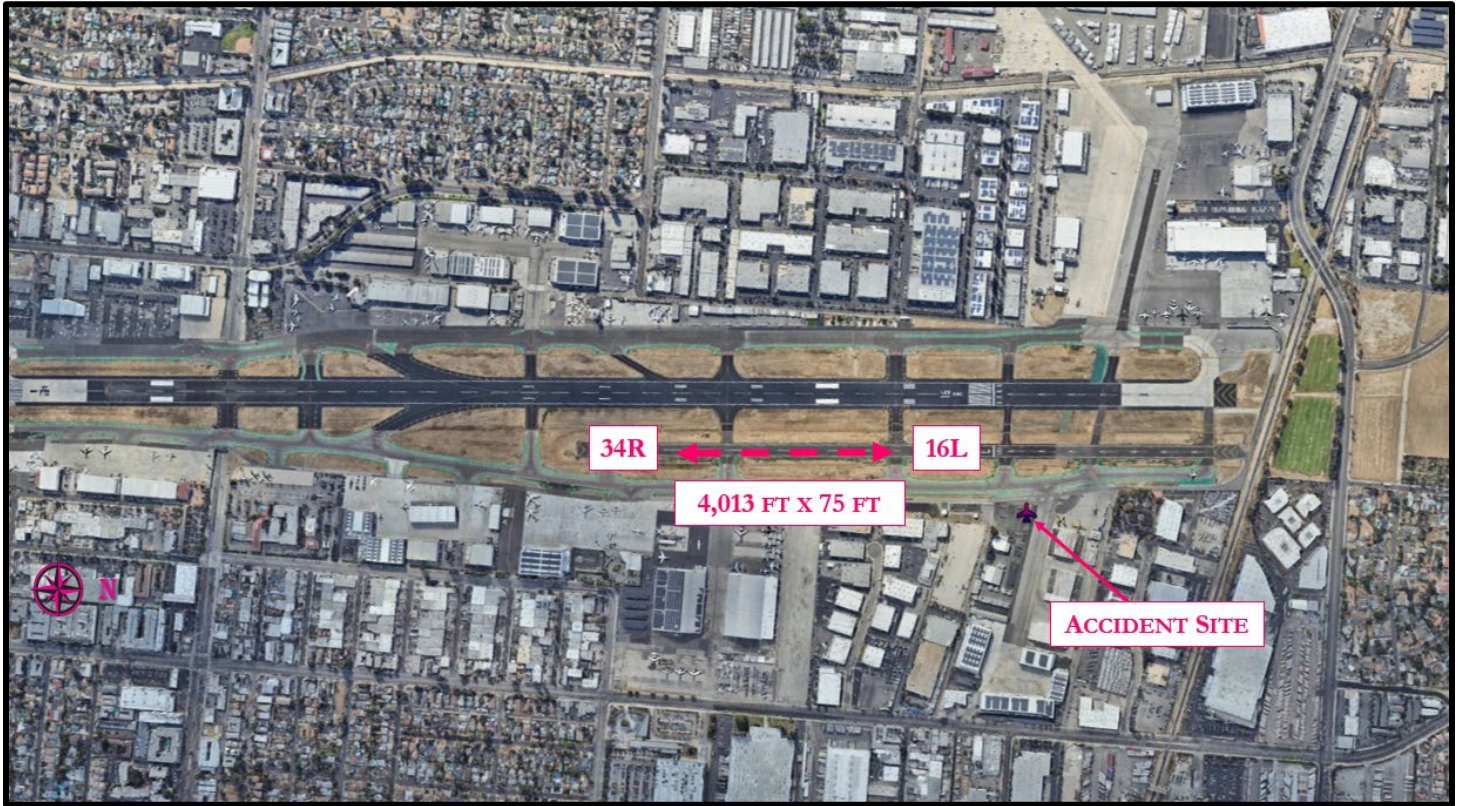
*Figure 11: Airport Environment*

The accident site was located about 425 feet from the edge of runway 16L at the following coordinates: 34.215743, -118.488153. The wreckage was found all within the same vicinity on a heading of 300°. The furthest wreckage was part of the rocket from the BRS system. There were small plexiglass shards in front of the main wreckage. There was no evidence of soot or oil.
