# National Transportation Safety Board

WPR23FA301

## **AIRFRAME AND ENGINE EXAM REPORT**

Location: Idaho City, Idaho  
Date: August 4, 2023  
Time: 10:10  
Airplane: N617G, Glastar with Superior engine.

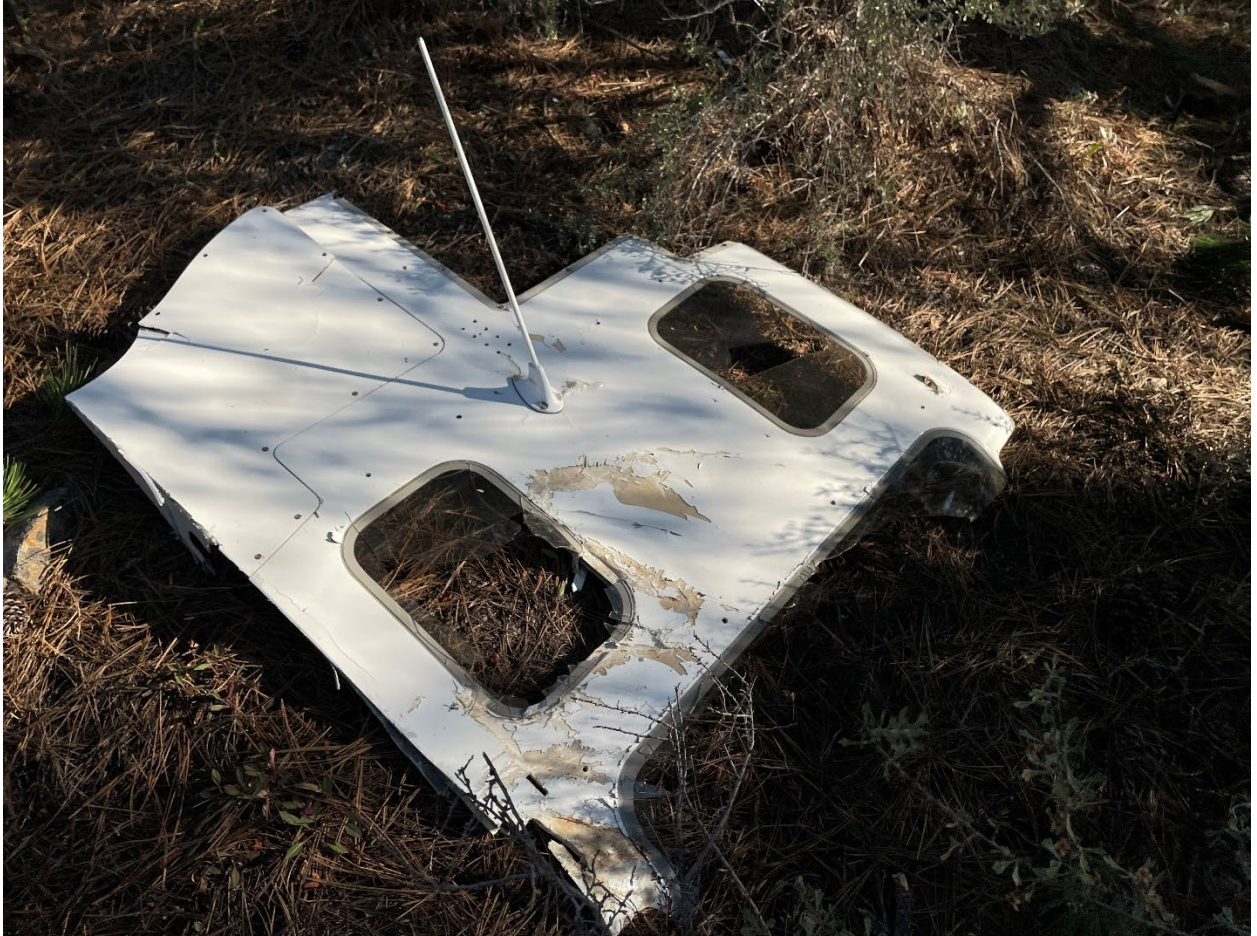
**Figure 6. Top of cabin**

The cockpit area was heavily damaged, consistent with intrusion by a tree. There was no postaccident fire.

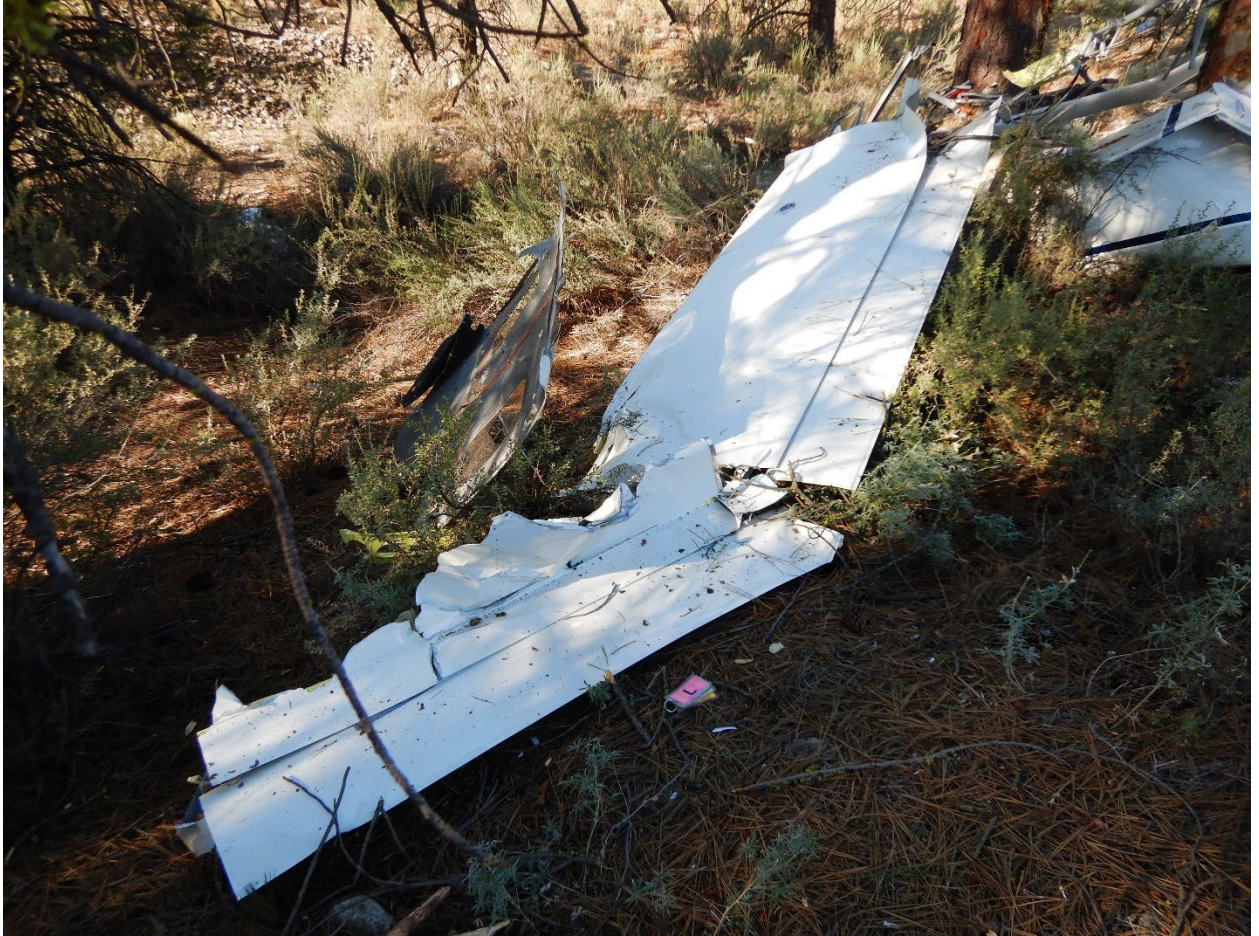
Both wings fractured and separated from the top of the fuselage. The left wing exhibited a circular indentation that started about 3 ft inboard of the wing tip and progressed outboard. The wing tip and about 1 ft of the wing fractured and separated from the wing. The left-wing fuel tank remained secured and contained an undetermined amount of fuel. The quantity of fuel was easily observed in the tank and indicated an abundant amount of fuel. The left-wing aileron remained attached to the wing and exhibited spanwise damage. The left-wing flap remained attached to the wing and exhibited minor damage. The flap indicated zero degrees flaps set. The lift strut had separated from the fuselage.

**Figure 7. Left wing, aileron, and flap.**

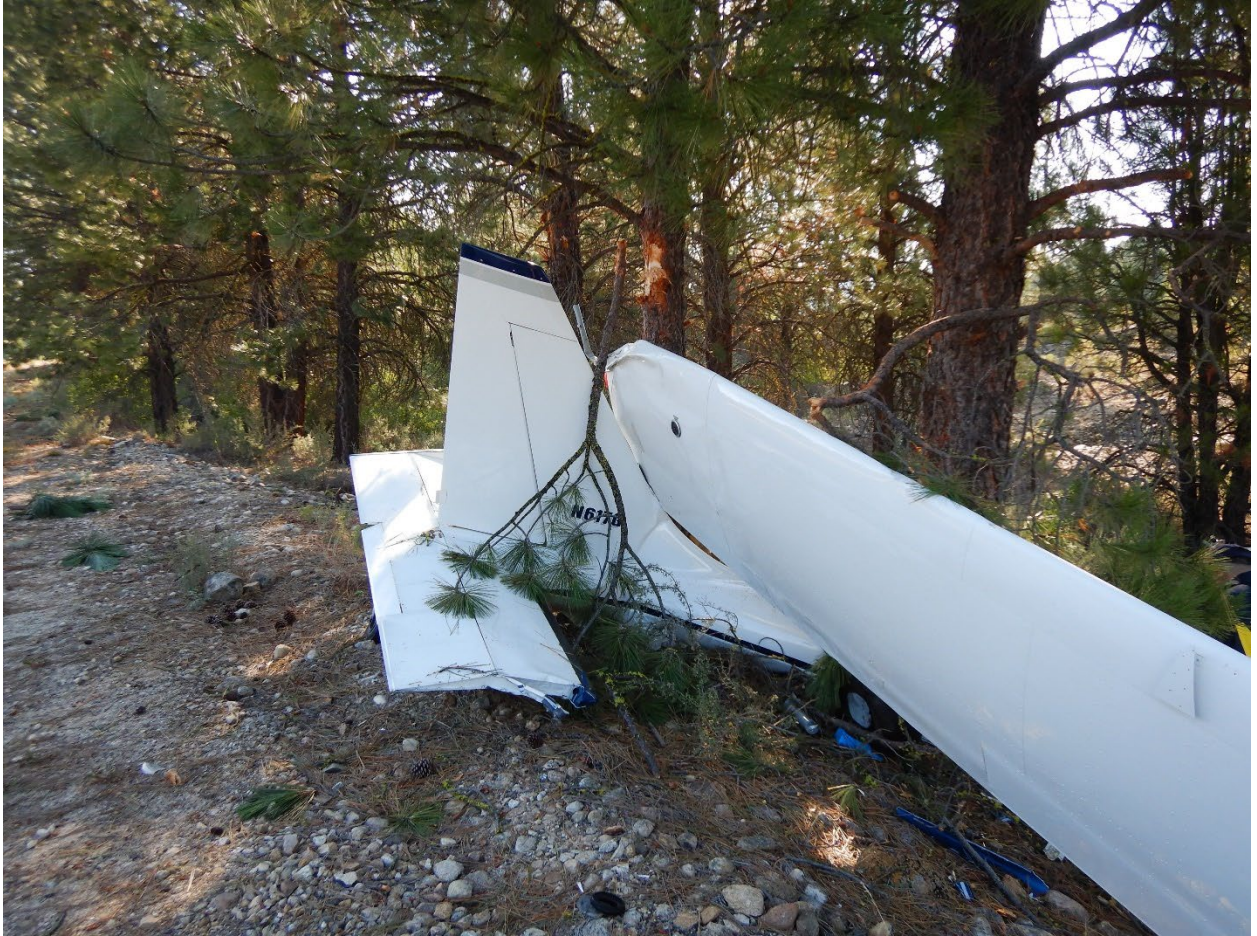
The right wing fractured and separated from the top of the fuselage. The wing came to rest between the wreckage and tree D. There was a circular indentation at the root of the leading edge that was adjacent to tree D. The right-wing aileron remained attached to the wing and exhibited minor damage. The right-wing flap remained attached to the wing and exhibited minor damage. An abundant amount of fuel remained in the right-wing tank. The lift strut separated from the fuselage.

**Figure 11. Right wing upper surface, empennage right side.**

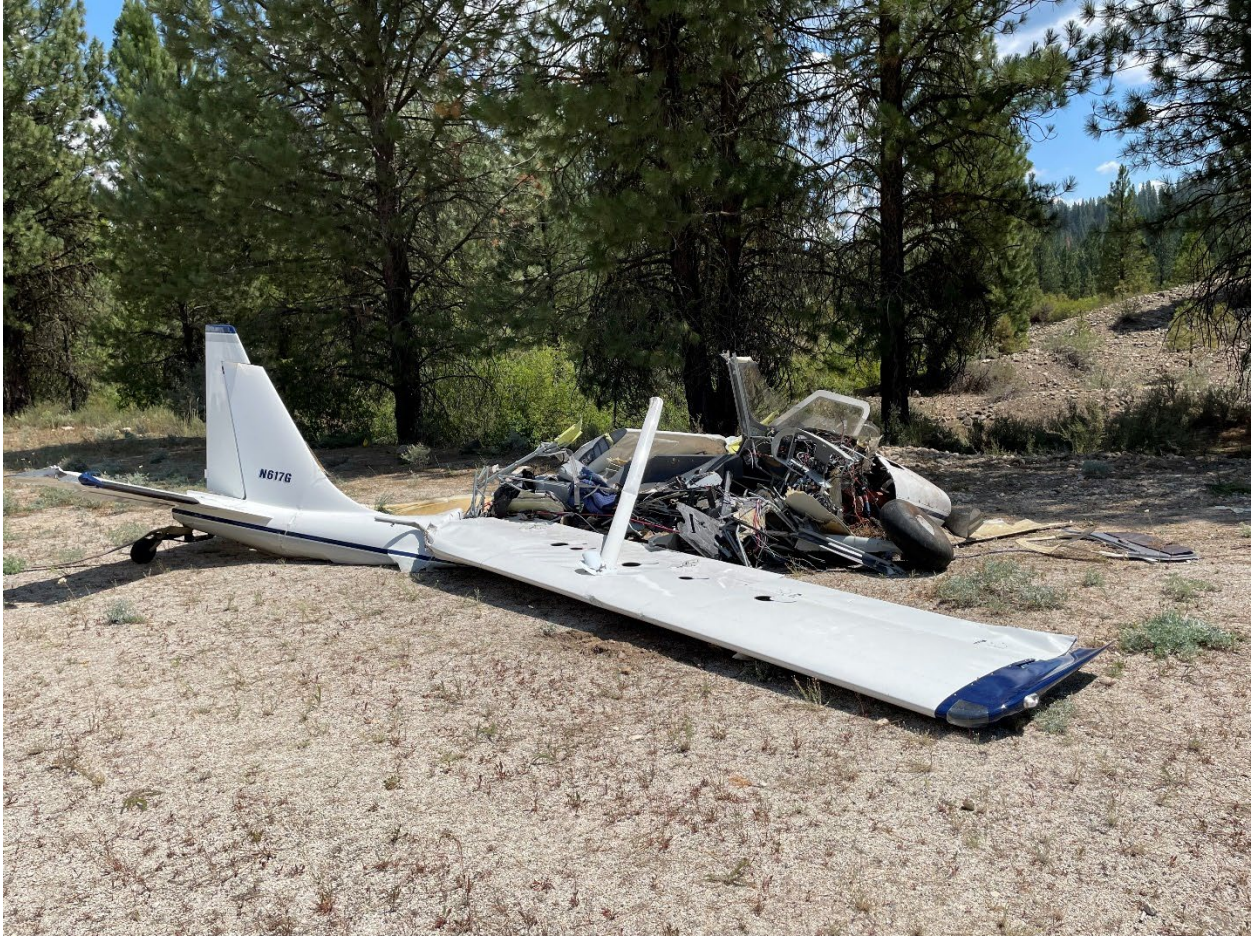
**Figure 12. Right wing underside, aileron, and flap**

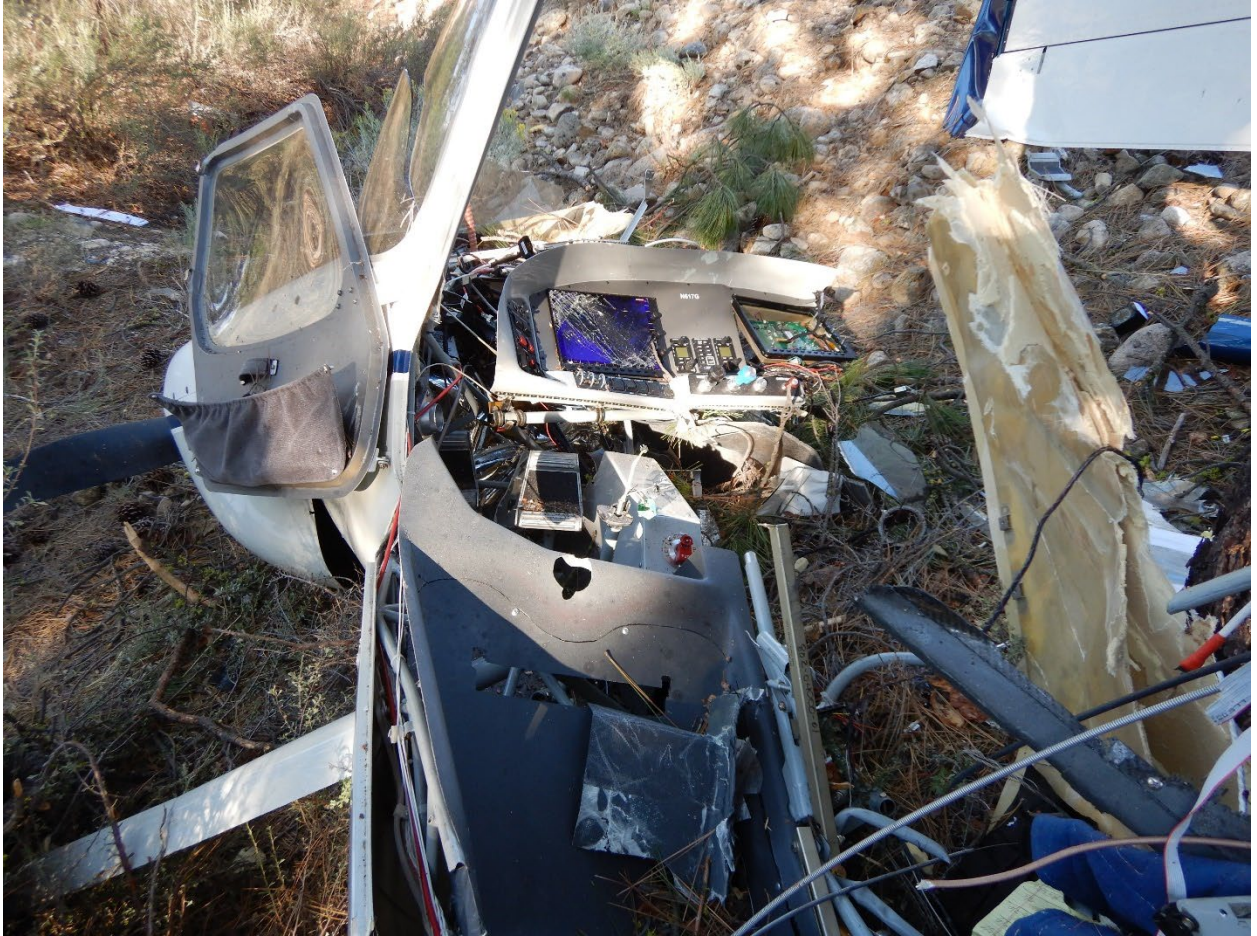
The cockpit was destroyed. The instrument panel was damaged; however, the two electronic displays were recovered and retained for possible download of data. There were no conventional gauges installed on the instrument panel, The seats were damaged, and their track position was undetermined. In a conversation with a fellow pilot, who owned a very similar airplane, the seats were not the type that could easily be repositioned inside the airplane. It was explained that to reposition the seats, the person would have to exit the airplane to make the adjustment.

The throttle was positioned in the full forward position (full power). The propeller handle was positioned in the full forward position (high RPM). The mixture lever was separated from the throttle quadrant and found in the debris.

**Figure 13. Cockpit**

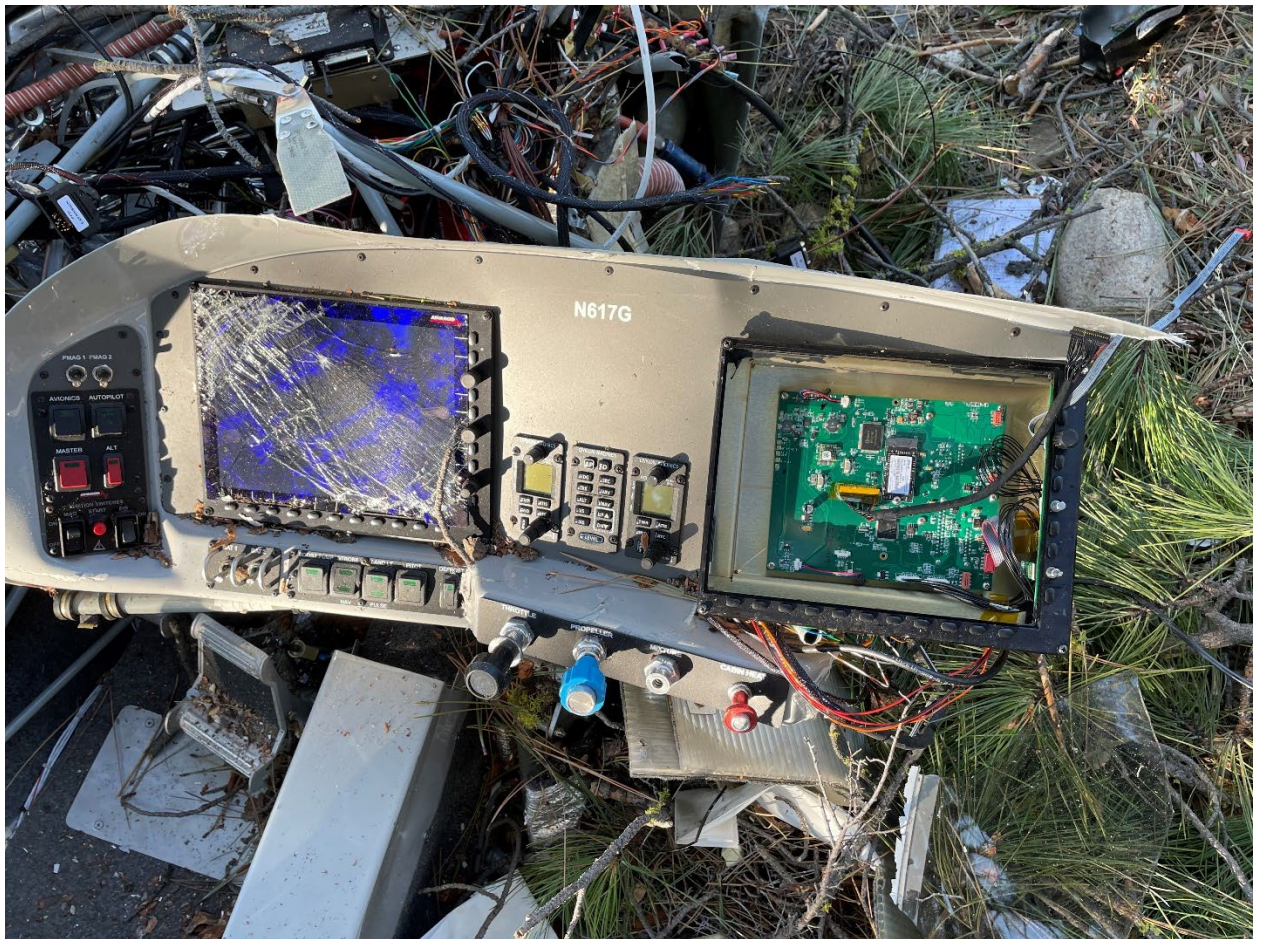
**Figure 14. Instrument panel**

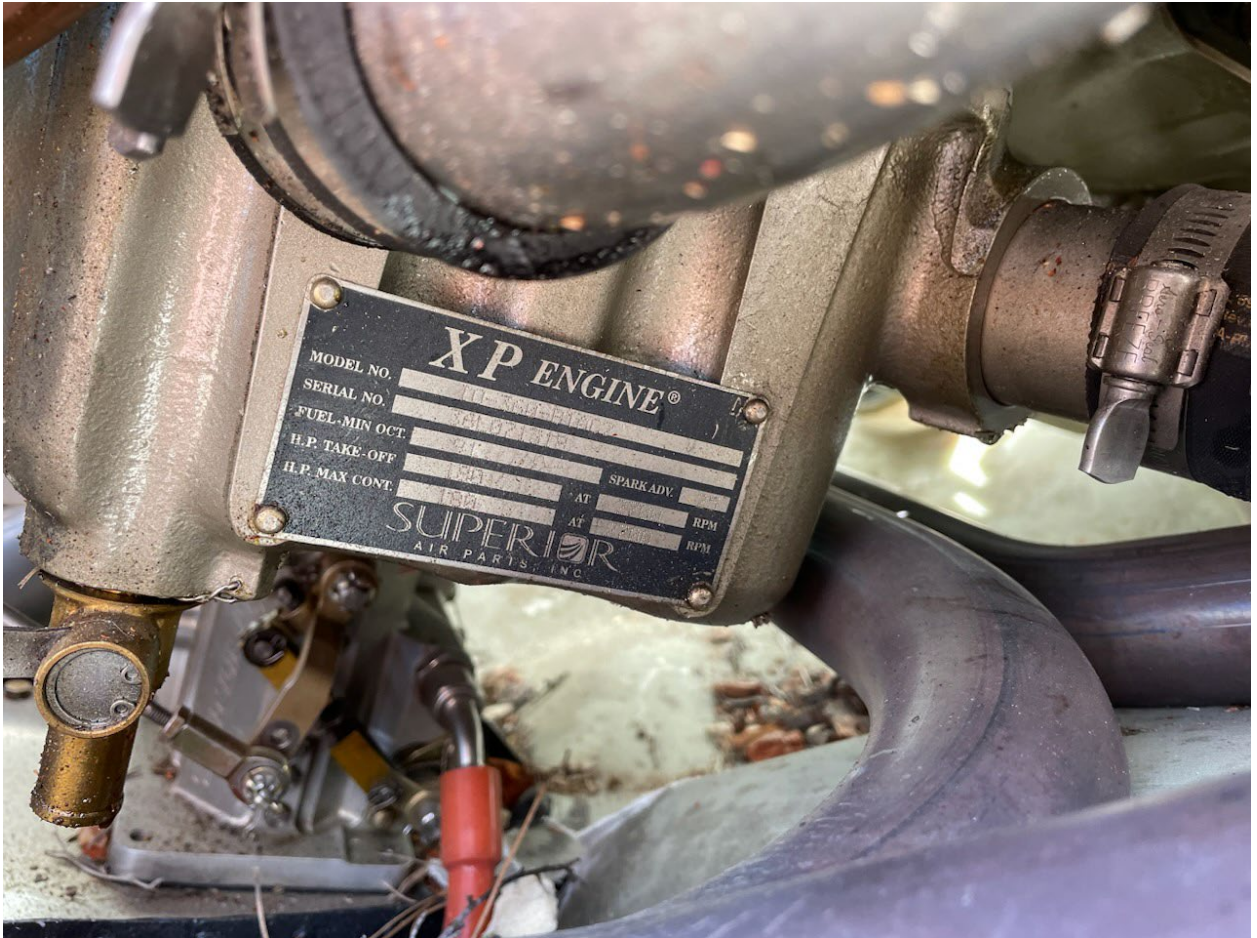
Figure 17. Engine data plate

The engine was manufactured by Superior Air Parts Inc. Model: IO-360-B1AC2, serial number: 361071318, rated at 180 horsepower. The engine remained attached to the undamaged engine mounts that remained attached to the fire wall. The engine exhibited no damage, when viewed from above. There was sufficient oil in the case. There were no signs of damage to the engine case or cylinders.

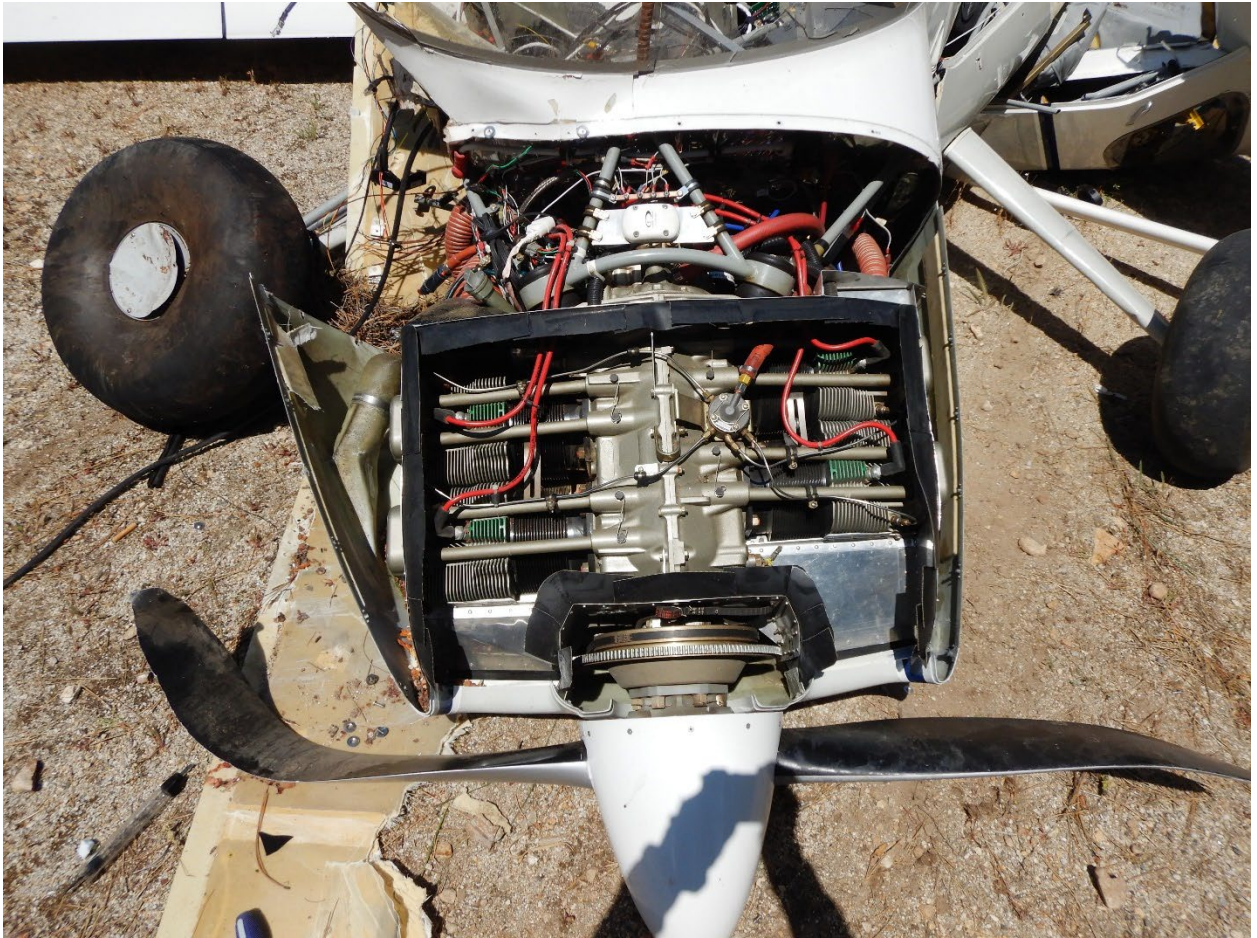
February 7, 2024. Engine examination performed. The engine was located at a hangar at the Nampa Airport (MAN), Nampa, Idaho. The engine did not exhibit signs of heavy impact damage and exhibited only minor damage to external components. The intake tubes and the exhaust tubes, located at the bottom of the engine were not crushed. The fuel servo, located at the bottom of the engine exhibited minor impact damage. The air filter attached to the fuel servo exhibited upward crush damage.

**Figure 18. Engine and propeller**
