**NATIONAL TRANSPORTATION SAFETY BOARD**  
Office of Aviation Safety

**Wreckage Examination Report**

**A. ACCIDENT      WPR23LA022**

Location:            Nogales, New Mexico  
Date:                October 20, 2022  
Time:                1258 MST  
Operator:           Private  
Aircraft:            Beech V35B  
Registration:       N50JM

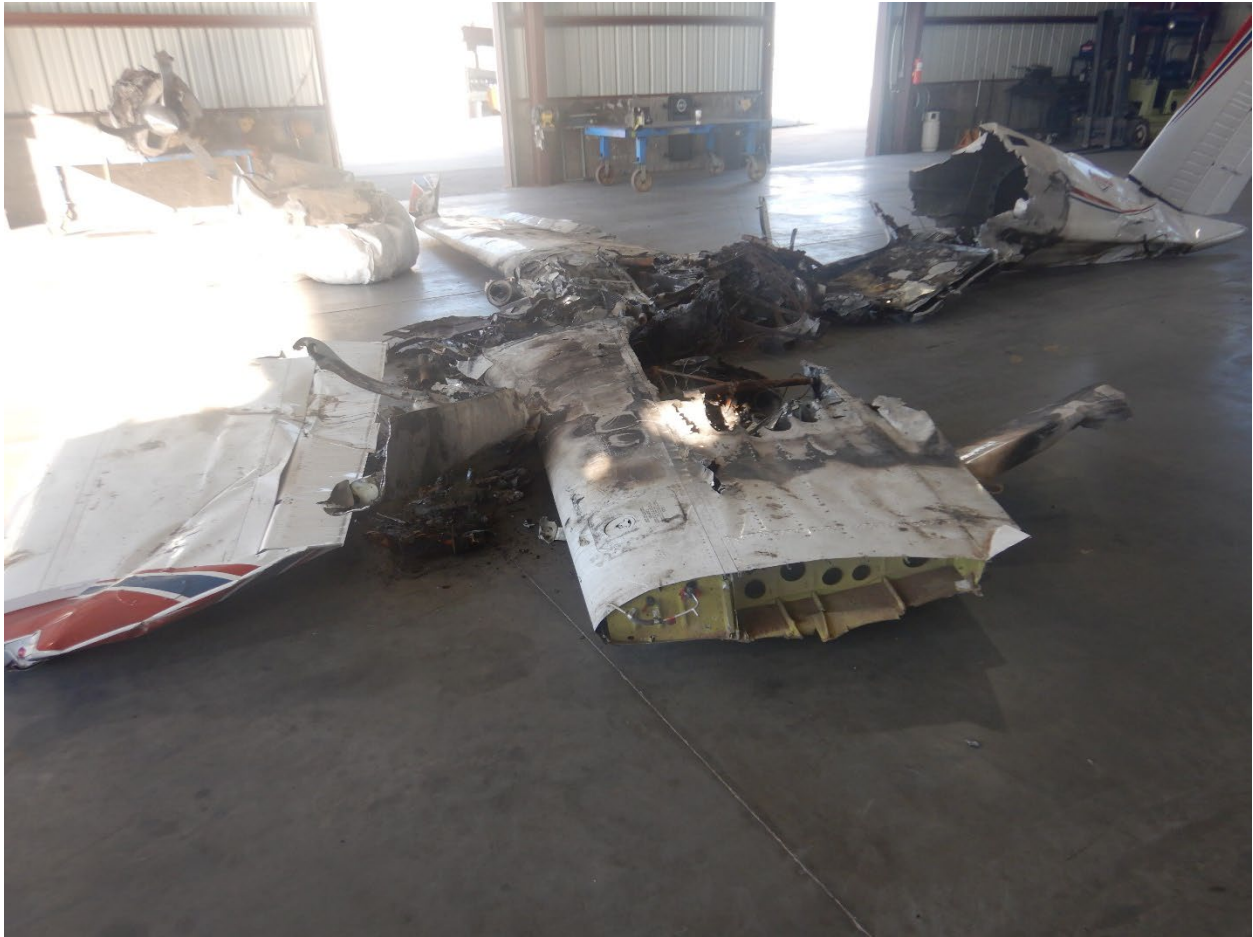
*Photograph 2: Aircraft layout for exam*

The inboard left wing had separated from fuselage at the wing attach fittings and the outboard portion of the wing was separated by recovery personnel about midspan. The right wing remained attached to the fuselage. Both ailerons and flaps remained attached to the trailing edges of their respective wings. The right wing flap and aileron were damaged by postcrash fire. The left outboard underside of the left wing and wing cap exhibited scratching from ground contact.

The elevator/rudder control surfaces remained attached to the empennage, which had separated from the airplane. Both trim tabs remained attached at the trailing edges of the elevator/rudder control surfaces.
