## **Engine Investigation Report**

**Model: T63-A-720**

**Serial: AE-405882**

**Accident Date: 6 February 2023  
Wreckage Exam Date: 13 June 2023  
Engine Exam Date: 28 November 2023  
Report Date: 2 January 2024  
NTSB Case: WPR23LA107**

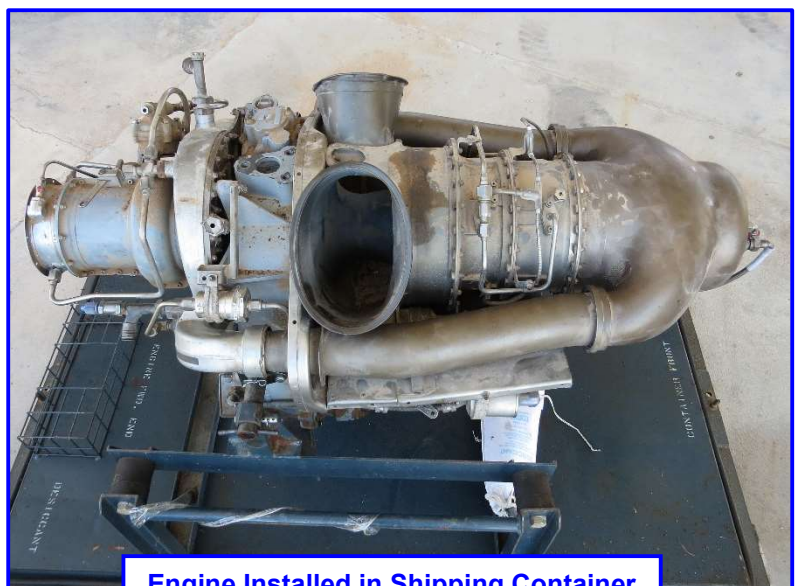
**Engine Installed in Shipping Container**

The engine was removed from the aircraft with little to no complications & placed in an awaiting shipping container provided by Rolls-Royce Air Safety. The engine was shipped to Arrow Aviation in Broussard, Louisiana for further examination.

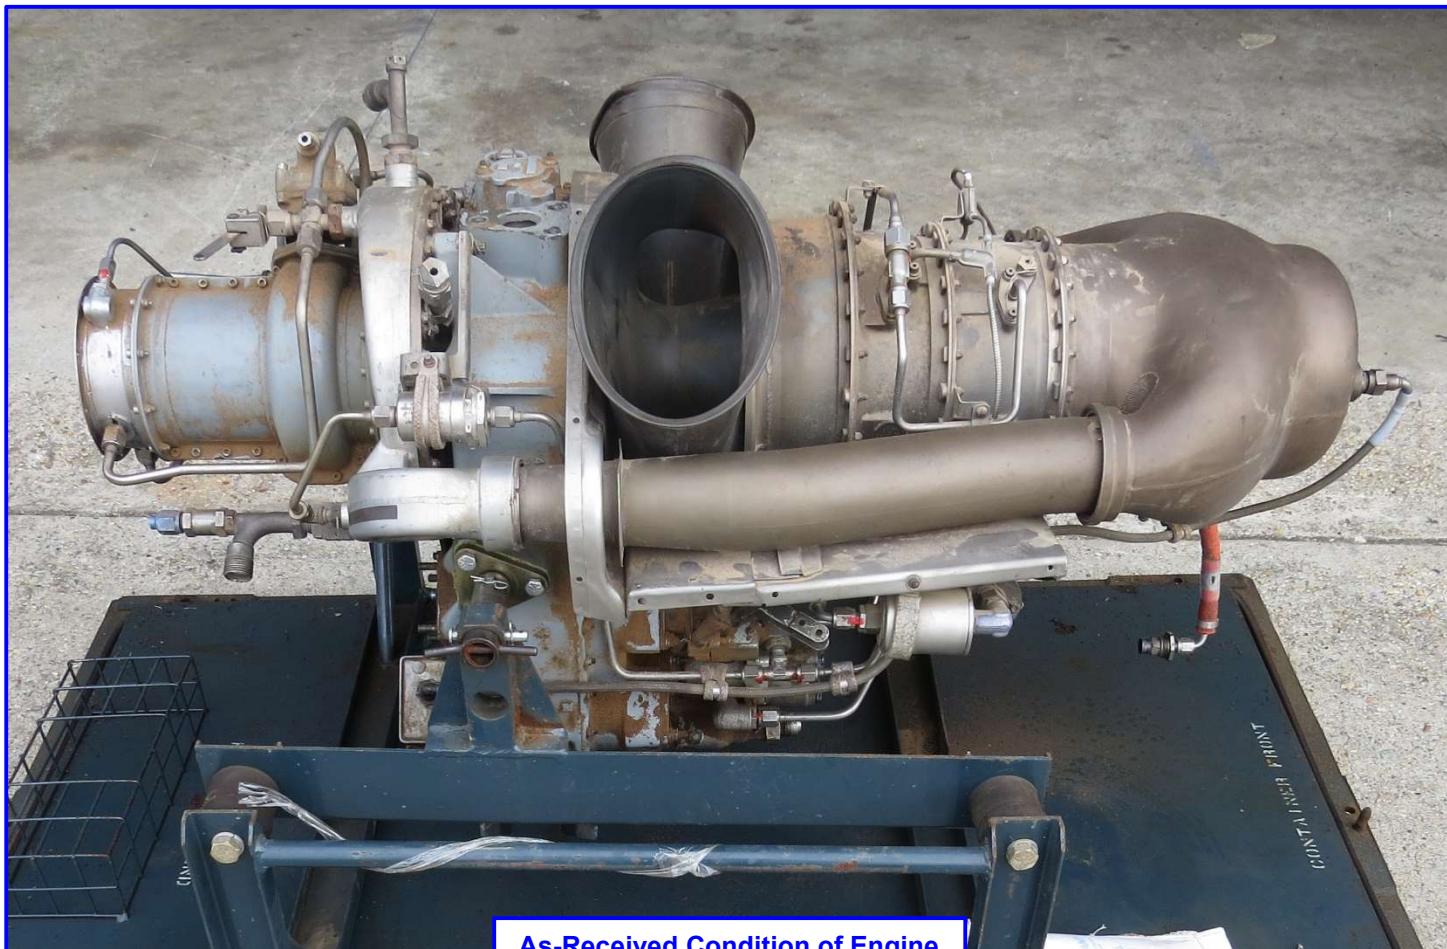
As-Received Condition of Engine

The engine was placed in a turnover stand and rotated upside down while accessing the pressure oil filter in the accessory gearbox. The oil filter bowl was drained into a bucket. Approximately 30 cc of clear, odor free oil was collected in the bucket. Small bits of non-metallic dirt or similar debris was observed in the bottom of the bucket that likely fell from external engine surfaces during the engine rotation.

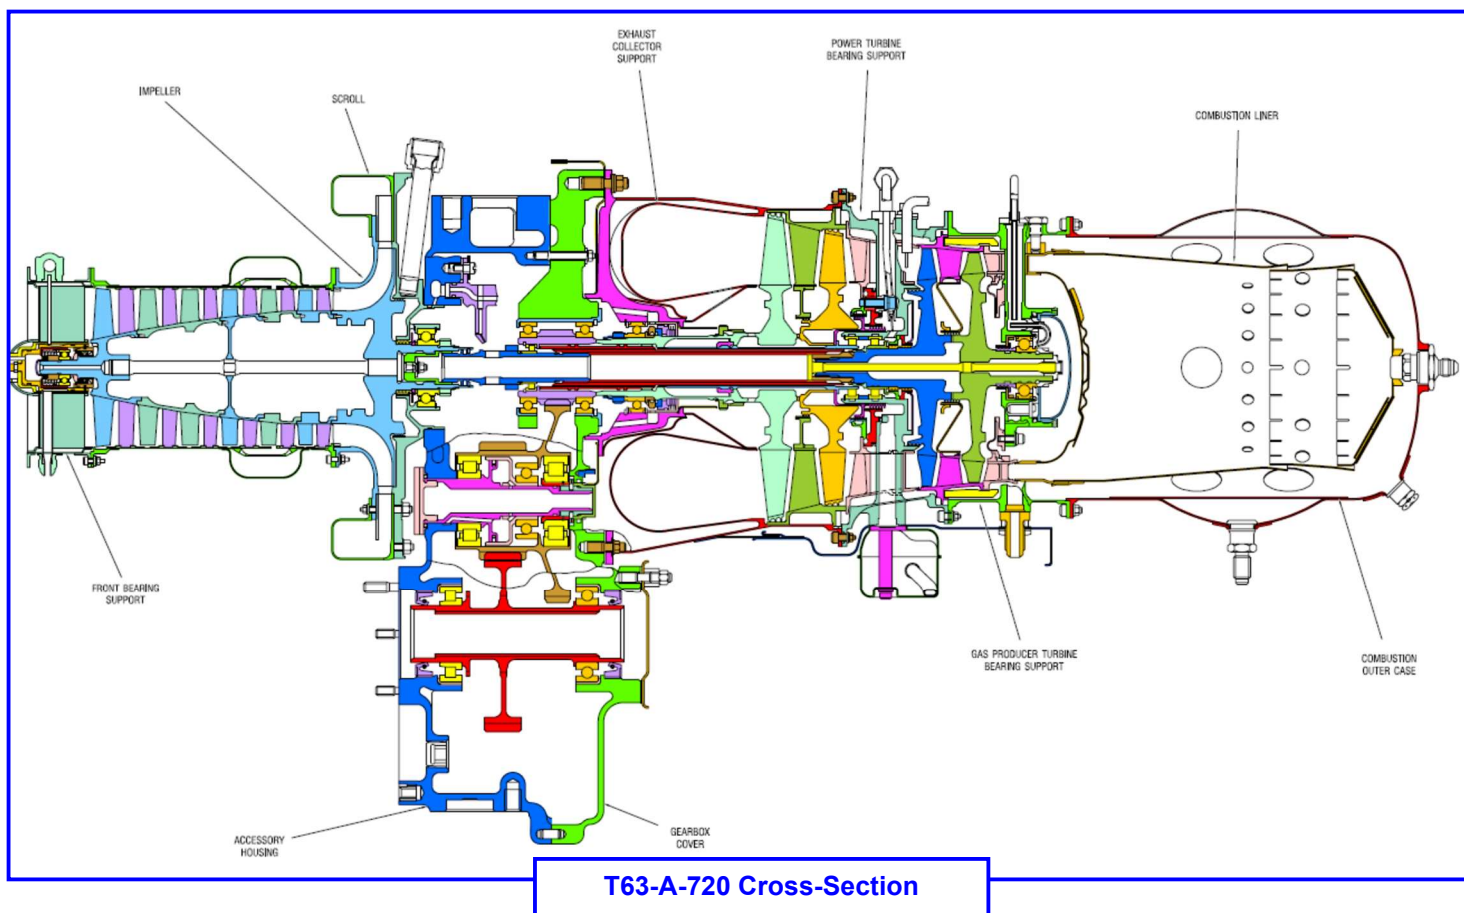
The engine successfully started, ran & shut down. When corrected for standard atmospheric conditions, the engine yielded performance -14.3% below new-production standards at “low cruise” (300 horsepower), -11.9% below new production standards at normal cruise (370 horsepower), and -2.6% below new production standards at maximum (Take-Off) power (420 horsepower) achieving a maximum predicted 409 SHP at the specification 1490°F MGT (measured gas temperature). The performance data was reflective of the engine hitting the max allowable MGT limit at each of the 5 calibration points before achieving the specified horsepower value.

The engine’s test performance was likely indicative of the noted dirty compressor condition. Additionally, a slight leak was noted during the run at the anti-ice valve that was hard-wired in the closed position by the operator. The burner drain valve on the outer combustion case was also noted as having an air leak during test.
