National Transportation Safety Board

WPR23LA184

**INVESTIGATIVE SUPPLEMENTAL MATERIAL**

Location: Creswell, Oregon  
Date: 05.09.2023  
Time: 1750 Pacific standard time  
Airplane: Rans S-21

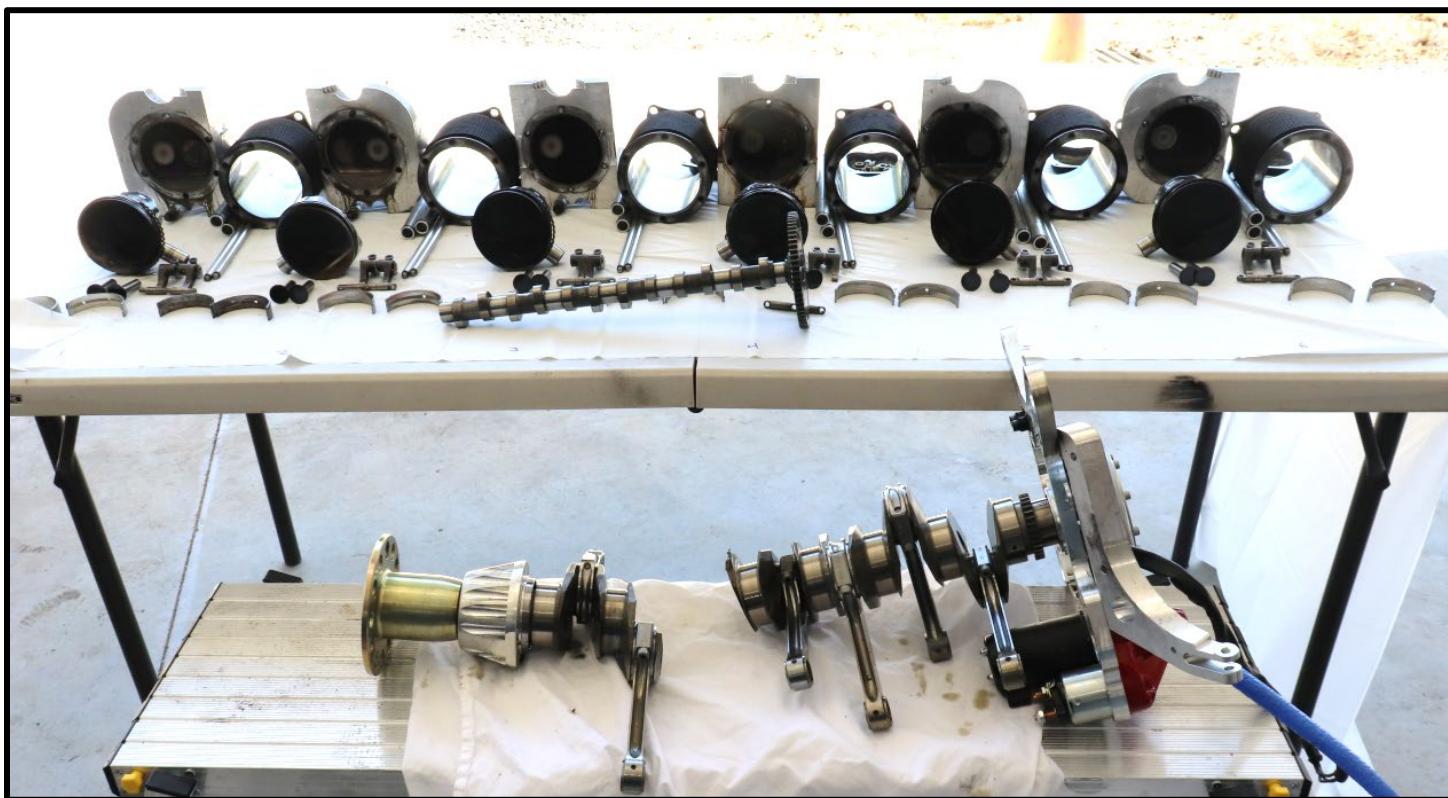
*Figure 5: Cylinders, Pistons, Tappets, Bearings with Crankshaft*

Upon applying force to the propeller, the engine would not rotate through. Removal of the pistons revealed that the crankshaft was fractured at a web, just aft of the journal of the No. 2 connecting rod. The thrust bearing mount was able to move forward and aft.

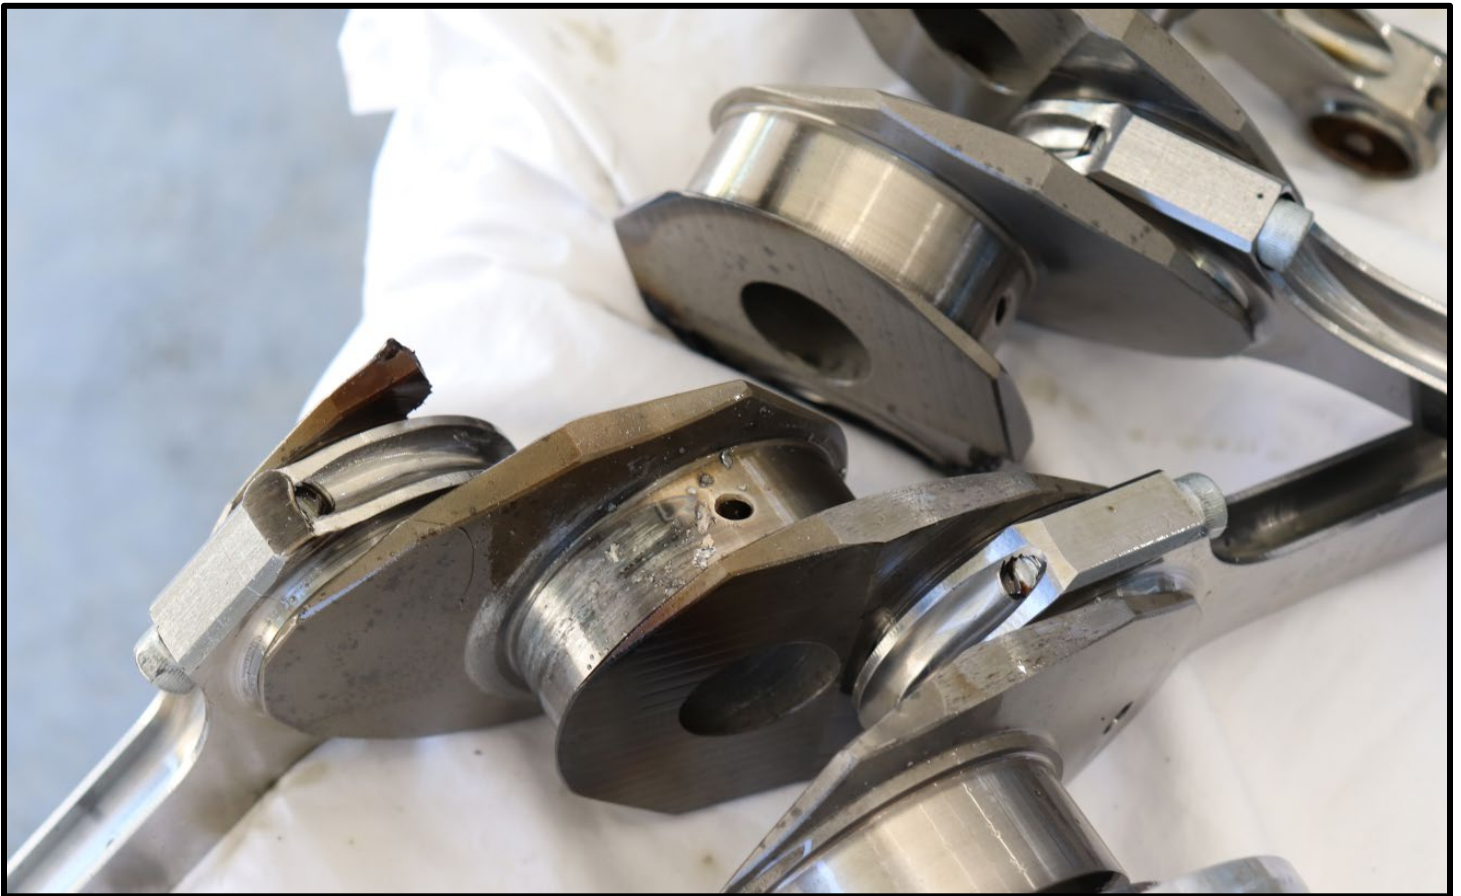
*Figure 8: Journal Adjacent to Fracture Surface*

The fracture exhibited a half-moon shape, having proceeded through approximately half the web. The fracture surface was relatively shiny and reflective, with some areas of heat tinting on the forward face. The preliminary assessment of the fracture surfaces were consistent with a fatigue fracture at the radius on the connecting rod journal
