VIKING AIR DHC-6-400 TWIN OTTER  
FAA REGISTRATION: N153QS  
NTSB ACCIDENT NO: WPR23LA192  
PROJECT FINAL REPORT

**DATE:** March 06, 2023

**Submitted To:**  
Richard Ball  
Lone Star Retrieval (LSR)

**Submitted By:**  
Eclipse Group, Inc.

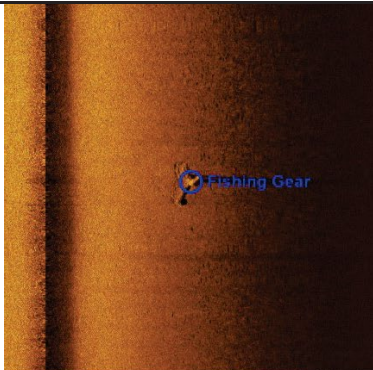
| Target Image | Target Info | User Entered Info |
|---|---|---|
| | <b>Fishing Gear</b> <ul style="list-style-type: none"> <li>Sonar Time at Target: 7/28/2023 6:58:20 PM</li> <li>Click Position<br/>37.4723023607 -123.0279761363 (WGS84)<br/>(X) 497526.27 (Y) 4147268.87 (Projected)</li> <li>Map Projection: EPSG:26910</li> <li>Acoustic Source File: HMB_209_0500_1822.jsf</li> <li>Ping Number: 23826</li> <li>Range to target: 46.88 Meters</li> <li>Fish Height: 15.53 Meters</li> <li>Heading: 175.600 Degrees</li> <li>Course Made Good: 160.604 Degrees</li> <li>Event Number: (-1)</li> <li>Line Name: HMB_209_0500_1822</li> <li>Water Depth: 496.03 Meters</li> </ul> | <b>Dimensions and Attributes</b> <ul style="list-style-type: none"> <li>Target Width: 4.20 Meters</li> <li>Target Height: 7.02 Meters</li> <li>Target Length: 11.71 Meters</li> <li>Target Shadow: 38.65 Meters</li> <li>Mag Anomaly: N/A</li> <li>Avoidance Area: N/A</li> <li>Classification1: N/A</li> <li>Classification2: N/A</li> <li>Area: N/A</li> <li>Block: N/A</li> <li>Description: N/A</li> </ul> |

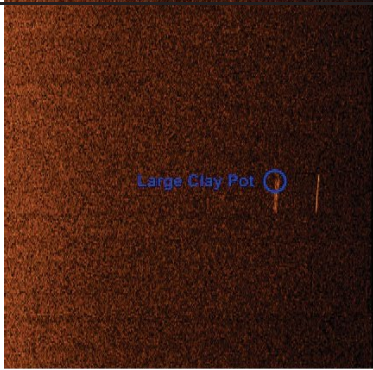
| Target Image | Target Info | User Entered Info |
|---|---|---|
| | <b>Large Clay Pot</b> <ul style="list-style-type: none"> <li>Sonar Time at Target: 8/2/2023 11:52:02 AM</li> <li>Click Position<br/>37.5269339012 -123.1203485472 (WGS84)<br/>(X) 489366.20 (Y) 4153336.27 (Projected)</li> <li>Map Projection: EPSG:26910</li> <li>Acoustic Source File: HMB_214_1517_1132.jsf</li> <li>Ping Number: 1594827</li> <li>Range to target: 102.25 Meters</li> <li>Fish Height: 16.79 Meters</li> <li>Heading: 322.390 Degrees</li> <li>Course Made Good: 339.742 Degrees</li> <li>Event Number: (-1)</li> <li>Line Name: HMB_214_1517_1132</li> <li>Water Depth: 909.36 Meters</li> </ul> | <b>Dimensions and Attributes</b> <ul style="list-style-type: none"> <li>Target Width: 0.92 Meters</li> <li>Target Height: 0.20 Meters</li> <li>Target Length: 8.73 Meters</li> <li>Target Shadow: 1.22 Meters</li> <li>Mag Anomaly: N/A</li> <li>Avoidance Area: N/A</li> <li>Classification1: N/A</li> <li>Classification2: N/A</li> <li>Area: N/A</li> <li>Block: N/A</li> <li>Description: N/A</li> </ul> |

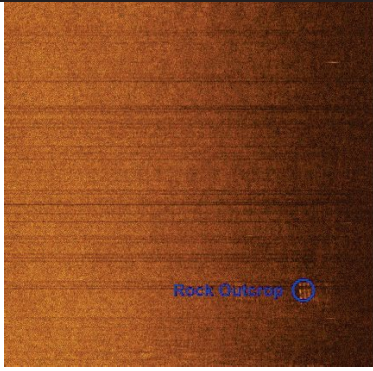
| Target Image | Target Info | User Entered Info |
|---|---|---|
| | <b>Rock Outcrop</b> <ul style="list-style-type: none"> <li>Sonar Time at Target: 6/26/2023 6:27:28 PM</li> <li>Click Position<br/>37.4840733510 -123.0238912592 (WGS84)<br/>(X) 497887.80 (Y) 4148574.67 (Projected)</li> <li>Map Projection: EPSG:26910</li> <li>Acoustic Source File:<br/>HalfMoonBay_SSS_20230626_Line41.002.jsf</li> <li>Ping Number: 116253</li> <li>Range to target: 423.27 Meters</li> <li>Fish Height: 56.33 Meters</li> <li>Heading: 147.890 Degrees</li> <li>Course Made Good: 159.950 Degrees</li> <li>Event Number: (-1)</li> <li>Line Name:<br/>HalfMoonBay_SSS_20230626_Line41.002</li> <li>Water Depth: 412.09 Meters</li> </ul> | <b>Dimensions and Attributes</b> <ul style="list-style-type: none"> <li>Target Width: 2.50 Meters</li> <li>Target Height: 0.00 Meters</li> <li>Target Length: 19.39 Meters</li> <li>Target Shadow: 0.00 Meters</li> <li>Mag Anomaly: N/A</li> <li>Avoidance Area: N/A</li> <li>Classification1: N/A</li> <li>Classification2: N/A</li> <li>Area: N/A</li> <li>Block: N/A</li> <li>Description: N/A</li> </ul> |

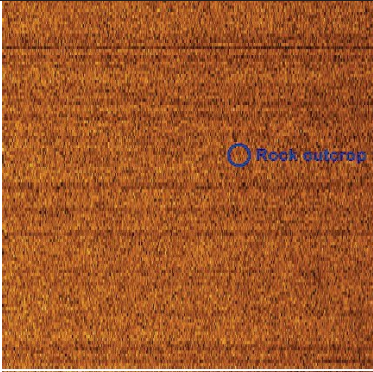
| | <p><b>Rock Outcrop</b></p> <ul style="list-style-type: none"> <li>• Sonar Time at Target: 7/28/2023 6:33:17 PM</li> <li>• Click Position<br/>37.4898030410 -123.0351935227 (WGS84)<br/>(X) 496888.82 (Y) 4149210.65 (Projected)</li> <li>• Map Projection: EPSG:32610</li> <li>• Acoustic Source File: HMB_209_0500_1822.jsf</li> <li>• Ping Number: 15197</li> <li>• Range to target: 29.12 Meters</li> <li>• Fish Height: 15.38 Meters</li> <li>• Heading: 173.890 Degrees</li> <li>• Course Made Good: 160.201 Degrees</li> <li>• Event Number: (-1)</li> <li>• Line Name: HMB_209_0500_1822</li> <li>• Water Depth: 490.24 Meters</li> </ul> | <p><b>Dimensions and Attributes</b></p> <ul style="list-style-type: none"> <li>• Target Width: 1.28 Meters</li> <li>• Target Height: 0.57 Meters</li> <li>• Target Length: 5.91 Meters</li> <li>• Target Shadow: 1.02 Meters</li> <li>• Mag Anomaly: N/A</li> <li>• Avoidance Area: N/A</li> <li>• Classification1: N/A</li> <li>• Classification2: N/A</li> <li>• Area: N/A</li> <li>• Block: N/A</li> <li>• Description: N/A</li> </ul> |

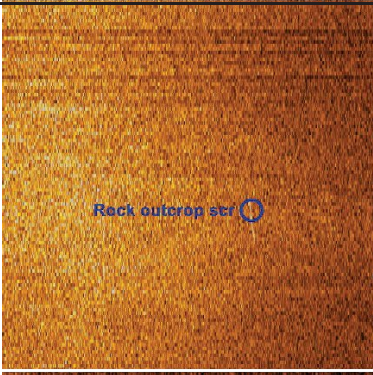
| | <p><b>Rock Outcrop</b></p> <ul style="list-style-type: none"> <li>• Sonar Time at Target: 6/25/2023 6:32:14 PM</li> <li>• Click Position<br/>37.5200139187 -123.1149645963 (WGS84)<br/>(X) 489840.98 (Y) 4152567.95 (Projected)</li> <li>• Map Projection: EPSG:26910</li> <li>• Acoustic Source File:<br/>HalfMoonBaySSS_20230625_Line26.001.jsf</li> <li>• Ping Number: 179533</li> <li>• Range to target: 135.70 Meters</li> <li>• Fish Height: 72.59 Meters</li> <li>• Heading: 321.690 Degrees</li> <li>• Course Made Good: 340.257 Degrees</li> <li>• Event Number: (-1)</li> <li>• Line Name:<br/>HalfMoonBay_SSS_20230625_Line26.001</li> <li>• Water Depth: 727.16 Meters</li> </ul> | <p><b>Dimensions and Attributes</b></p> <ul style="list-style-type: none"> <li>• Target Width: 0.55 Meters</li> <li>• Target Height: 0.00 Meters</li> <li>• Target Length: 14.26 Meters</li> <li>• Target Shadow: 0.00 Meters</li> <li>• Mag Anomaly: N/A</li> <li>• Avoidance Area: N/A</li> <li>• Classification1: N/A</li> <li>• Classification2: N/A</li> <li>• Area: N/A</li> <li>• Block: N/A</li> <li>• Description: N/A</li> </ul> |

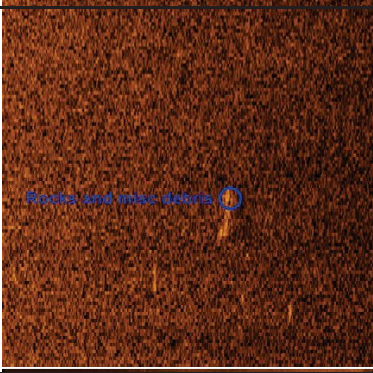
| | <p><b>Rocks and Misc Debris</b></p> <ul style="list-style-type: none"> <li>• Sonar Time at Target: 8/3/2023 6:43:50 AM</li> <li>• Click Position<br/>37.5247514729 -123.1270680664 (WGS84)<br/>(X) 488772.15 (Y) 4153094.92 (Projected)</li> <li>• Map Projection: EPSG:26910</li> <li>• Acoustic Source File: HMB_215_1521_0626.jsf</li> <li>• Ping Number: 1961992</li> <li>• Range to target: 51.81 Meters</li> <li>• Fish Height: 14.58 Meters</li> <li>• Heading: 324.500 Degrees</li> <li>• Course Made Good: 340.086 Degrees</li> <li>• Event Number: (-1)</li> <li>• Line Name: HMB_215_1521_0626</li> <li>• Water Depth: 907.30 Meters</li> </ul> | <p><b>Dimensions and Attributes</b></p> <ul style="list-style-type: none"> <li>• Target Width: 0.93 Meters</li> <li>• Target Height: 0.40 Meters</li> <li>• Target Length: 4.04 Meters</li> <li>• Target Shadow: 1.46 Meters</li> <li>• Mag Anomaly: N/A</li> <li>• Avoidance Area: N/A</li> <li>• Classification1: N/A</li> <li>• Classification2: N/A</li> <li>• Area: N/A</li> <li>• Block: N/A</li> <li>• Description: N/A</li> </ul> |

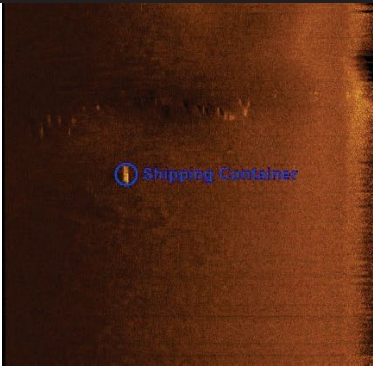
| | <p><b>Shipping Container</b></p> <ul style="list-style-type: none"> <li>• Sonar Time at Target: 6/26/2023 5:03:54 PM</li> <li>• Click Position<br/>37.5557395281 -123.0477922269 (WGS84)<br/>(X) 495778.78 (Y) 4156526.33 (Projected)</li> <li>• Map Projection: EPSG:26910</li> <li>• Acoustic Source File:<br/>HalfMoonBay_SSS_20230626_Line41.001.jsf</li> <li>• Ping Number: 109027</li> <li>• Range to target: 334.46 Meters</li> <li>• Fish Height: 50.22 Meters</li> <li>• Heading: 146.790 Degrees</li> <li>• Course Made Good: 159.282 Degrees</li> <li>• Event Number: (-1)</li> <li>• Line Name:<br/>HalfMoonBay_SSS_20230626_Line41.001</li> <li>• Water Depth: 606.12 Meters</li> </ul> | <p><b>Dimensions and Attributes</b></p> <ul style="list-style-type: none"> <li>• Target Width: 6.31 Meters</li> <li>• Target Height: 2.72 Meters</li> <li>• Target Length: 22.57 Meters</li> <li>• Target Shadow: 19.16 Meters</li> <li>• Mag Anomaly: N/A</li> <li>• Avoidance Area: N/A</li> <li>• Classification1: N/A</li> <li>• Classification2: N/A</li> <li>• Area: N/A</li> <li>• Block: N/A</li> <li>• Description: N/A</li> </ul> |

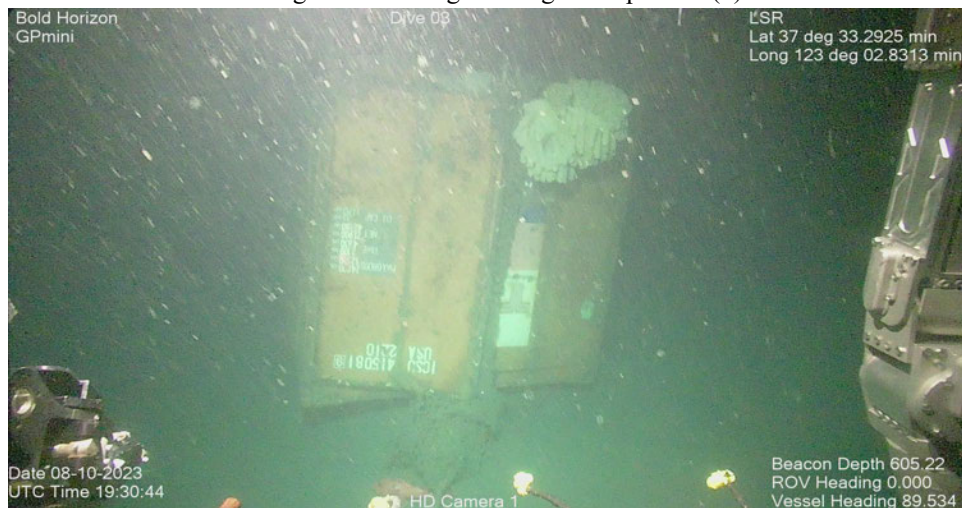
**Figure #18. Shipping Container**

area and noted they believed the engine was not structurally attached to the plane. After further inspection, the ROV recovered to reposition. At 09:52, the Bold Horizon had moved locations to “Area Delta” to begin dive #3. During this dive, the ROV inspected another larger target, which appeared to be an upside-down shipping container (corner numbers: ICSO415081, USA 2210).

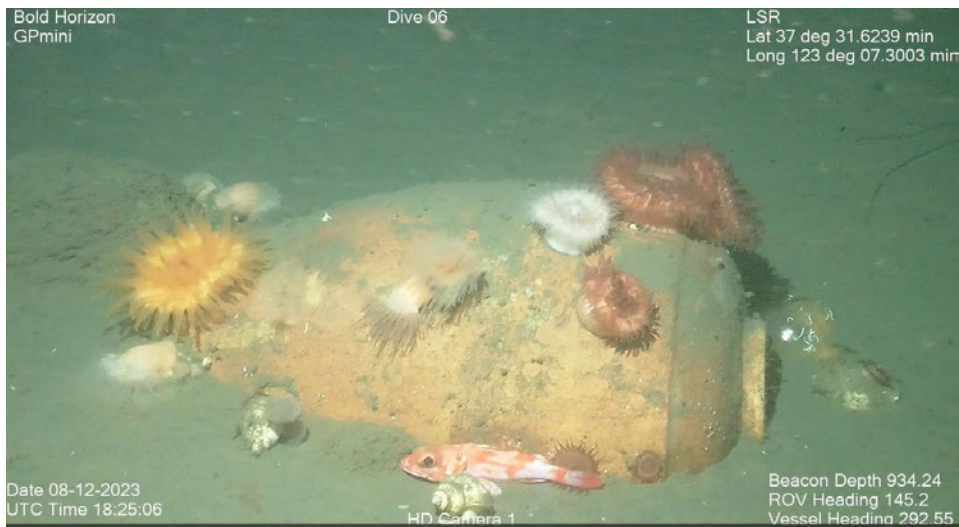
**Figure #20. Large Clay Pot**

| | | <b>19:30</b> | Target is an ISO container: corner numbers ICSO 415081, USA 2210; container is upside down |
|---|---|---|---|
| | | <b>18:27</b> | Found pottery, position: latitude 37° 31.647' N, 123° 07.024' W. |

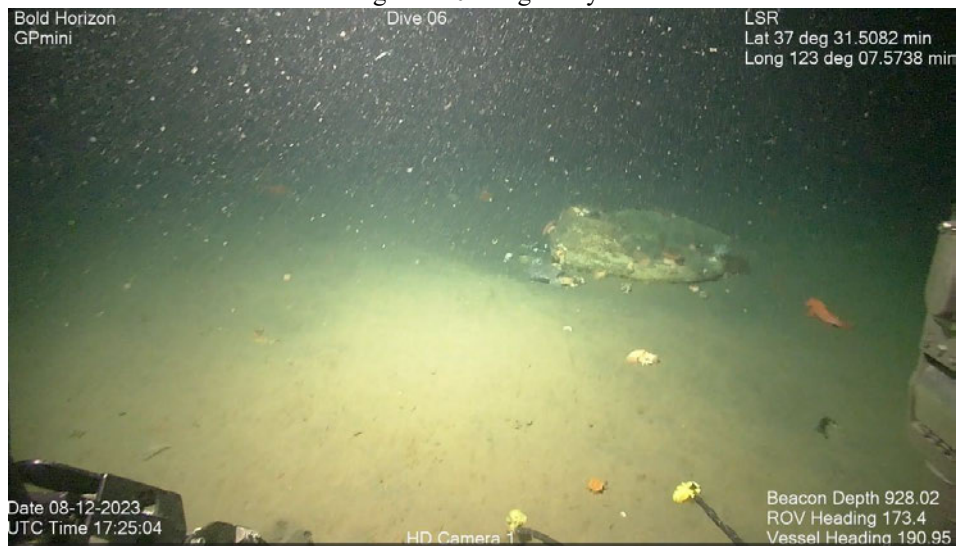
**Figure #21. Large Rock**

| | | <b>19:30</b> | Target is an ISO container: corner numbers ICSO 415081, USA 2210; container is upside down |
|---|---|---|---|
| | | <b>17:26</b> | Found rock, position: latitude 37° 31.507' N, 123° 07.570' W. |
