# National Transportation Safety Board

WPR23LA220

## **FOLLOW UP EXAMINATION SUMMARY**

Location: Nephi, Utah  
Date: 6/8/2023  
Time: 12:19 Mountain daylight time  
Airplane: N7318Y

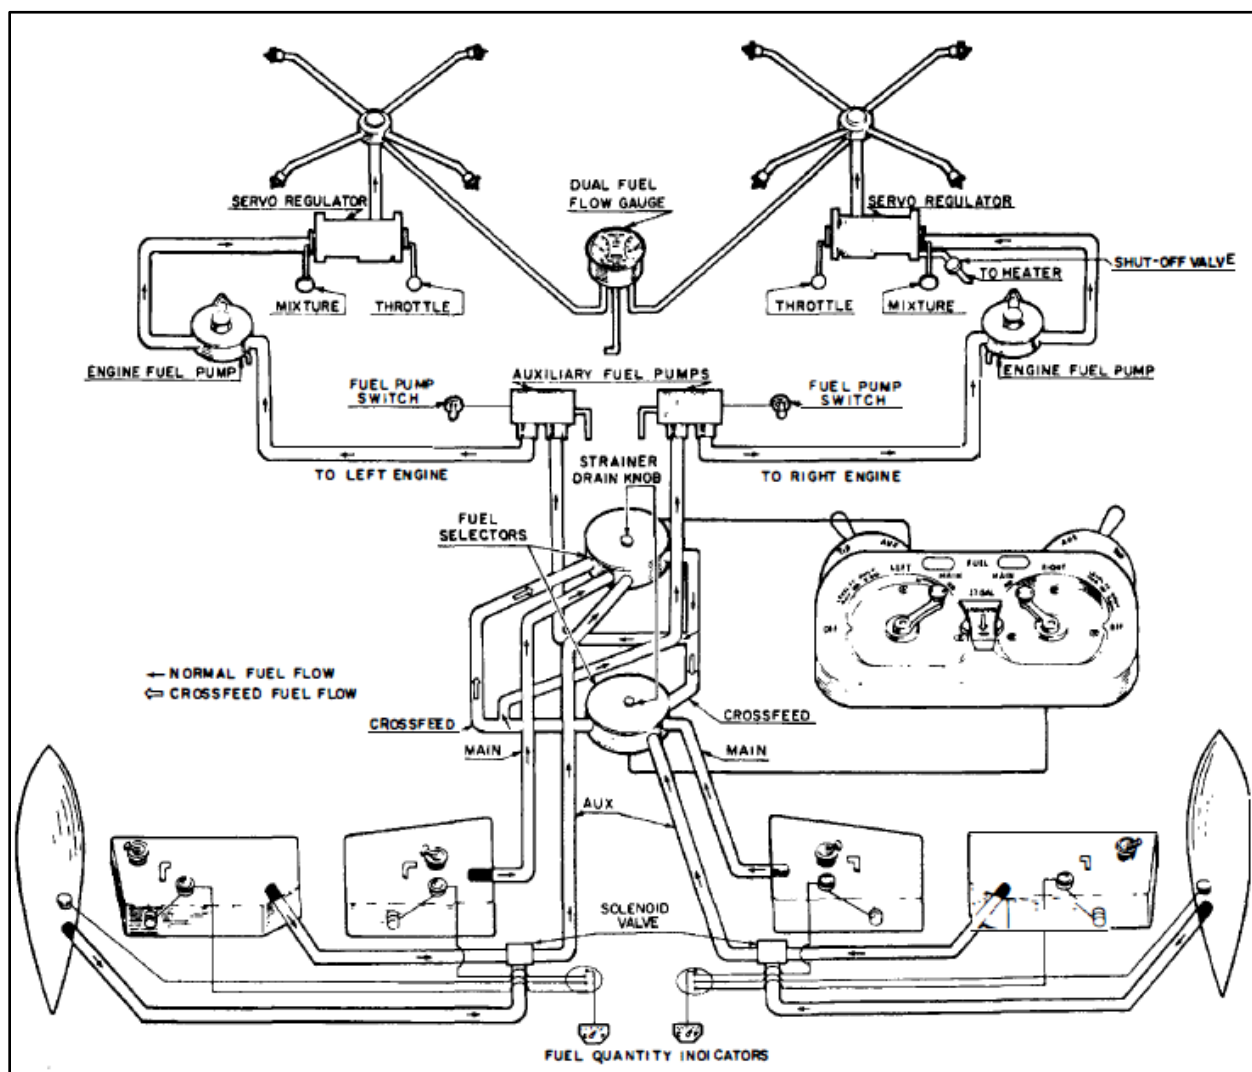
Figure 2. Fuel schematic diagram

During normal operation use the engine driven fuel pump to draw fuel from the cell directly adjacent to that engine. However, fuel can be drawn from any cell to both engines using the engine driven fuel pump or the electric auxiliary fuel pump. For emergency single engine operation, a crossfeed is provided to increase the range.

When using fuel from cells on the opposite side of the operating engine, move the fuel selector for the inoperative engine to the main or auxiliary position; then move the fuel selector for the operating engine to the crossfeed position. For single engine landing, fuel must be pumped from the main cell on the same side as the operating engine.
