# National Transportation Safety Board

WPR23LA255

## **MATERIALS LABORATORY**

Factual Report 24-081

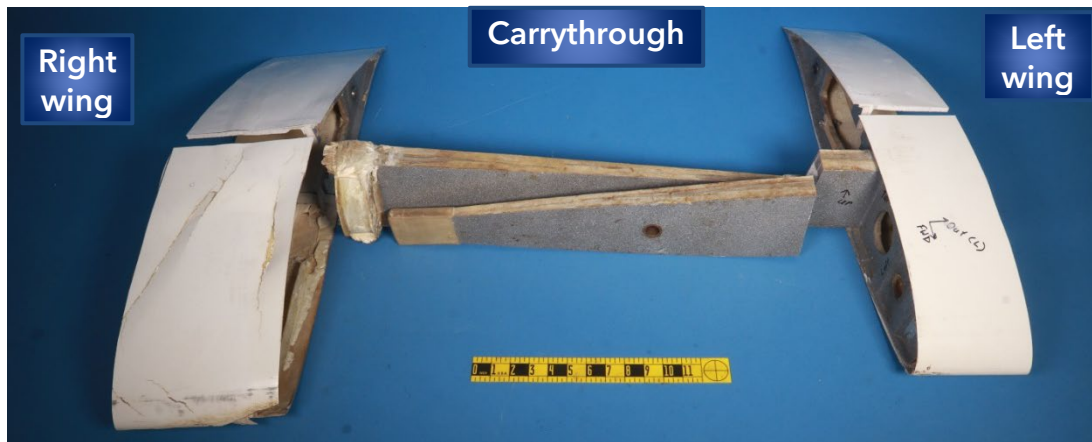
Next, the aileron control rod and bellcrank assemblies were disassembled from the closeout ribs. Then, a transverse cut was made through the left carrythrough beam, and chordwise and spanwise cuts were made through the left and right wing pieces as shown in figure 10. On the right wing, the upper and lower skins were already completely separated from each other inboard of the chordwise lab cut, but the upper and lower skin pieces remained partly attached at the spar. The upper skin was nearly separated from the spar, so the skin was pulled by hand to produce a lab fracture of the remaining portion.

A vertical spanwise cut was made through the middle of the spar and carrythrough beam on the left wing piece shown in figure 10. The forward side of the cut was then polished and prepared similar to the previous sections to reveal the reinforcement layers in the upper and lower cap. An overall view of the section through the left wing spar caps, reinforced rib segment, and carrythrough beam is shown in figure 23 with closer views of the spar caps where they intersected the reinforced rib area. The reinforcement layers were continuous from the spar caps, through the reinforced rib area, and into the carrythrough beam. In the reinforced rib area, the caps were separated by two laminated wood panels, and in the carrythrough beam section, the caps were separated by a stiff foam core.

**Figure 10.** Right and left wing pieces and carrythrough beams after sectioning.
