# National Transportation Safety Board

WPR23LA294

## **AIRFRAME AND ENGINE EXAMINATION REPORT**

Location: Ravensdale, Washington  
Date: July 30, 2023  
Time: 1301 Pacific daylight time  
Airplane: Cessna 195

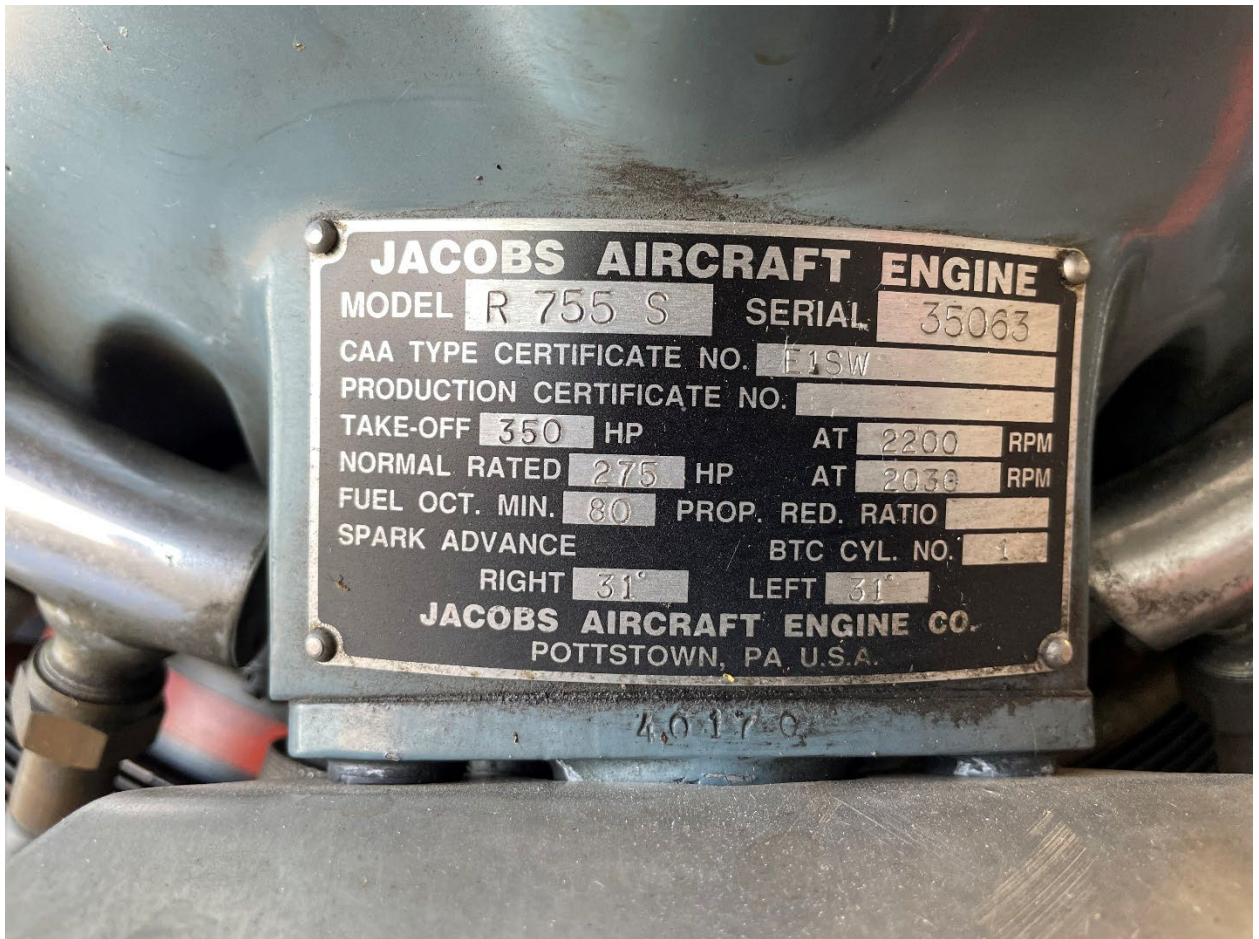
**Figure 13. Engine data plate.**

The radial engine was identified as a Jacobs, model R755-S, serial number: 35063, 7-cylinder radial engine. It remained attached to the engine mounts that remained attached to the firewall. The engine exhibited no external damage. There was no sign of fuel leaks or blue staining around the engine, nor the three-piece engine cowling (same area as shown in figure 1). Several small strips, aft of the engine cowling, were removed and exhibited no signs of fuel stains.
