# National Transportation Safety Board

WPR23LA338

## **POWERPLANTS**

Group Chair's Factual Report

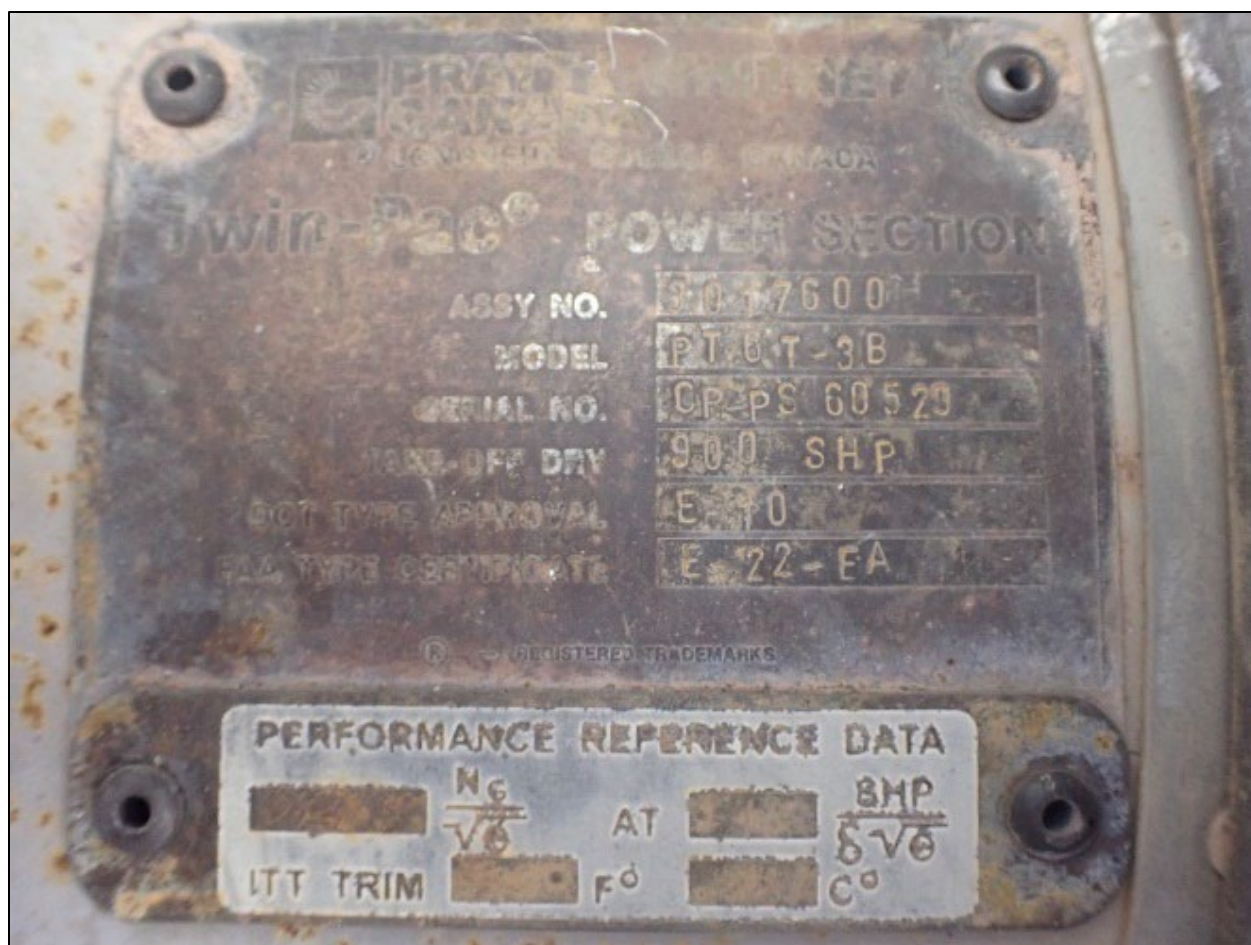
**Figure 3.** Left engine data plate

The left engine was secure in a wooden box (Figure 2). According to the engine data plate, the left engine was s/n CP-PS 60529 but its box was mislabeled "s/n 72332" (Figure 3). The accessory gearbox's internal components were in a separate bag inside the box.

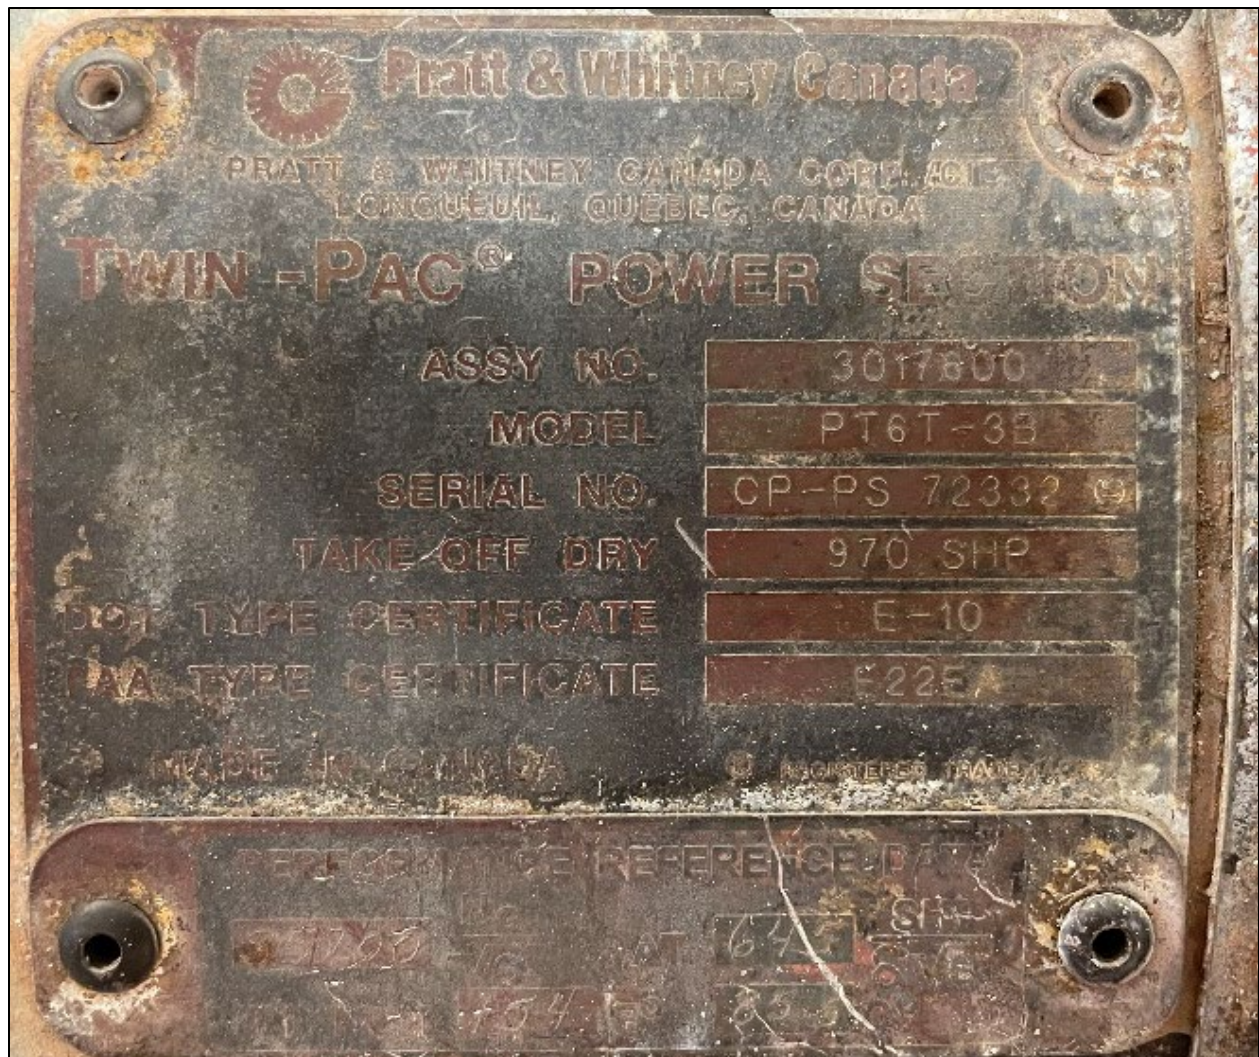
**Figure 18.** Right engine data plate

The right engine was secure in a wooden box (Figure 17). According to the engine data plate, the right engine was s/n CP-PS 72332 but was in the box mislabeled "s/n 60529" (Figure 18). Internal components from the accessory gearbox and the combining gearbox were included in separate bags inside the box.
