# Materials Investigation – Laboratory Report

| Part No.: 3120872-01 | RFA No: [REDACTED] | Report No.: [REDACTED] |
| Part Name: BLADE-TURBINE | Date Received: 2024-03-20 | Page 3 of 17 |
| Serial No.: Various | Engine Model: PT6T-3 | Eng. Serial No.: 60529 |

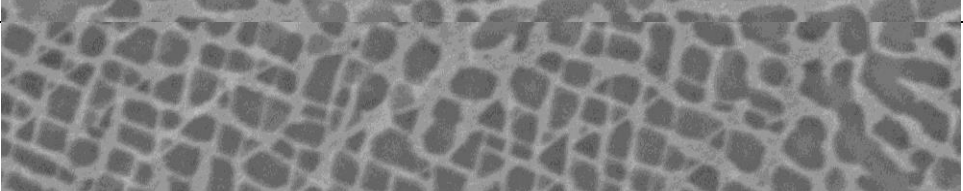
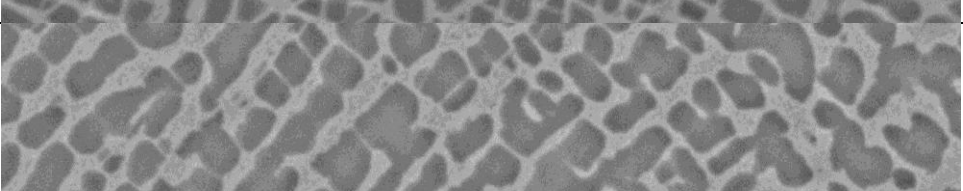
| Location | Observations | Blade 24 microstructure |
|---|---|---|
| 0 mm Platform | Coarsening +<br>Solutioning | |
| Root | Coarsening +<br>Solutioning | |

**Figure 11** Microstructure evaluation of blade 24 (HC [REDACTED]) at 0.125" from the trailing edge. The evaluation was completed up to 40mm (1.57 in) from the platform due to the fractured condition. The microstructure of the blade (including in the Root) exhibited solutioning as well a reprecipitation which would be consistent with overheating. Etchant: [REDACTED].
