# National Transportation Safety Board

WPR23FA352

## **ENGINE TEARDOWN REPORT**

Location: San Pedro, California  
Date: September 25, 2023  
Time: 1250 Pacific Daylight Time  
Airplane: Sling 4 TSI, Registration N135WT

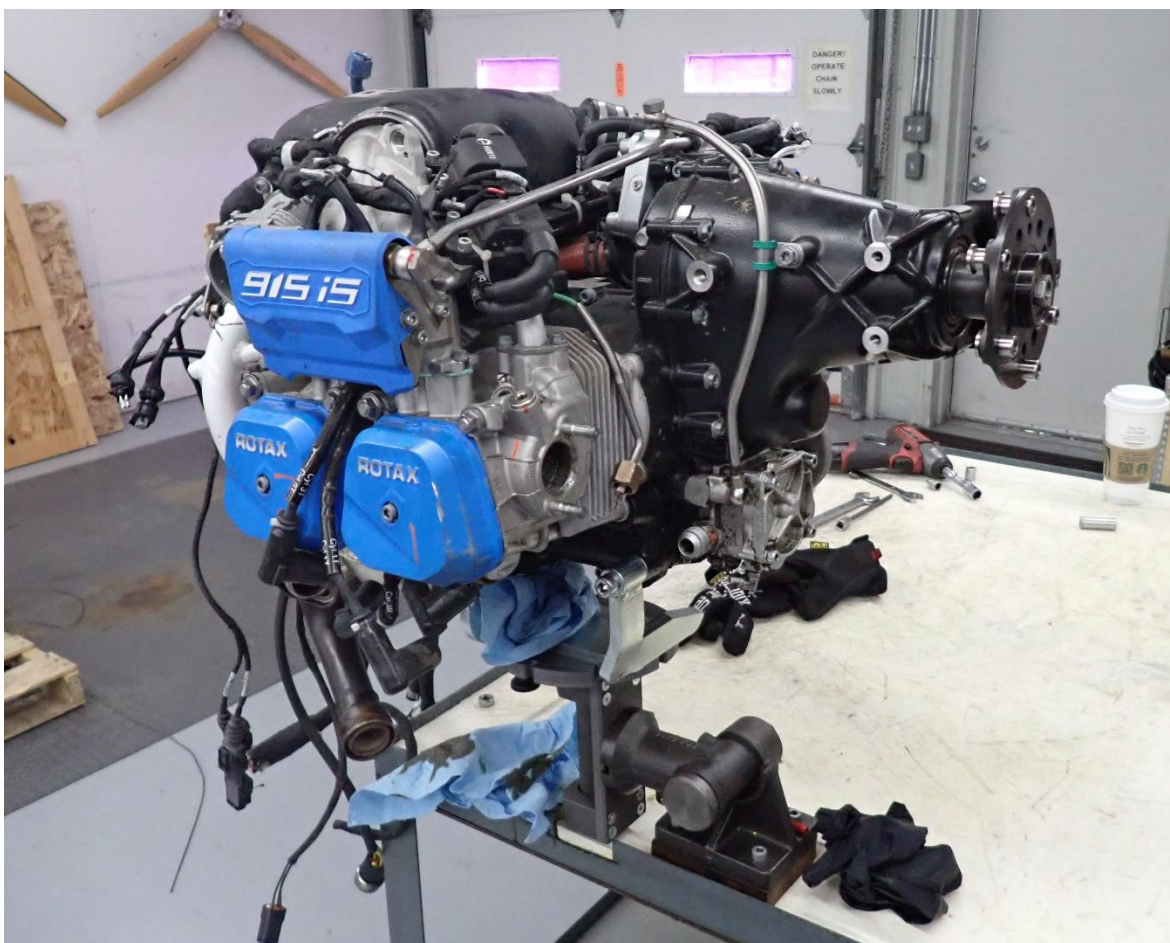
**Figure 1: Engine on mount with firewall and engine mount removed**

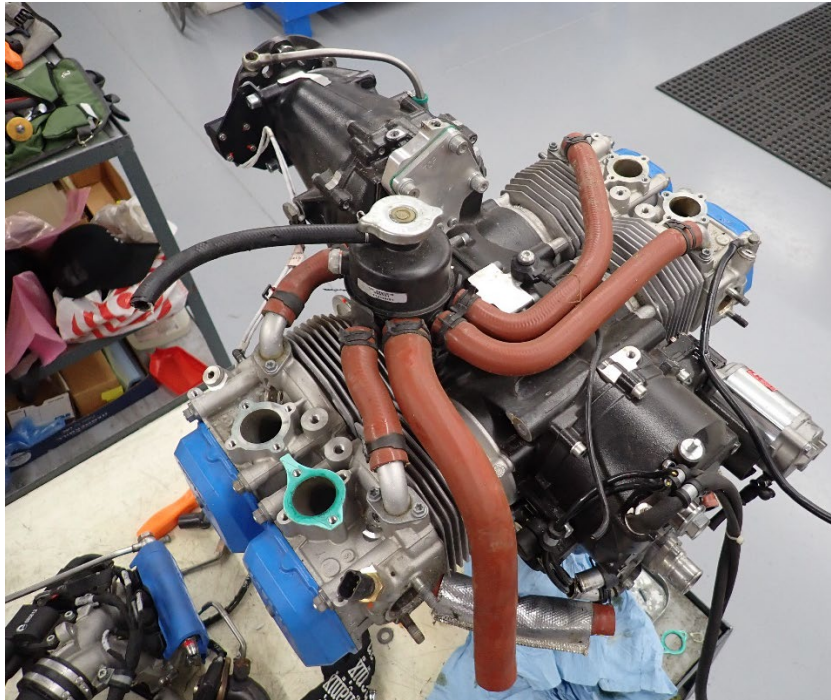
The cylinders remained installed on the crankcase with all the securing hardware properly attached. Each cylinder and piston were removed and documented. Cylinder 4 exhibited extensive mechanical damage and gouging throughout the cylinder head (both spark plugs had been previously removed). The cylinder 4 piston also displayed extensive mechanical damage and gouging (consistent with the damage to the cylinder head interior). The no. 4 intake valve was separated and resting along the bottom of the cylinder wall with extensive gouge markings and deformation. The cylinder 4 exhaust valve was found inside the airbox heavily damaged and fragmented.

**Figure 2: Cylinders as installed in the engine (airbox removed)**

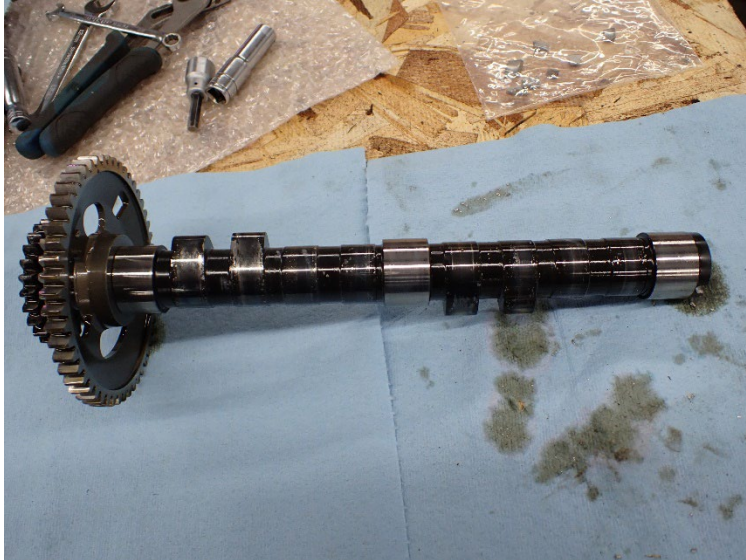
Crankshaft and camshaft continuity to the accessory case was achieved after the cylinders and pistons were removed when the propeller flange was rotated using a hand tool. The connecting rods were all installed at their respective connecting rod journals and the counterweights and crankwebs were in place. The main journals appeared normal and the bearings exhibited some scoring with normal wear and some of the bearings had evidence of foreign object contact. The cylinder 4 connecting rod displayed gouge marks at the rod bushing. The camshaft lobes were normal and unremarkable.

**Figure 16: Camshaft**
