## ***ROTECH FLIGHT SAFETY INC.***

# **INVESTIGATION REPORT**

| <b>Aircraft Make:</b> | Sling | <b>Aircraft registration:</b> | N135WT |
| <b>Aircraft Model:</b> | 4 TSI | <b>Aircraft S/N</b> | 131S |

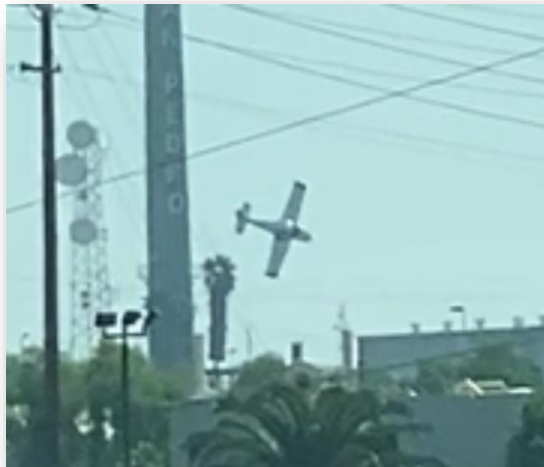
Photograph 1: Accident airplane seconds before impact

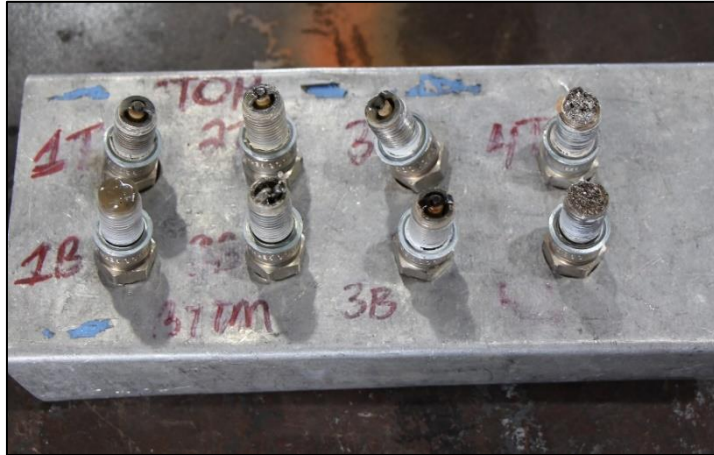
**Spark Plugs:** The spark plugs were removed and placed in a holding tray for orientation. They were visually inspected for condition and any signs of abnormal operation. Each plug was marked "ROTAX" on the insulator with part number 297 656. For additional specifications, please refer to the BOSCH report.

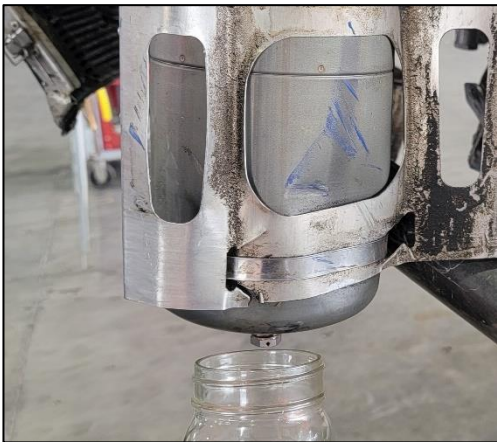
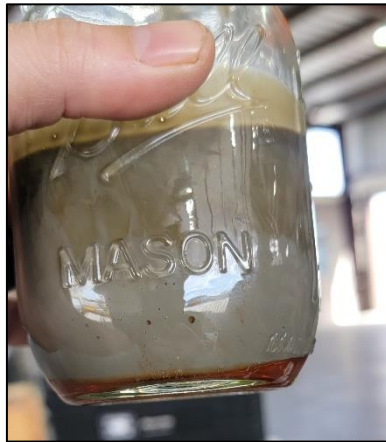
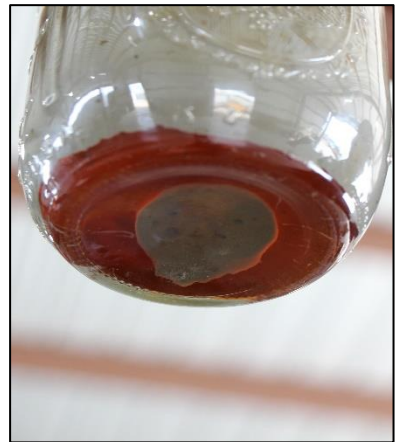
**Lubrication system:** Approximately 250 mL of oil was drained from the oil tank into a clean glass container. The oil had a sludge-like consistency and a dark grey color. Additionally, a liquid resembling coolant antifreeze was found within the tank.

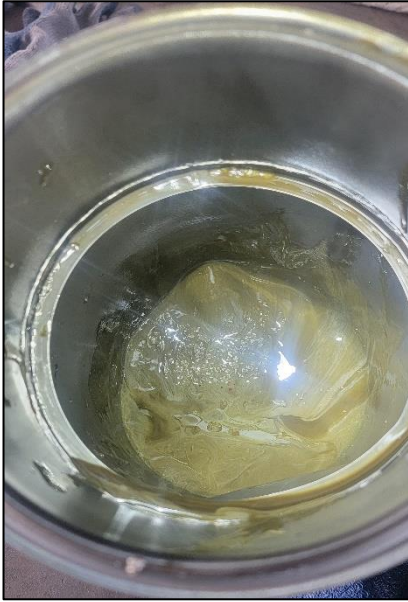
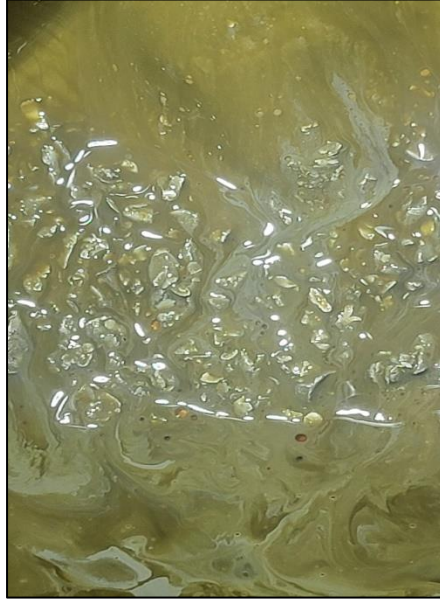
**Lubrication system (Continued):** Upon internal inspection, a significant amount of foreign object debris (FOD) was observed at the bottom of the oil tank.

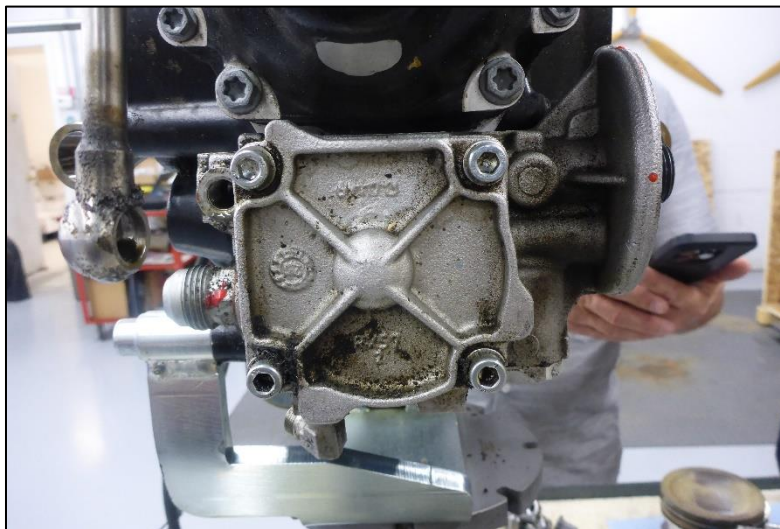
The oil pump was removed and inspected. No anomalies were discovered.

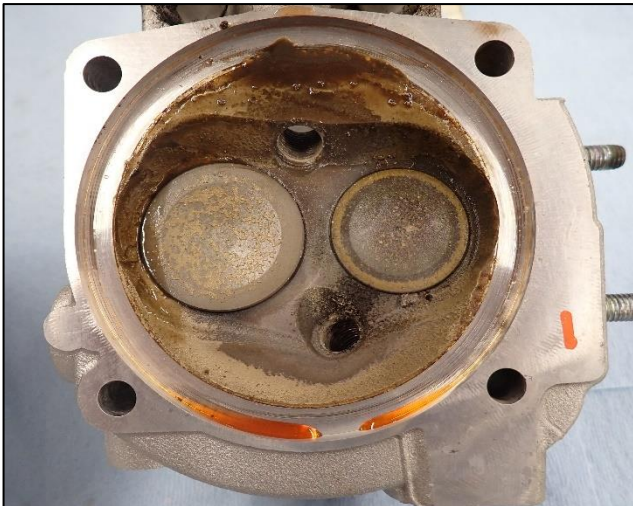
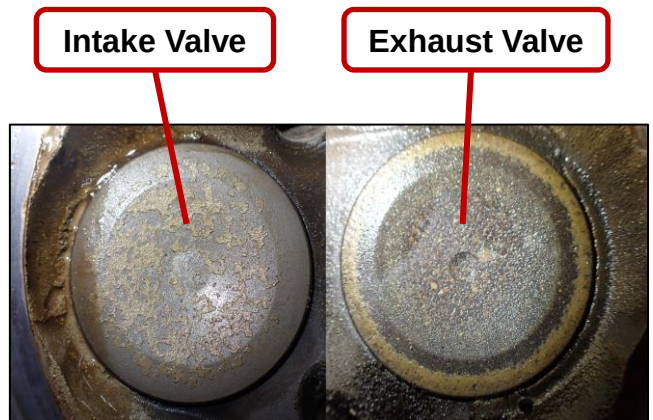
Upon removing the intake and exhaust manifolds, the cylinder head was taken off the cylinder, exposing the #1 combustion chamber and valves.

**#1 Cylinder head (Continued):** A buildup of engine oil, coolant, and a small amount of metallic material was observed on the face and combustion section of the cylinder head. Additionally, a small buildup of what appeared to be lead was found on the face of the cylinder head and on the intake and exhaust valves, indicating the engine was operating with 100LL Av-Gas fuel. Unusual burn patterns and material buildup were observed near the top spark plug and the exhaust valve.

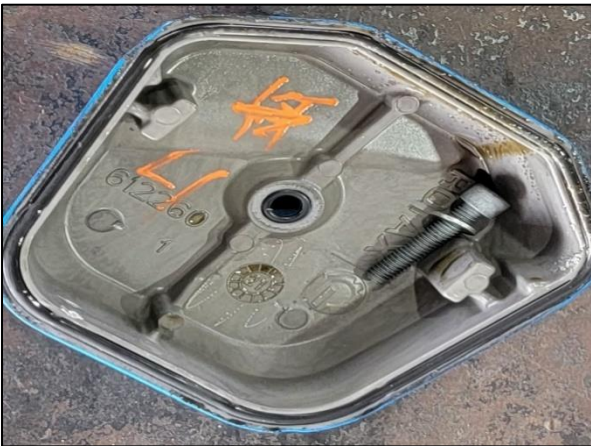
**#4 Cylinder head:** The rocker cover was removed to expose the rocker arms, rocker arm shafts, valve spring retainer washers, valve spring keepers, valve springs, and pushrods. Evidence of lubrication oil was observed within the valve cover. All components appeared intact and in good physical condition.

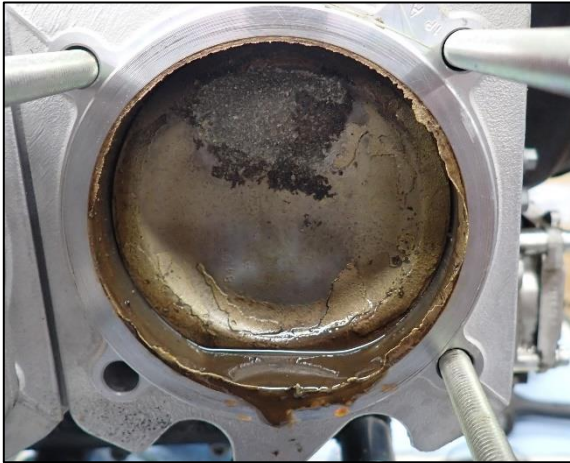
**#1 Piston:** A buildup of engine oil was observed on the combustion side of the piston. Additionally, a small accumulation of what appeared to be lead was found on the piston face, indicating the engine was operating with 100LL Av-Gas fuel. Unusual burn patterns and material buildup were noted near the top 12 o'clock position of the piston face.

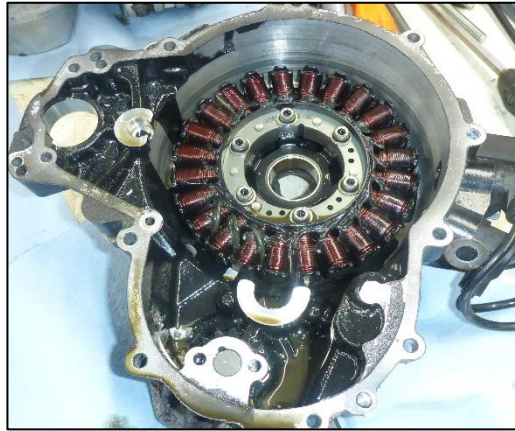
**Ignition housing:** The ignition housing, containing the stator assembly and water pump drive gear, was visually examined but not function tested. The stator windings and wiring showed no signs of overheating, and no anomalies were observed with the stator assembly. The water pump drive gear was in good condition, and no anomalies were found within the stator housing or its internal components.

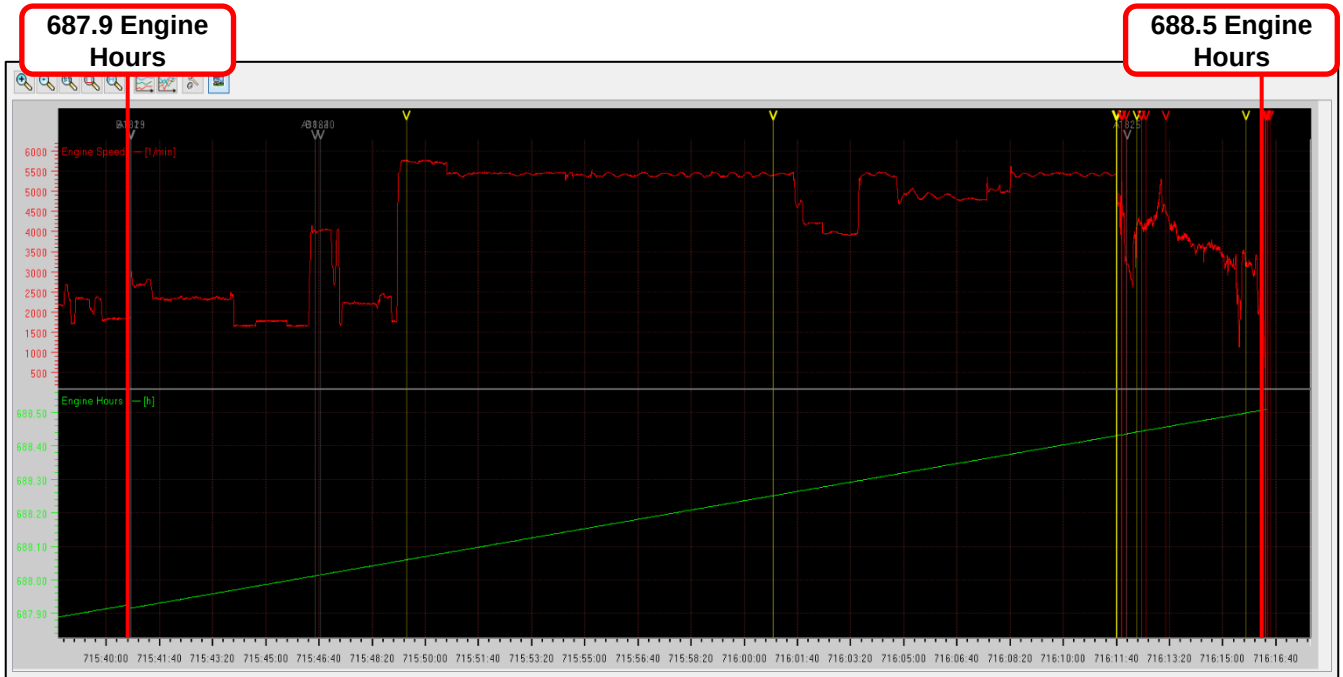
According to the ECU data, the engine had accumulated a total of 687.90 engine hours and 715:40:47.200 ECU hours at the start of the accident flight. At the time of the incident, the ECU recorded 688.50 engine hours and 716:16:19.500 ECU hours, indicating that the engine was running for approximately 0.6 hours, or 36 minutes, during the accident flight.

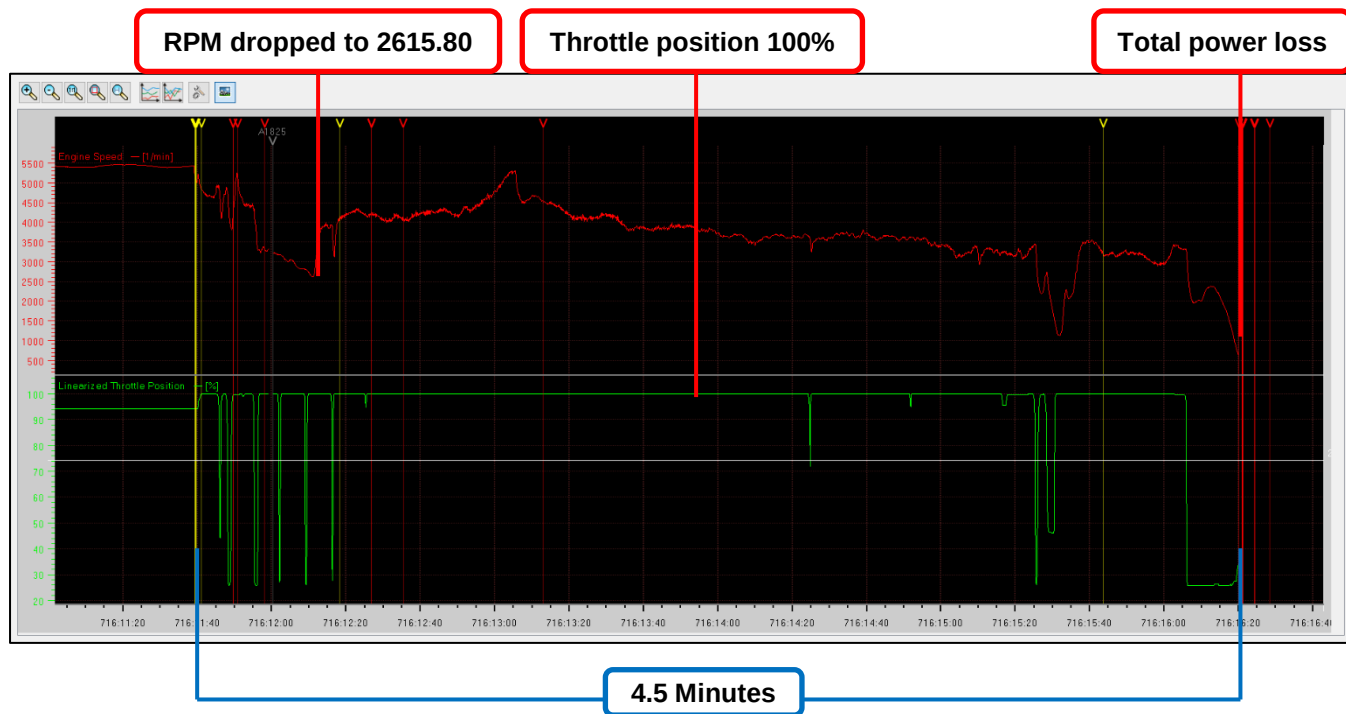
**Analysis of Key Engine Parameters:** An in-depth analysis of key engine parameters was conducted between engine hours 688.30 (ECU timestamp 716:08:20.500) and 688.43 (ECU timestamp 716:11:57.000), with ECU timestamp 716:11:39.000 marking the moment of power loss. This analysis aimed to identify trends or anomalies both preceding and following the initial RPM drop and onset of engine roughness.
