# National Transportation Safety Board

WPR23LA352

## **MATERIALS LABORATORY**

Factual Report 24-069

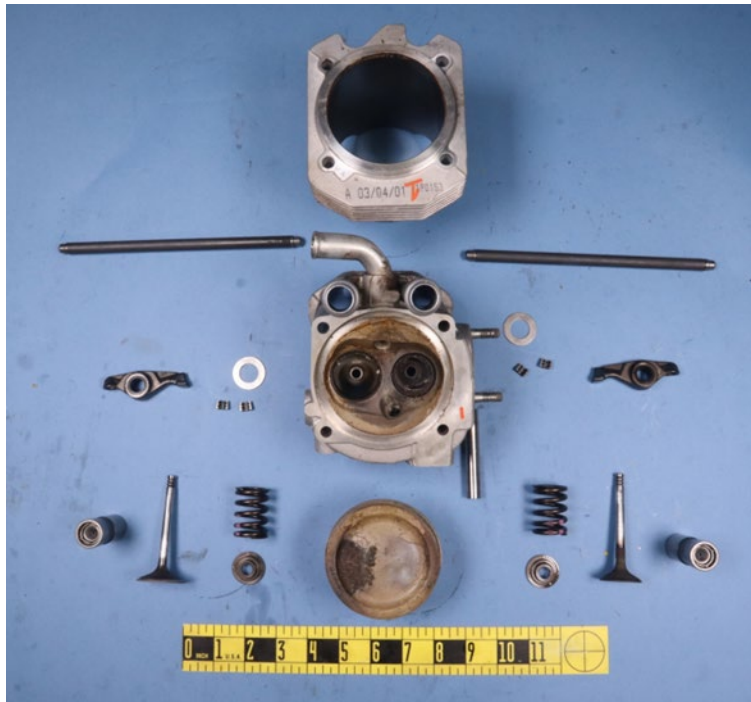
Figures 1-4 show overall images of the cylinders and components submitted for inspection. The cylinder components consisted of the cylinder, cylinder head, piston, and valve train components for the intake and exhaust valves. Also submitted were the spark plugs (Figure 5) and knock sensor (Figure 6). Mechanical damage was noted in cylinder 2, cylinder 4, and the spark plugs. Cylinders 1 and 3 were largely undamaged, but their conditions are documented below.

**Figure 1.** Cylinder 1 components; intake components on the left side of the image, and exhaust components on the right.

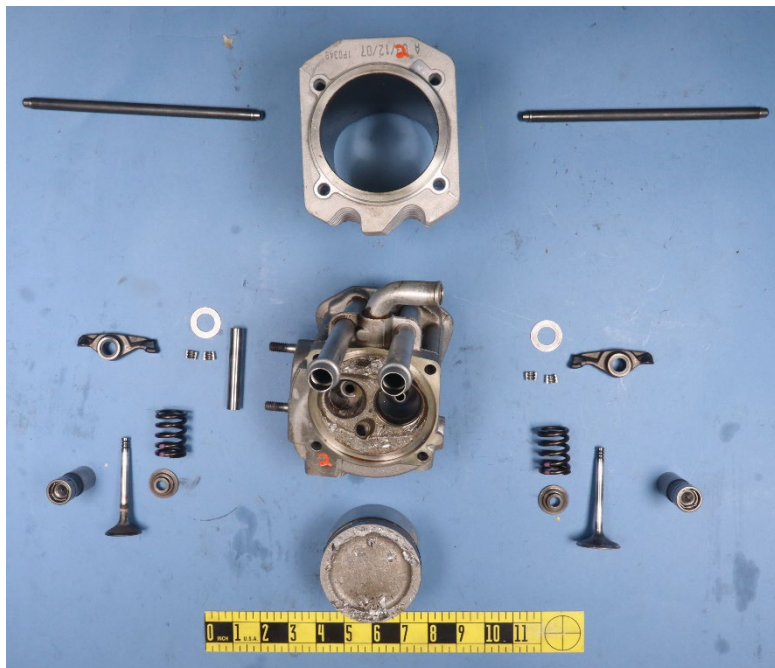
**Figure 2.** Cylinder 2 components; exhaust valve train components on the left side of the image, and intake valve train components on the right.

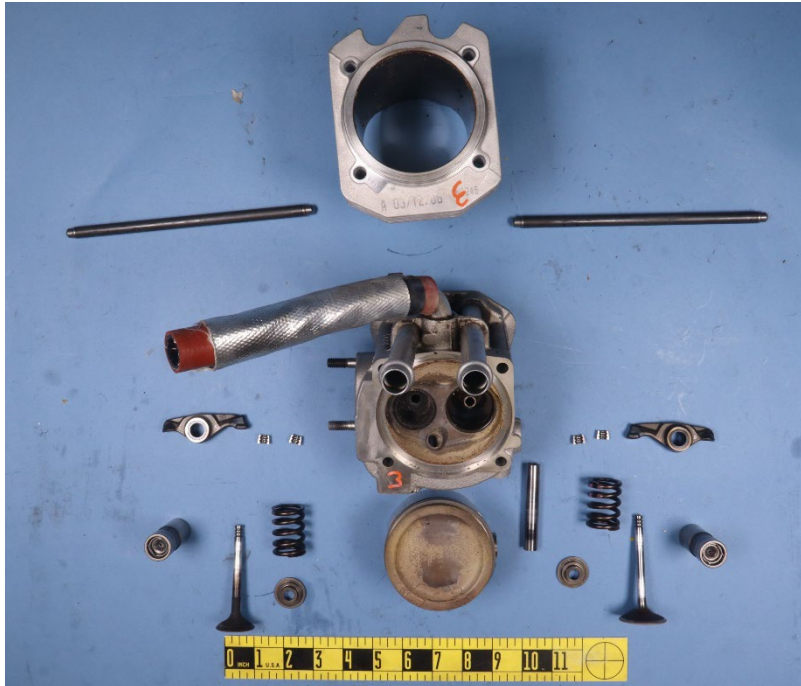
**Figure 3.** Cylinder 3 components; exhaust valve train components on the left side of the image, and intake valve train components on the right.

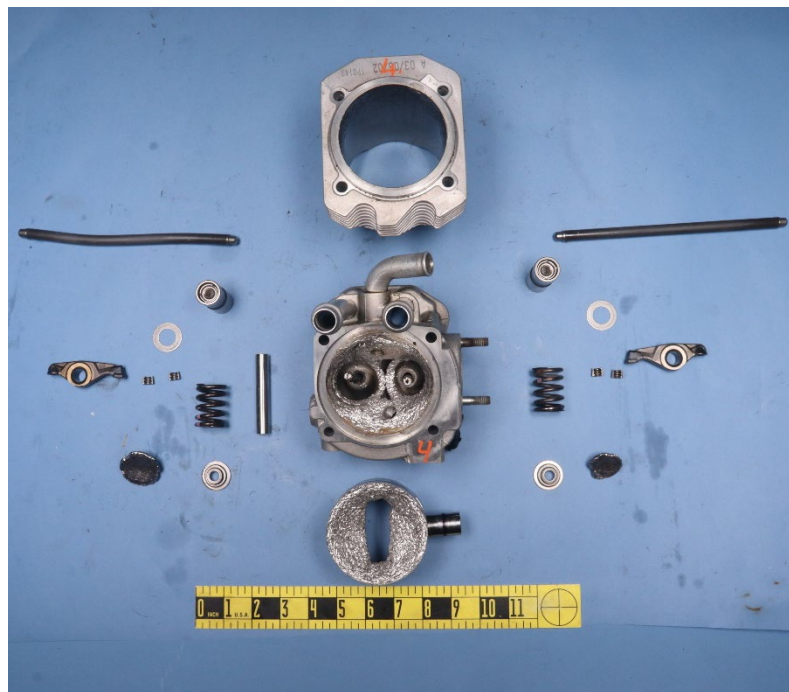
**Figure 4.** Cylinder 4 components; intake valve train components on the left side of the image, and exhaust valve train components on the right.

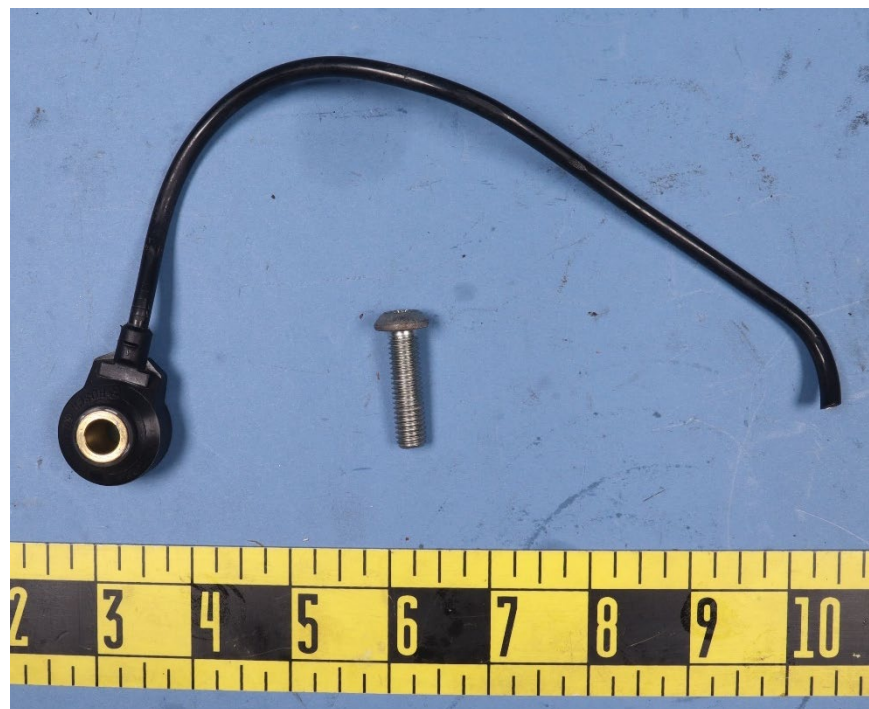
The eight spark plugs were submitted all together, and it was not possible to identify the cylinders that they came from (Figure 5). Four plugs showed damage to the electrode and grounds; in two plugs, the plugs and grounds were eroded away, and the surfaces showed damage consistent with repeated impact. Two other plugs had bent contacts and grounds. A fifth plug showed damage to the opposite end, where the terminal had bent and a piece of the insulator had broken off. The knock sensor showed no damage.

**Figure 6.** Knock sensor and attachment bolt.

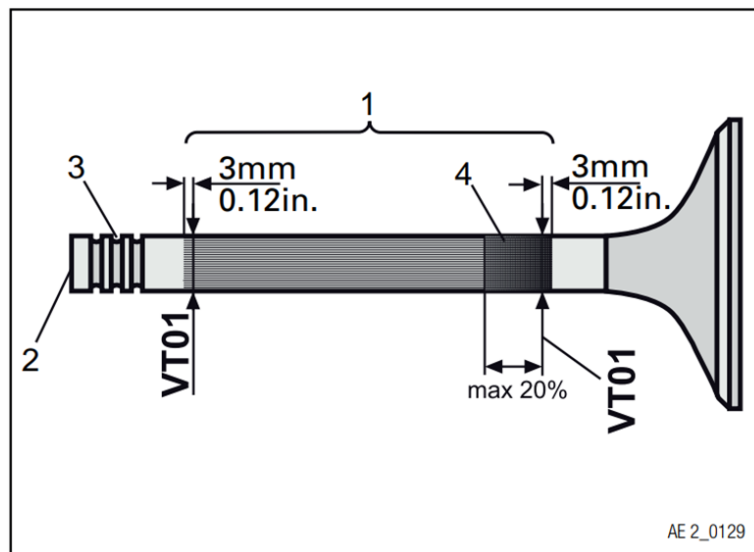
All exhaust valves taken from the cylinders are visible in Figure 19. For brevity, the valves will be referred to by the cylinder they were taken from (e.g. the valve from cylinder 1 shall be referred to as 'valve 1', cylinder 2 as 'valve 2', etc.). Per the Rotax Maintenance Manual Heavy, the surface of the stem that contacts the valve guide is known as the 'running surface.'<sup>3</sup> The ends of the surface are not defined with dimensions in the manual, but the location of surface wear (primarily consisting of shallow longitudinal scratches) on all the valve stems is consistent with the manual's

graphical depiction (Figure 20). The measured running surface on the intact valves was approximately 1.85 inches.

**Figure 20.** Schematic depiction of the valves taken from the Rotax Maintenance Manual Heavy. Measurements and markings indicate areas of necessary inspections described in the manual. The bracketed area demarcated by '1' is referred to as the 'stem' and the 'running surface' in the manual.

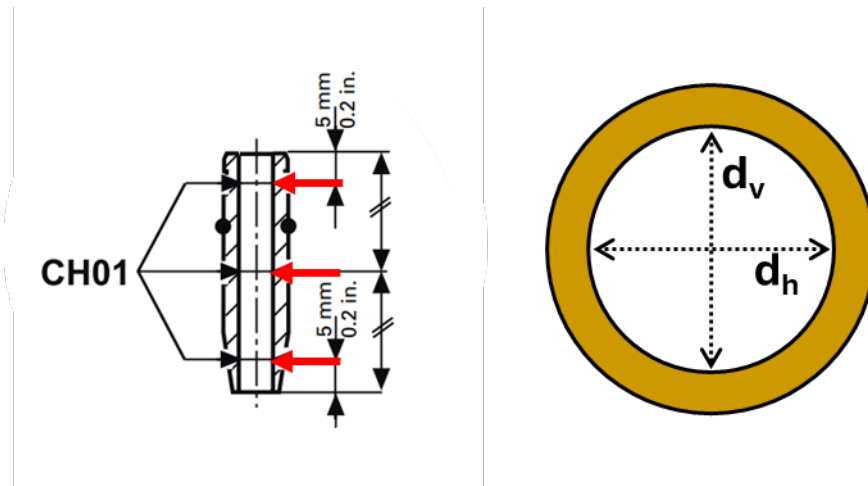
Complementing measurements were also taken of the exhaust valve guides in the cylinders 3 and 4. A combination split-ball gauge and flat-faced micrometer were used to measure the inner diameter of the exhaust valve guides. Measurements were taken near the top, middle, and bottom of each guide. Further, measurements were taken vertically ( $d_v$ ) and horizontally ( $d_h$ ) to check for uneven wear or deformation of the guides (Figure 21). The measurements and associated tolerances (listed in the maintenance manual) are shown in Table 3. The valve guides were widest at the bottom; at this location, cylinder 3 was outside the 50% tolerance limit. Cylinder 4 was at or was outside the 100% tolerance limit at all measured locations in the valve guide.

**Figure 21.** (Left) Schematic depiction of the locations to measure the inner diameter, adapted from the Rotax Maintenance Manual Heavy. (Right) Measurements were taken in two perpendicular directions. The vertical direction aligns with the nominal orientation of the cylinder when mounted.
