National Transportation Safety Board

WPR24FA001

## INVESTIGATIVE SUPPLEMENTAL MATERIALS

Location: Twisp, Washington  
Date: 10.01.2023  
Time: 1030 Pacific standard time  
Airplane: Cub Crafters

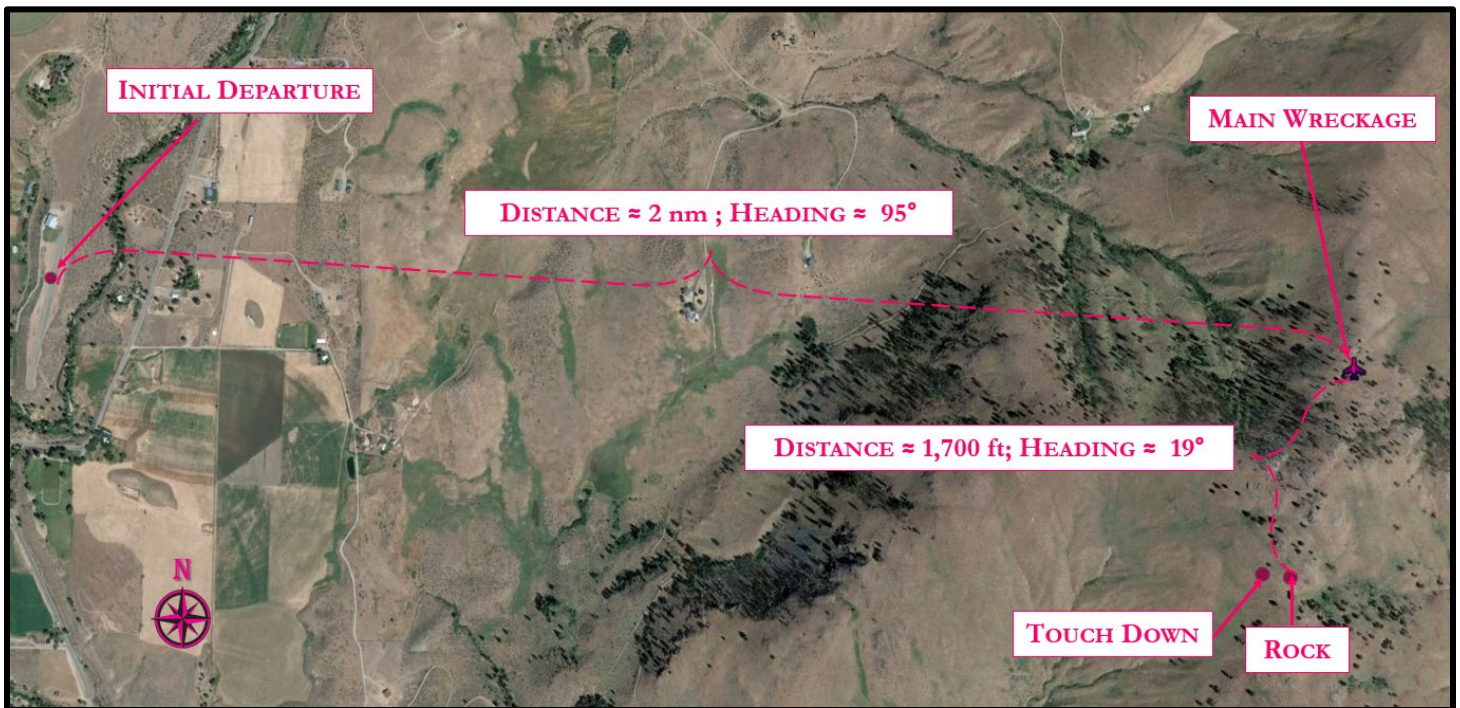
Figure 1: Main wreckage in reference to initial departure point

The pilot planned to take a local flight with his friend, who owned the same make of airplane. They departed a private airfield in their respective airplanes and flew directly to a hillside located about 2 nm to the east. The friend landed uphill on the slope of the hillside and positioned his airplane to the west of a tree. Using the radio, he communicated to the pilot that he should land his airplane in between his airplane and the tree. The pilot made two low passes over the ridge, performing reconnaissance over the landing area. The friend observed the airplane touchdown on the slope further to the east of his location and land upslope.

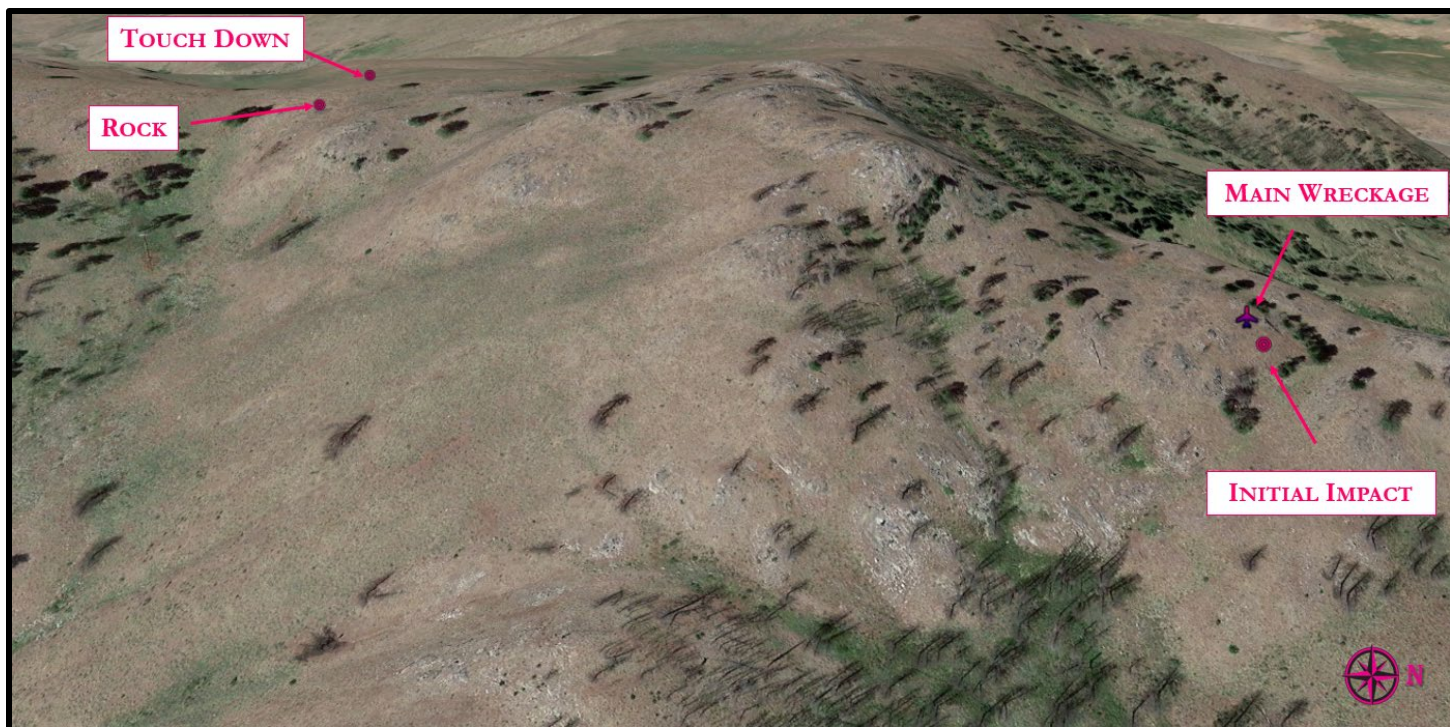
Figure 3: Main wreckage with reference to touchdown point

The wreckage was found distributed over a 90 ft distance on a median magnetic bearing of about 245°. The first identified points of contact consisted of disrupted dirt on the upslope of a hillside making up the far northeastern end of the debris field. The disruption in the terrain contained chips of silver paint and small pieces of fabric. The disrupted dirt widened into a crater that continued toward the wreckage with numerous vortex generators in the dirt and outboard wingtip structure. A large portion of the forward left-wing tip was 25 ft from the wreckage and pieces of plexiglass and splinters of propeller led up to the wreckage. There were fragments of the wooden propeller surrounding the accident site, and made up the farthest debris to the south.

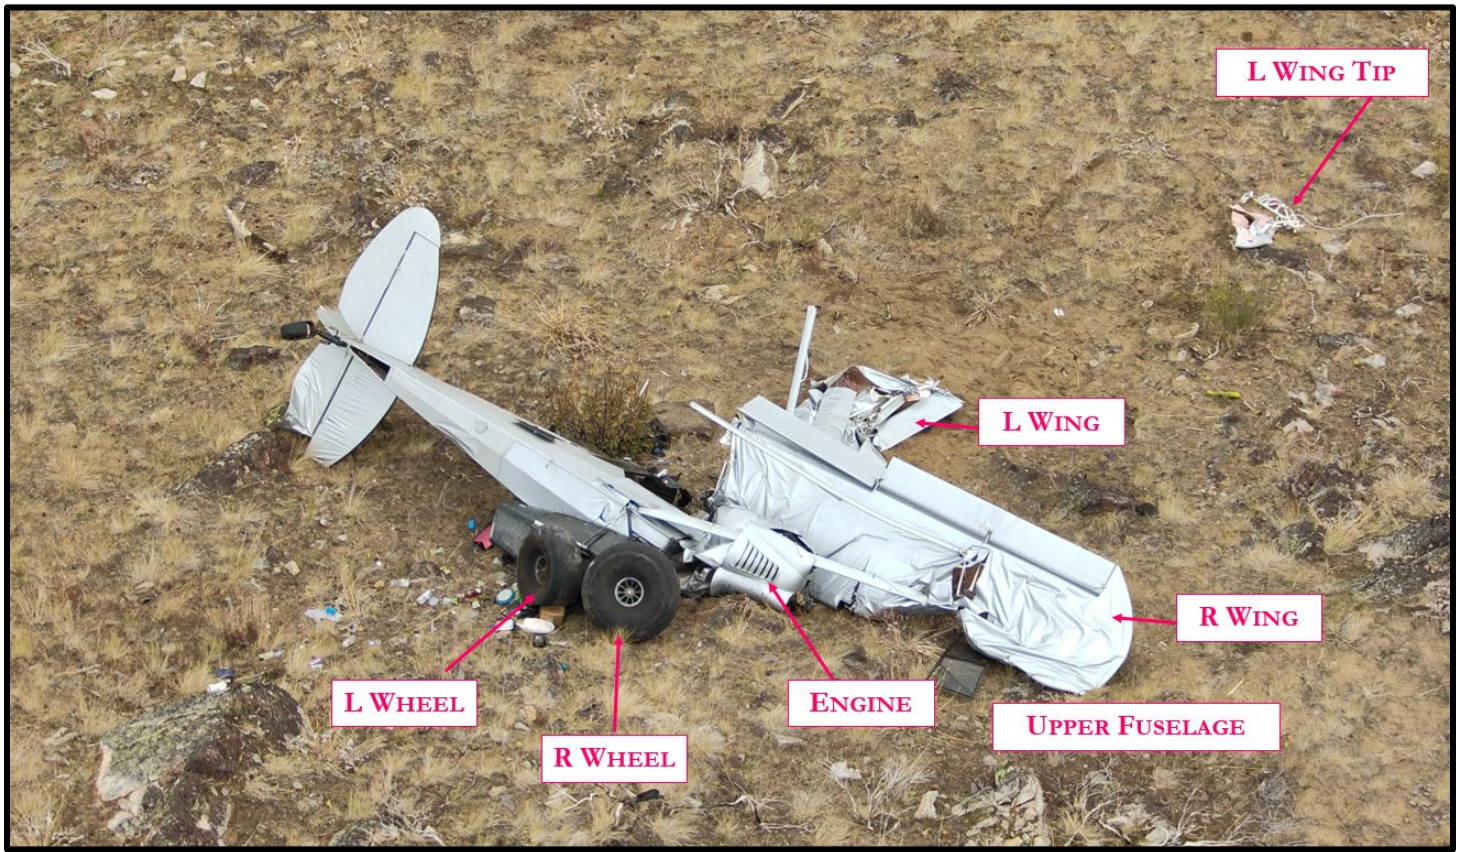
Figure 5: Main wreckage aerial view

The fuselage came to rest on its left side with the right wing folded forward over the engine. The left wing sustained crush deformation and came to rest inverted. The left forward and aft lift struts had separated, but remained attached to their respective fittings on the fuselage and wing. An approximate 1.5 ft piece of the left aft-lift strut remained attached to the airframe; the trailing edge of both portions of that strut contained black

marks consistent with the rubber from the tire. The flaps appeared to be partially down and the fuel selector was in the off position (it could not be confirmed if this was done by first responders).

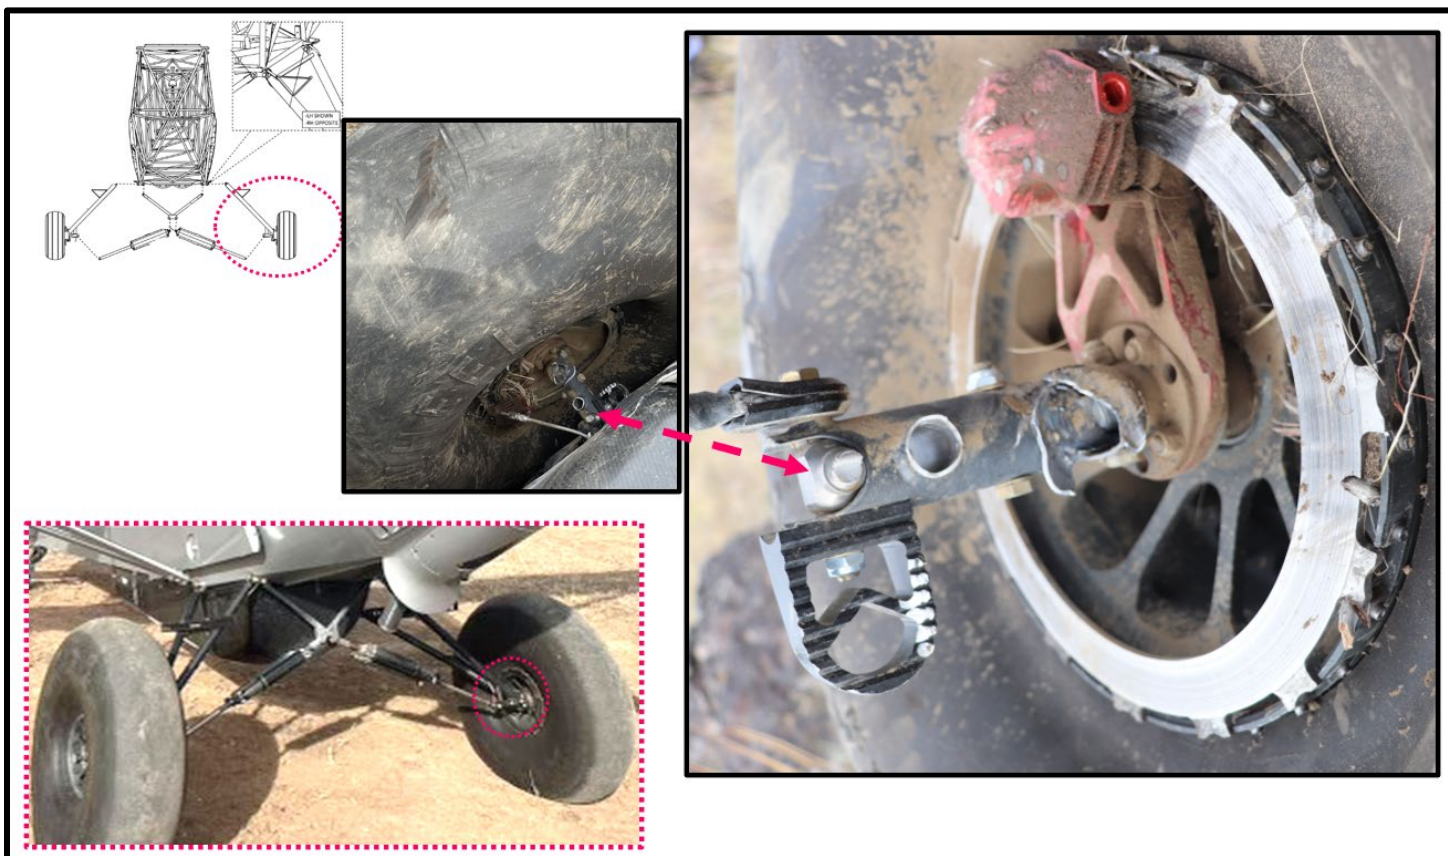
Figure 8: Left main landing gear strut

The landing gear struts were collapsed the bottom of the left struts were separated and appeared to have been worn from being dragged across terrain.

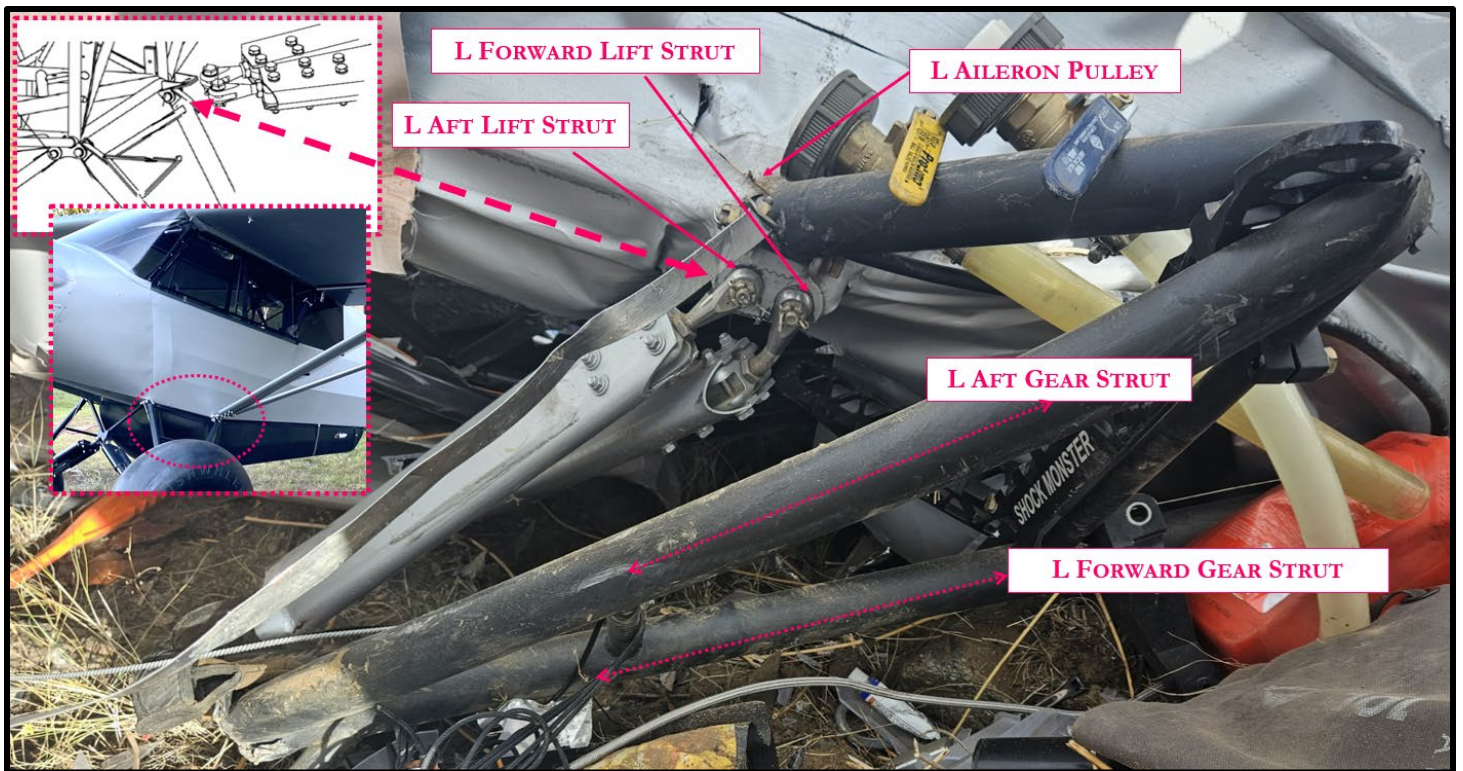
Figure 16: Left strut attachment

The left wing tip was at the far end of the debris field. The left-wing forward lift strut was partially severed and punctured through the right wing. The fracture surface was bent down and contained black marks on the trailing edge. The other piece of the forward lift strut remained attached to the airframe and the fracture surface was deformed downward with the silver paint flaked off. An approximate 1.5 ft piece of the left aft lift strut remained attached to the airframe; the trailing edge contained black marks. The fracture surface had a small paint transfer that was blue and similar in color to the plastic locks of containers found in the wreckage.
