National Transportation Safety Board

WPR24FA056

**INVESTIGATIVE SUPPLEMENTAL MATERIAL**

Location: Corona, CA  
Date: 12.16.2023  
Time: 1151 Pacific standard time  
Airplane: Vans RV-8

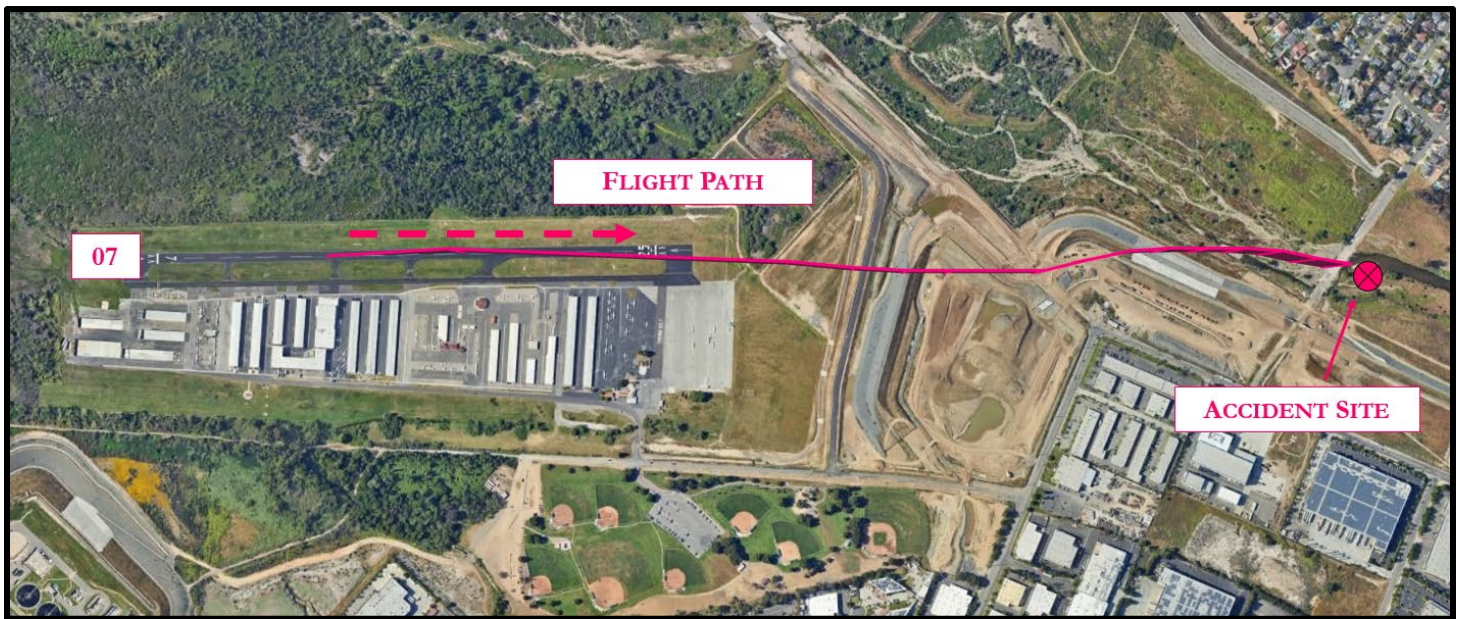
Figure 1: Flight Path

A review of the recorded security camera footage at the airport revealed that the airplane came into the frame at 1149:23 when it was midway down runway 07 (passing by the fuel tanks) with all the landing gear on the surface. The airplane continued down the runway and rotated about 4 seconds later. Based on the distance and time, the airplane’s speed was calculated to be 71 kts at the time of rotation and a sound spectrum analysis revealed that the engine rpm was about 2,500 at that time. The airplane climbed slightly, just passing over a berm at the airport’s perimeter reaching a maximum altitude of about 95 ft above the runway. The estimated ground speed was 58 kts. Thereafter, the airplane descended and made a left turn, disappearing from the frame.

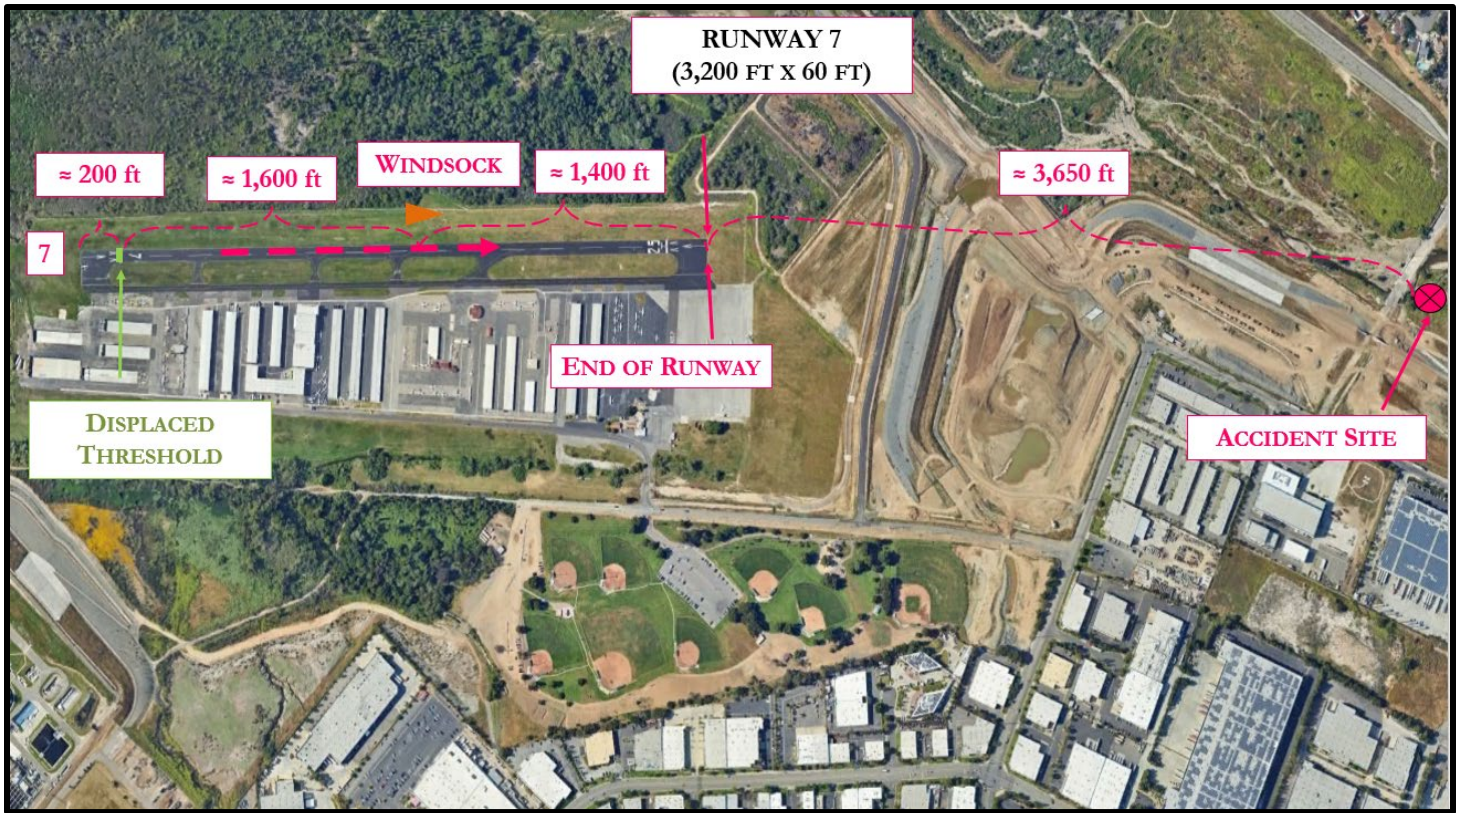
Figure 3: Airport Location in Reference to Accident Location

The accident site was located in soft dirt about 3,650 ft from the departure end of runway 25. In character, the terrain was located in a water-runoff and populated with large bush, trees, tumbleweeds, and discarded trash. The main wreckage, consisting of the engine and remains of the fuselage, came to rest upright under a tree and had burned the terrain in the surrounding 5 to 10 ft.

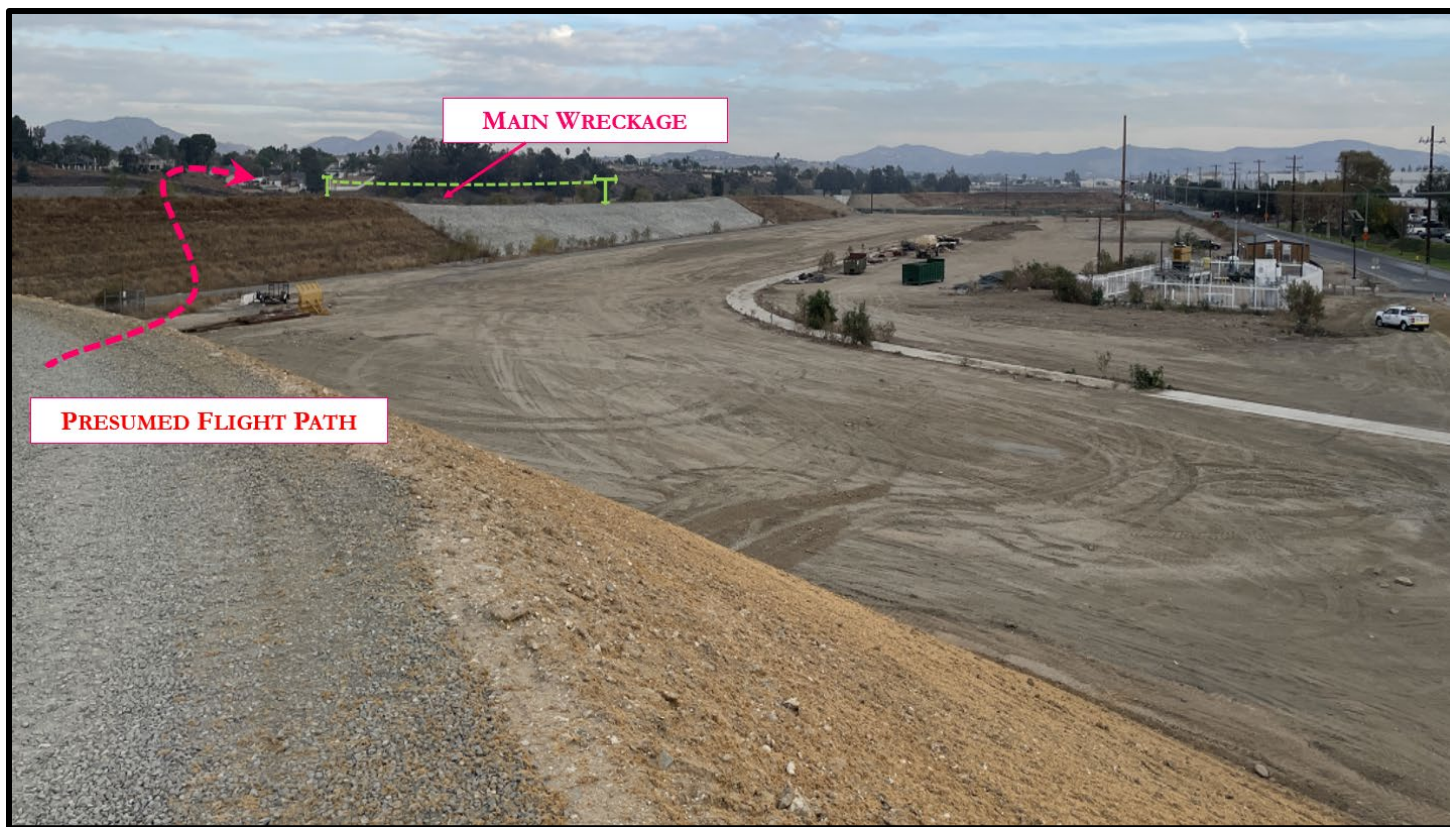
Figure 4: Terrain Between Airport and Accident Site

There was ongoing construction and an open dirt field immediately after the berm at the end of the runway between the airport and the accident site.

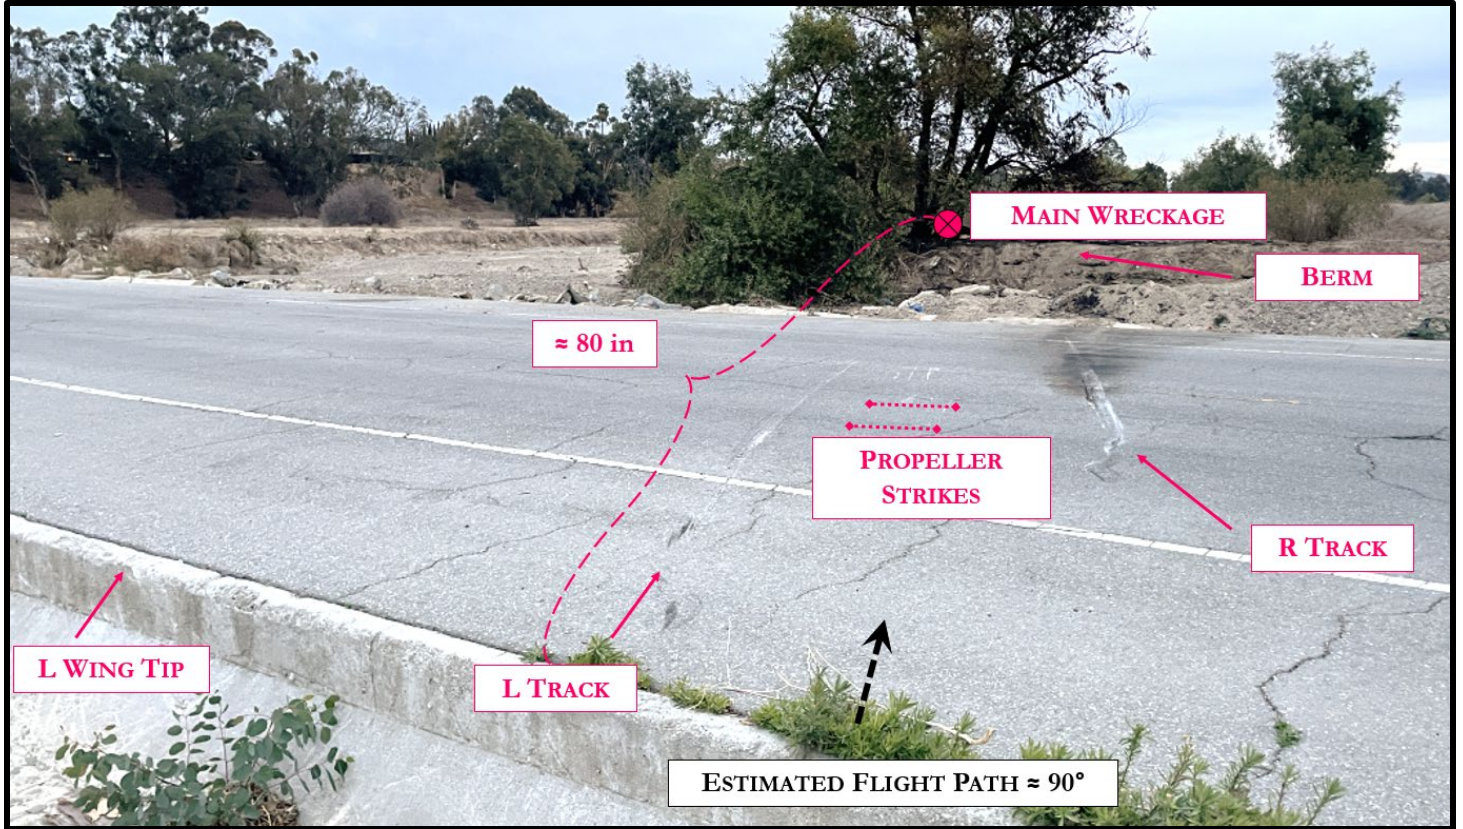
Figure 6: Debris Field

The first impact was a groove in the edge of the concrete wall making the lip of the road, consistent with contact from the left-wing tip. There were paint transfers and a small pile of paint chips adjacent to the divot. Small pieces of grey and white paint chips were scattered in the area as well as large portions of curved plexiglass that was similar in convex and had hardware pattern to that of the wingtip-light housing.

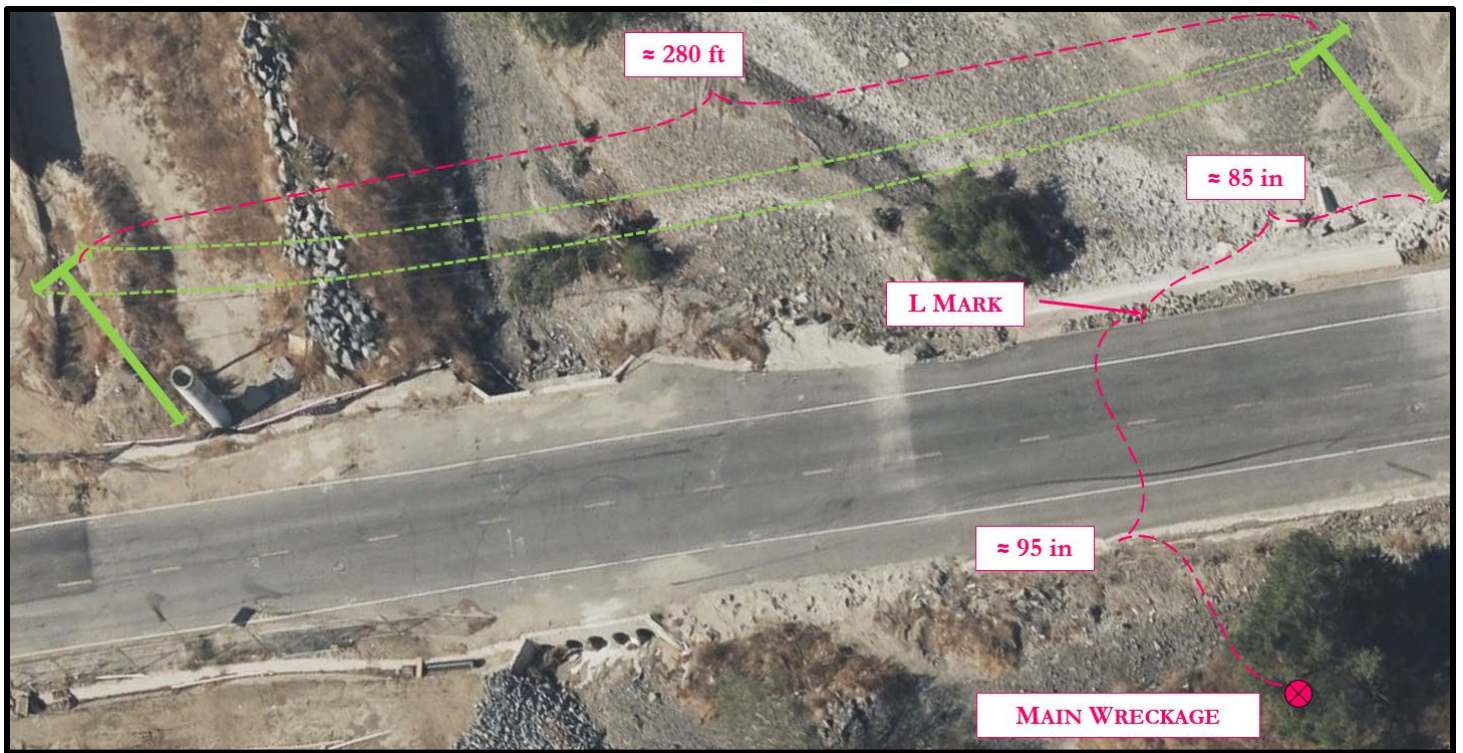
Figure 7: Accident Site in Reference to the Powerlines

The first identified points of contact consisted of disrupted concrete and markings on the west side of the flat paved road, making up the far west-end of the debris field. The initial impact was located between two powerline poles spaced 275 ft apart with numerous powerlines strung between them at 30 ft above the ground.

From that initial left-wingtip divot, located about 85 inches south, there was a black smudge transfer on the road's surface. As the debris field continued toward the main wreckage, that smudge track continued forward and became a white paint transfer line. About 4 ft along that white paint transfer line was a deep groove in the concrete that continued in the direction of the wreckage. The right track started 8 ft east of the beginning of the left track and paralleled that track with white transfer marks that became a deep groove in pavement.

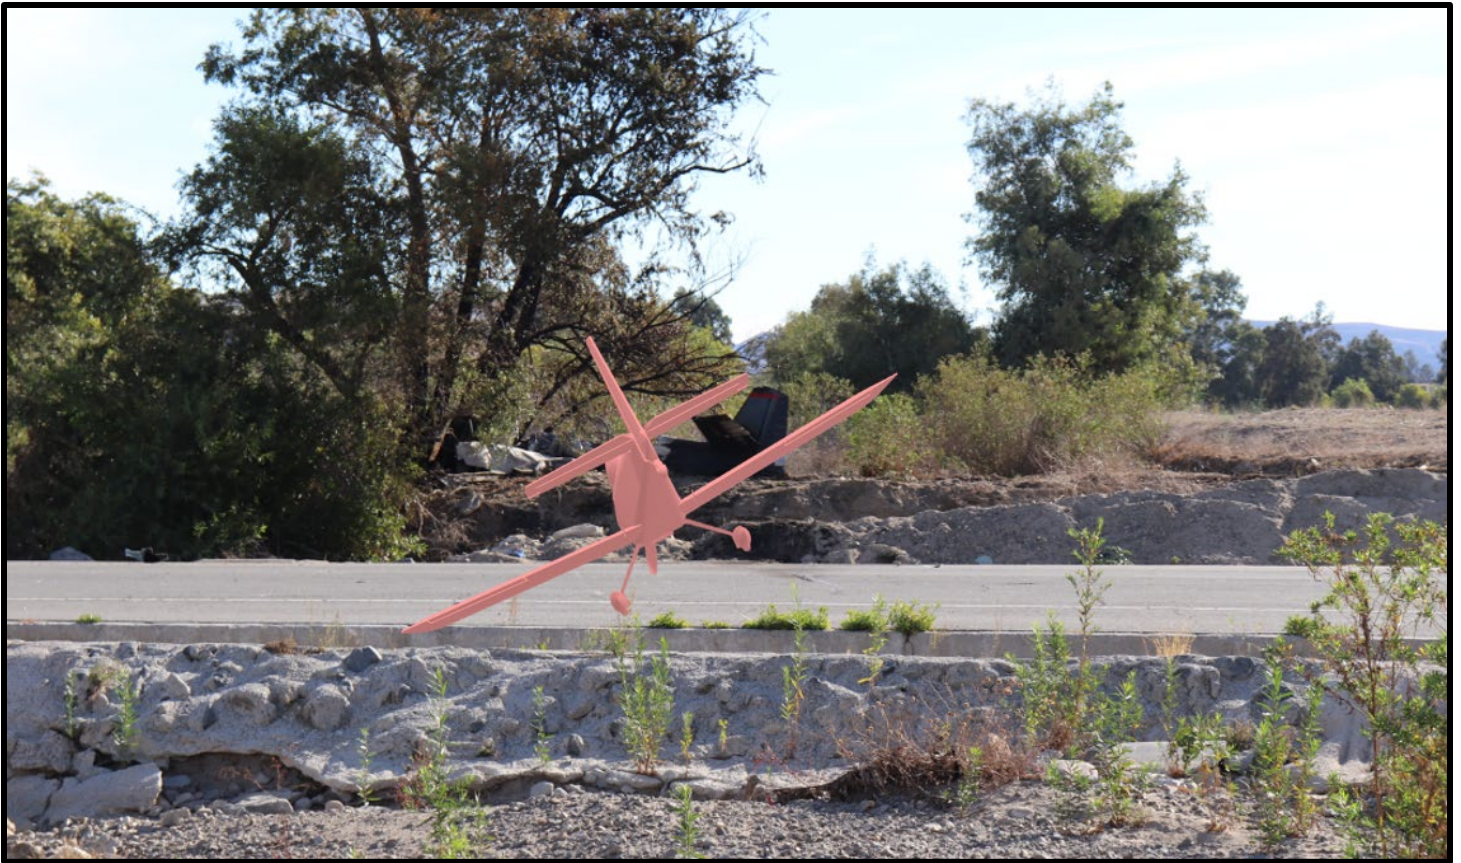
Figure 11: Visual of Possible Impact Angle

The dimensions and orientation of the witness marks were consistent with the left wing impacting the road first followed by the left wheel and then the right wheel.

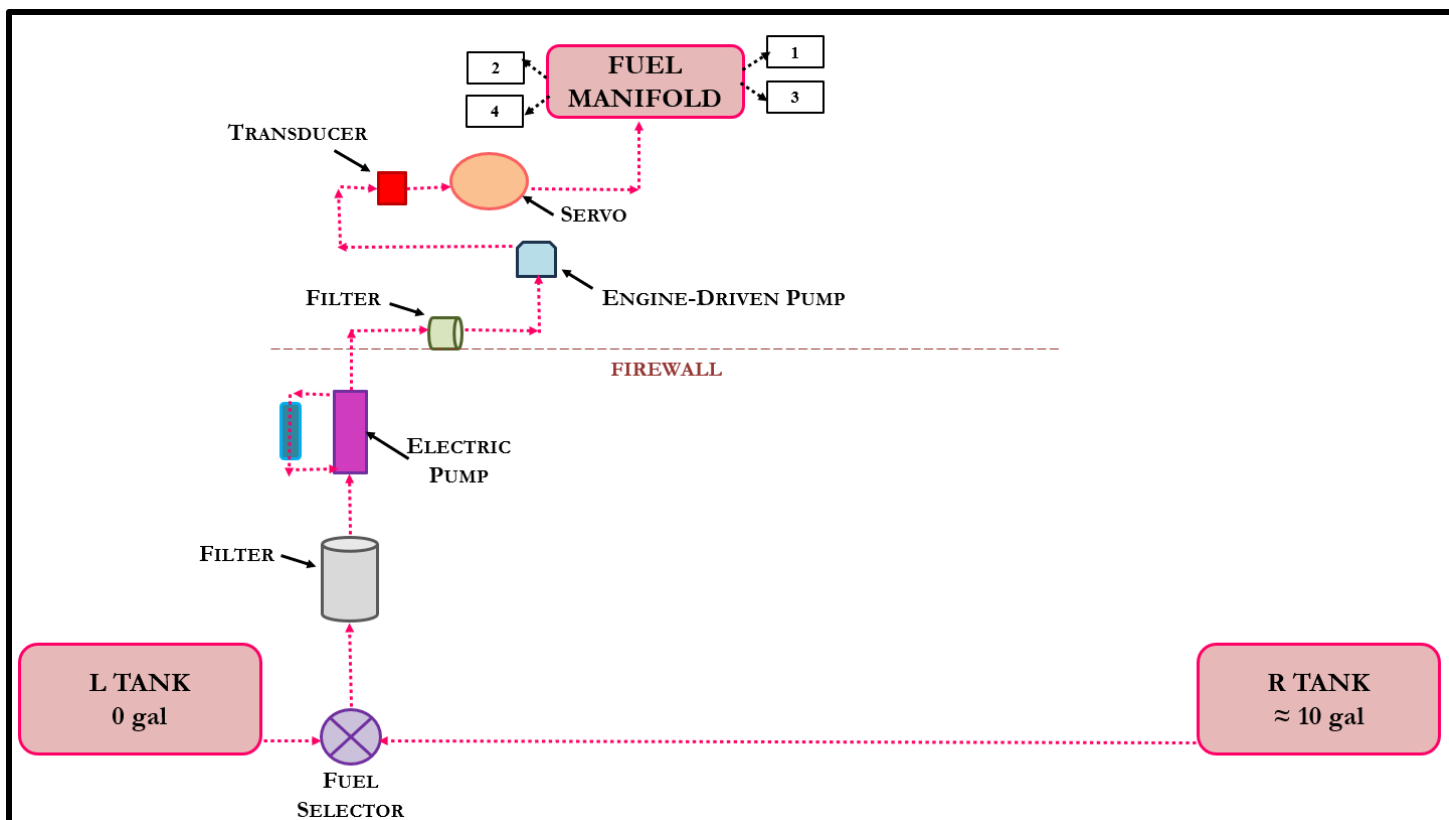
Figure 21: Fuel Diagram

The pilot/builder had deviated slightly from the original RV-8 fuel plan design and used several automotive parts not common in the building community. The left fuel tank was presumed empty and the right tank likely had about 10 gallons, but the quantities could not be verified because of the severe fire damage.

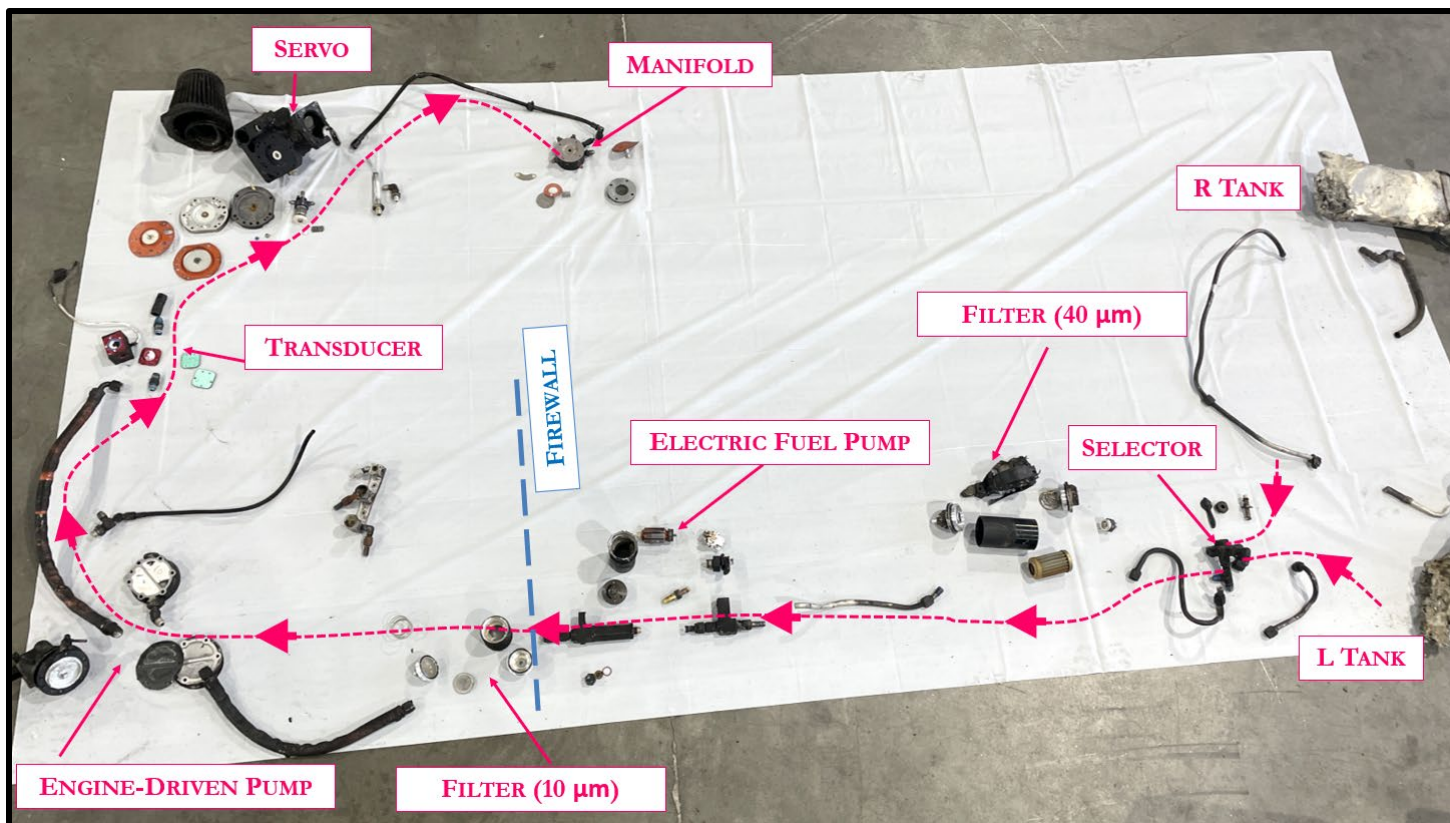
Figure 22: Fuel System (from wreckage)

The majority of the fuel system sustained major thermal damage. The right-wing fuel-cap was secured on the wing tank with the top tab flipped and affixed open. The left-wing fuel-cap was secured and flush on the wing. According to an RV-8 owner, it is common practice to keep the top tab lifted up when on the ground to help it vent (reduce the pressure from the heating on the ground).

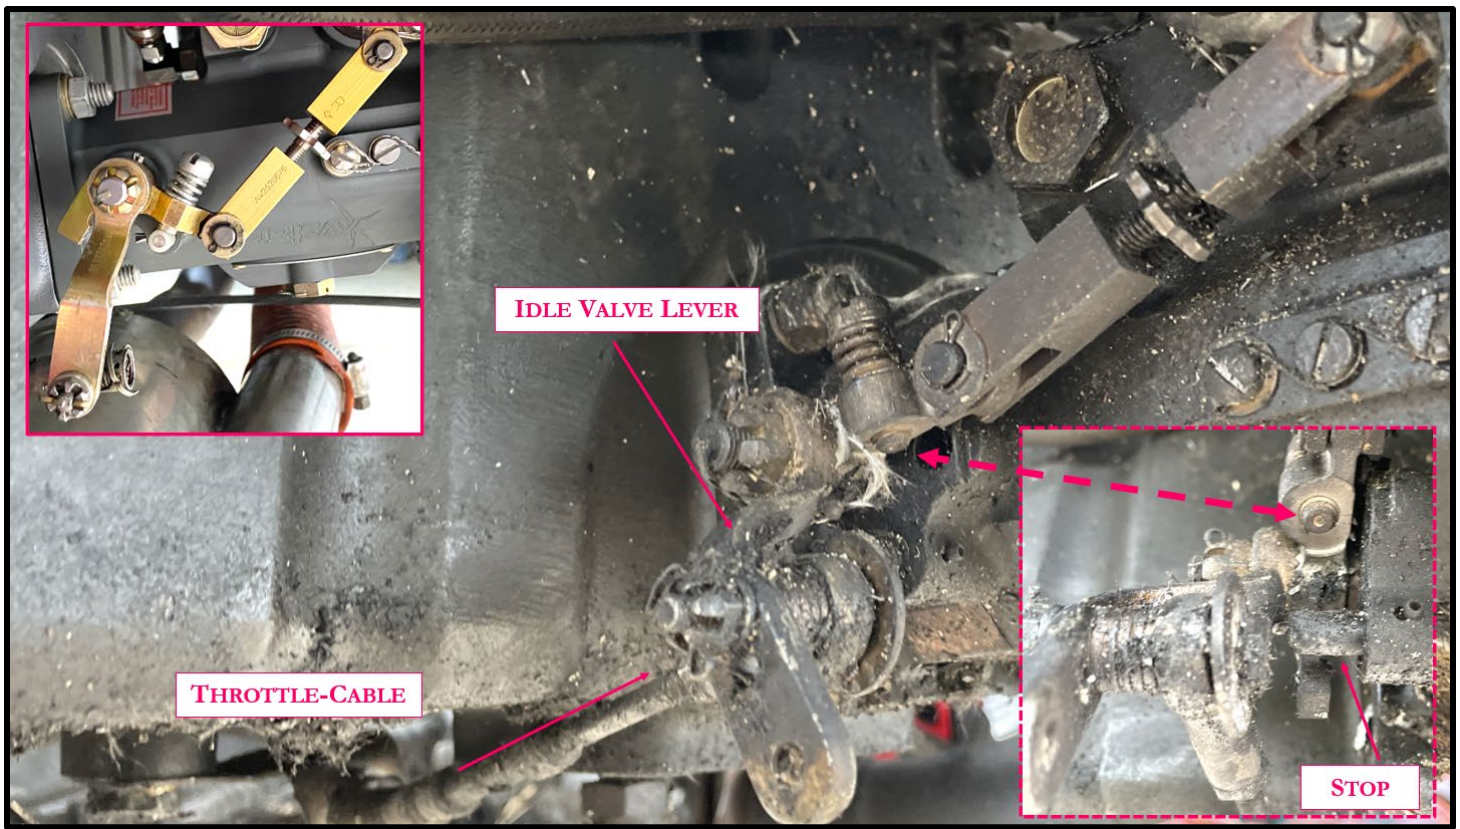
Figure 34: Throttle Control

The throttle quadrant was burned and displaced from the interior trim it had been mounted to. The throttle, manifold pressure, and mixture handles were all in the fully forward position. The handles were slightly bent to the left; the cables were

all attached to their respective levers at the bottom of the handles. Continuity could not be established from the throttle quadrant to the respective fittings on the engine components, due to impact damage and crush deformation.

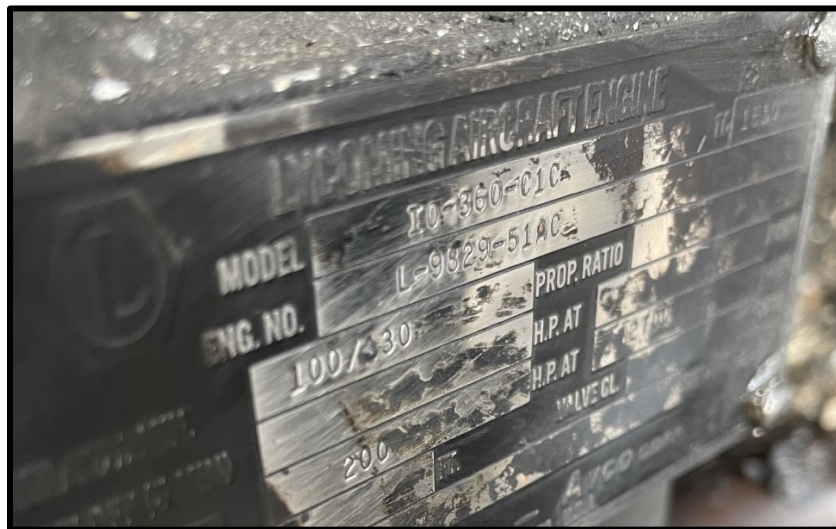
Figure 35: Engine Data Plate

The external examination of the Lycoming IO-360-C1C (s/n L-9829-51A) revealed no evidence of a pre-impact catastrophic mechanical malfunction or failure. The engine remained attached to the airframe via the engine mount and had sustained significant thermal damage from the post-impact ground fire. The top spark plugs were removed, and the crankshaft was rotated by hand using the attached propeller. The crankshaft rotated freely in both directions. Thumb compression was observed in proper order on all four cylinders. The complete valve train was observed to operate properly and was free of any pre-mishap mechanical malfunction. Normal lift action was observed at each rocker assembly, and clean, uncontaminated oil was present in all four rockerbox areas. Mechanical continuity was confirmed throughout the rotating and reciprocating group, valve train, and accessory section during hand rotation of the crankshaft.
