# National Transportation Safety Board

WPR24FA056

## **MATERIALS LABORATORY**

Factual Report 24-085

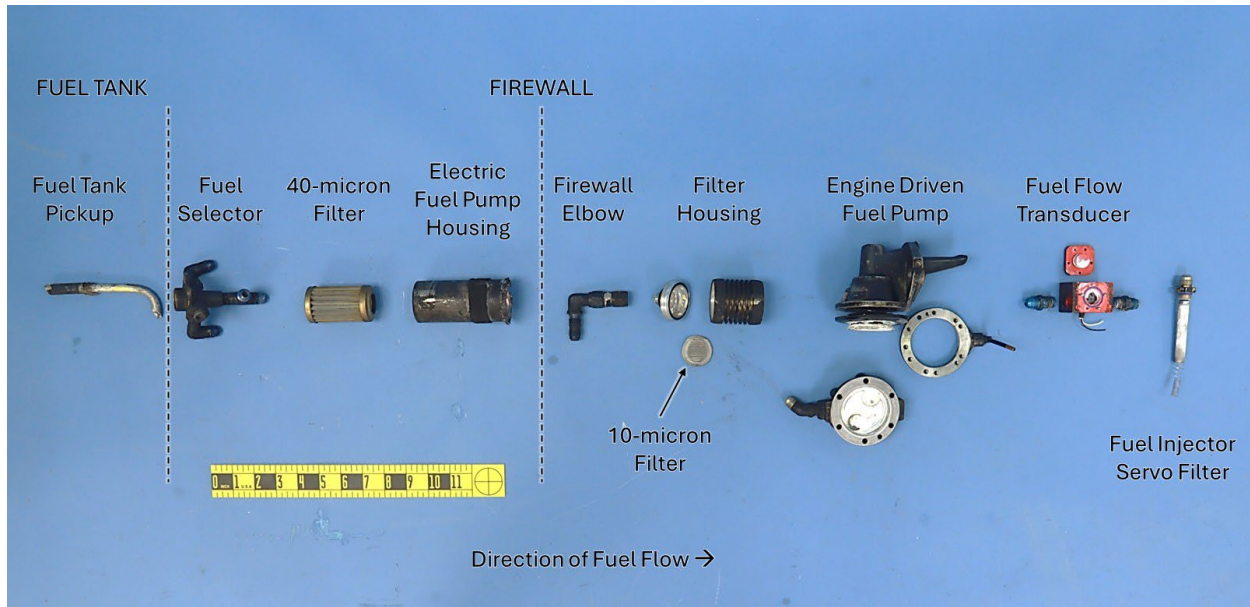
The components had been received disassembled and labeled as indicated in figure 1, relative to the direction of fuel flow. Closer images of each component are shown in subsequent figures.

**Figure 1.** Photograph of as received fuel system components placed in series relative to the direction of fuel flow and the position of the firewall.
