# National Transportation Safety Board

WPR24FA083

## **AIRPLANE PERFORMANCE STUDY**

Location: Westwater, Utah  
Date: February 7, 2024  
Time: 1048 MST  
1748 GMT  
Airplane: Hawker 900XP, N900VA

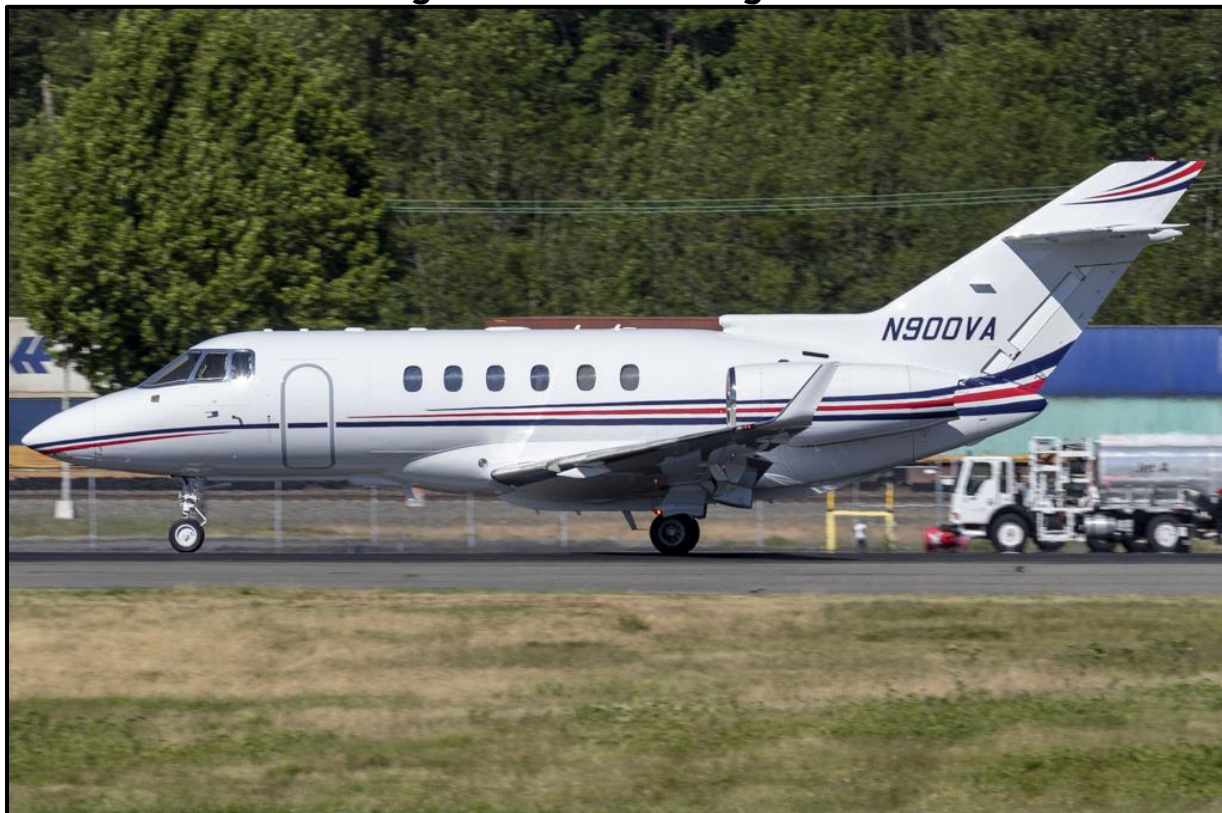
**Figure 3: Accident Airplane, a 2008 Hawker 900XP**

A picture of the accident airplane, a Hawker 900XP, is shown in Figure 3. It was manufactured by Hawker Beechcraft Corporation Aircraft (now Textron) in 2008 and is registered to Sil-Con Air, LLC. The airplane was equipped with two Honeywell (previously Garrett) TFE731 turbofan engines.
