# National Transportation Safety Board

WPR24FA104

## **AIRCRAFT AND ENGINE ON-SCENE EXAMINATION SUMMARY NOTES**

Location: Cave Junction, Oregon  
Date: March 7, 2024  
Time: 1124 Pacific standard time (PST)  
1824 coordinated universal time (UTC)  
Airplane: N4443G

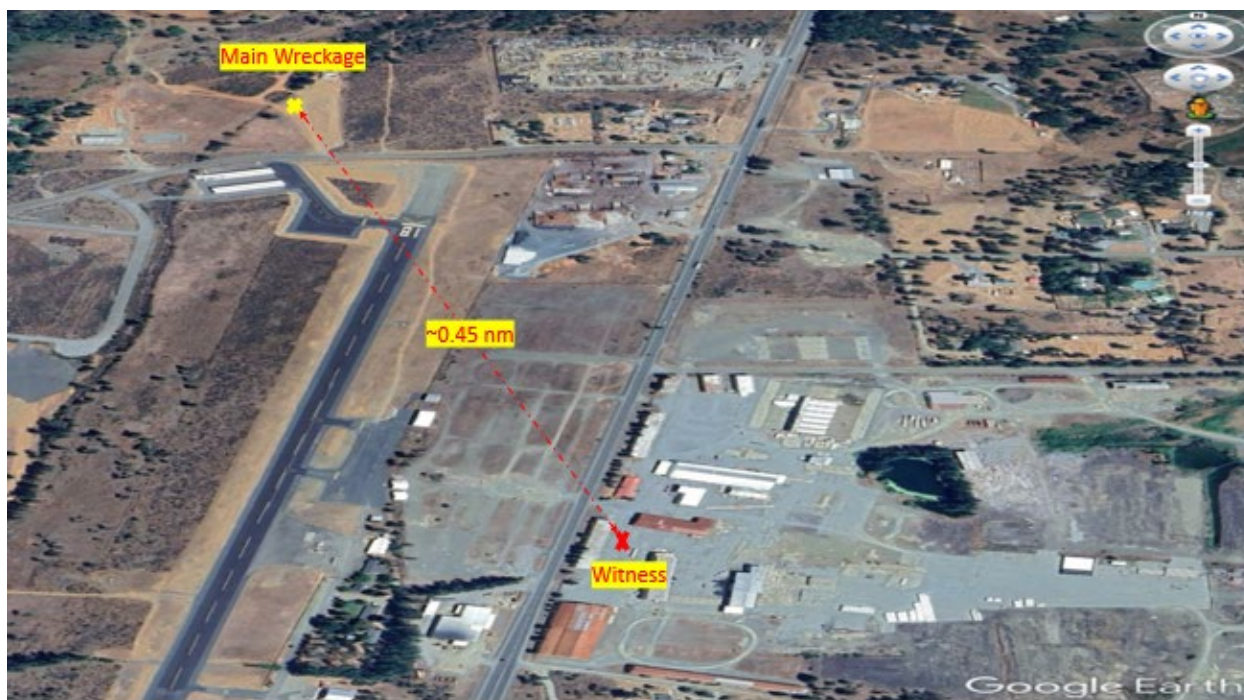
Witnesses reported that the airplane departed midfield about 1122 for a local flight after the pilot installed an overhauled engine. The airplane departed to the north and about 500 ft above the ground, turned left to the northwest and continued to turn left in about a 30-40° bank turn until it established a southeast heading. The witness then saw the airplane nosed down slightly and lose about 100 ft and shortly after, saw the airplane in a 90° nosed down dive towards the ground. The witness lost sight of the airplane prior to impact. See figure 1.

**Figure 1. Birdseye view of map showing witness location in relation to main wreckage.**
