| <b>Rolls-Royce</b> | Rolls-Royce Corporation<br>450 S. Meridian Street<br>Indianapolis, Indiana<br>46225-1103, USA | <b>REPORT NO.</b><br>24FAE-061-PR | <b>REV.</b><br>Initial | <b>PAGES</b><br>1 of 54 |
| <b>TITLE</b><br><b>METALLURGICAL INVESTIGATION OF A TURBINE TO COMPRESSOR COUPLING, P/N 23032345, INSTALLED IN AN M250-C30P ENGINE, S/N CAE895785, OPERATED BY HELIWORKS FLIGHT SERVICES</b> | | <b>PREPARED</b><br>Signatures on File | | |

| Part Name: | Turbine to Compressor Coupling |
| Engine Model: | M250-C30P |

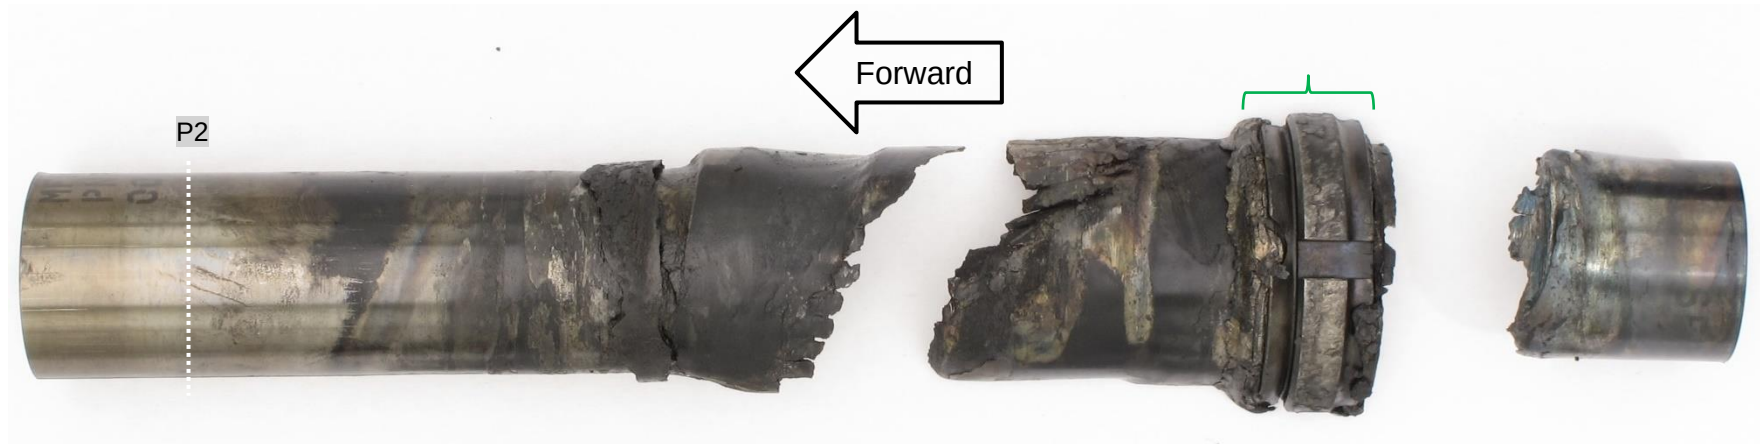
**Figure 9.** Overall view of the turbine to compressor coupling pieces. Not pictured: portions of the turbine to compressor coupling embedded in the 4<sup>th</sup> stage turbine wheel (see Figure 6) and the PT outer shaft (see Figure 5). The green brace indicates PT inner shaft material and the PT inner coupling nut adhered to the turbine to compressor coupling. The white dashed line indicates the approximate cross-section (P2) selected for metallographic examination as shown in Figure 17.

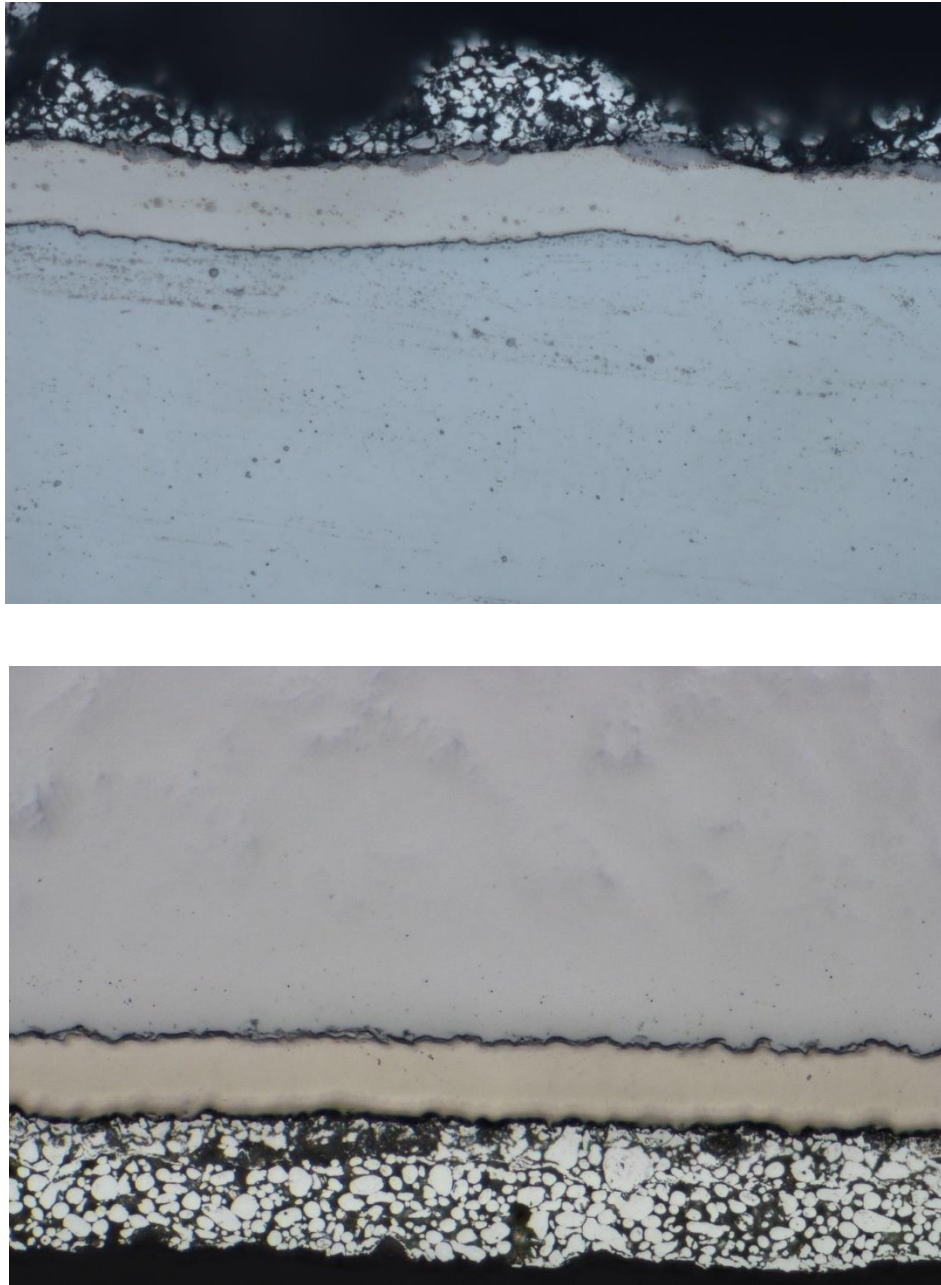
**Figure 16.** Representative metallographic images of the PT outer shaft inner (top) and outer (bottom) diameter surfaces showing nickel plating (red double arrow) and aluminum coating (yellow double arrow). Etchant: None.

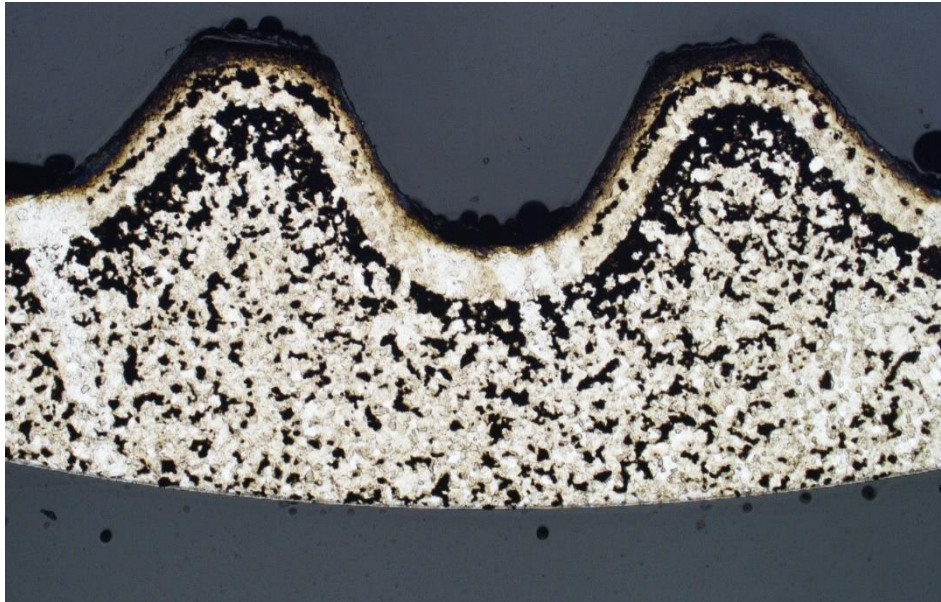
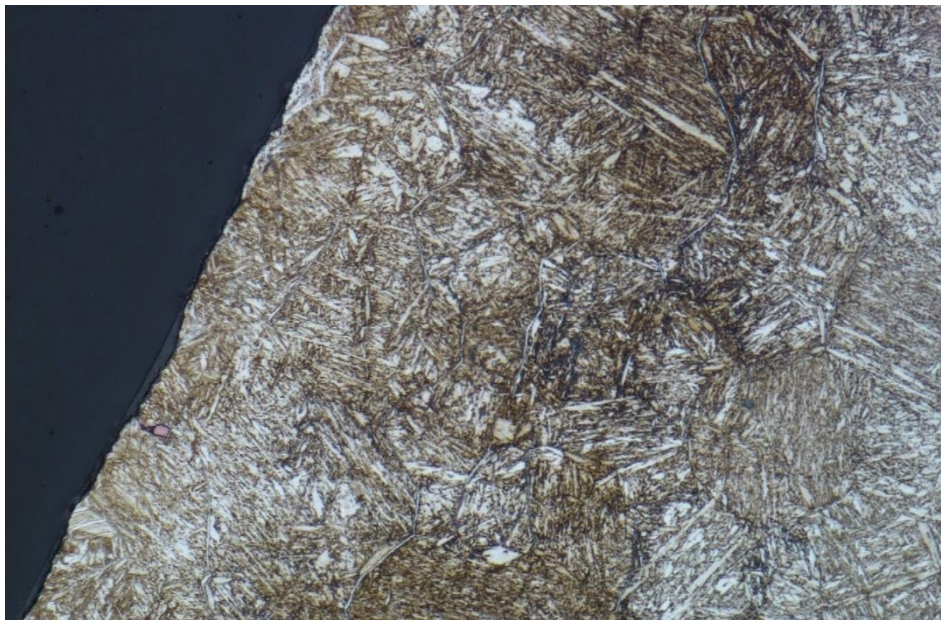
**Figure 17. Top: Metallographic image of the cross-section at plane P2, white dashed line in Figure 9, showing the spline teeth and case depth in the turbine to compressor coupling. Etchant: Marbles. Bottom: Representative microstructure of the turbine to compressor coupling case material. Etchant: Nital.**

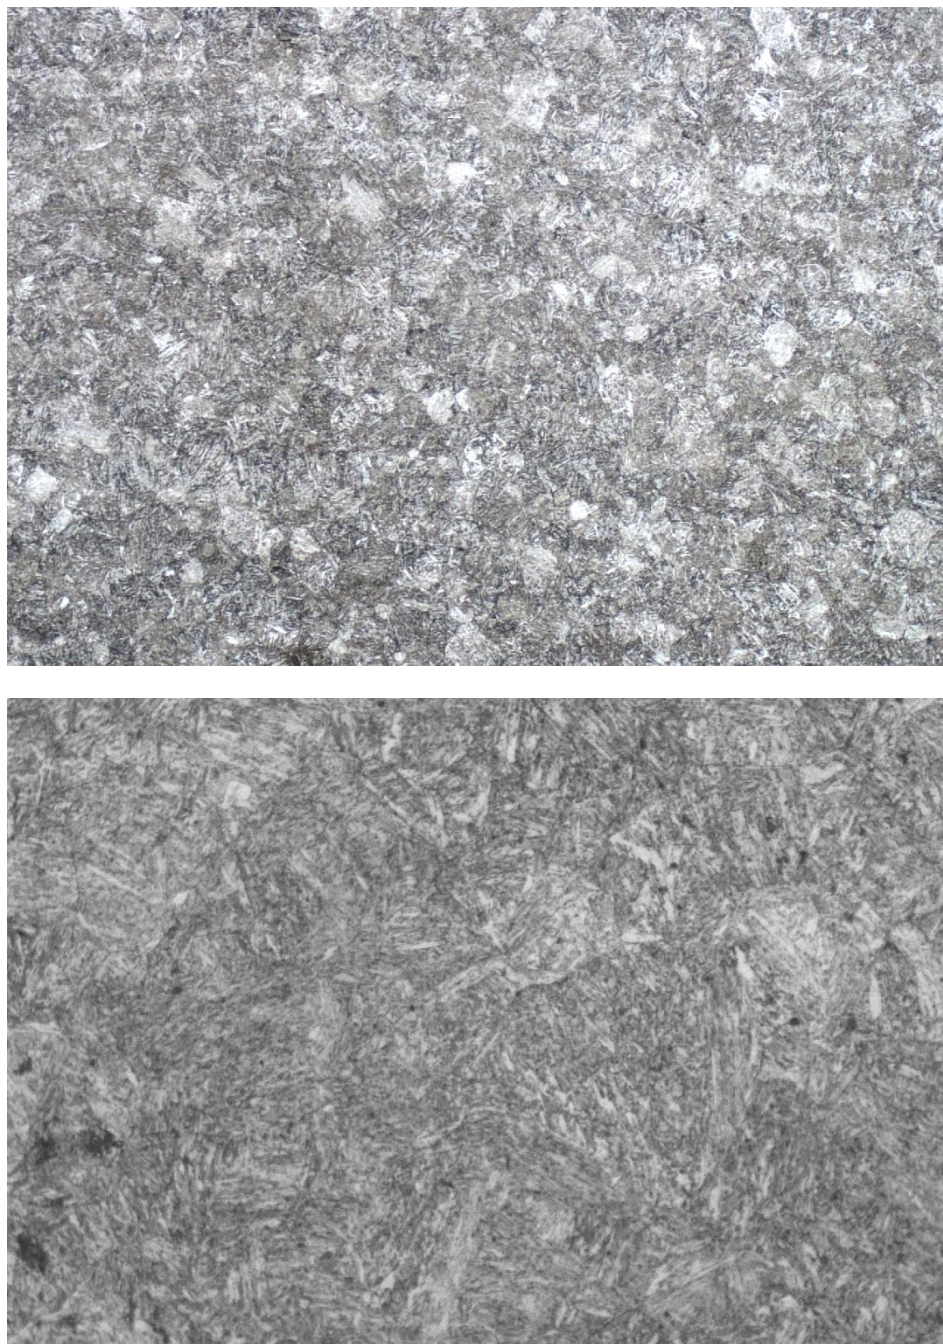
**Figure 18. Representative microstructure of the turbine to compressor coupling core material from cross-section P2 (see Figure 9). Etchant: Nital.**

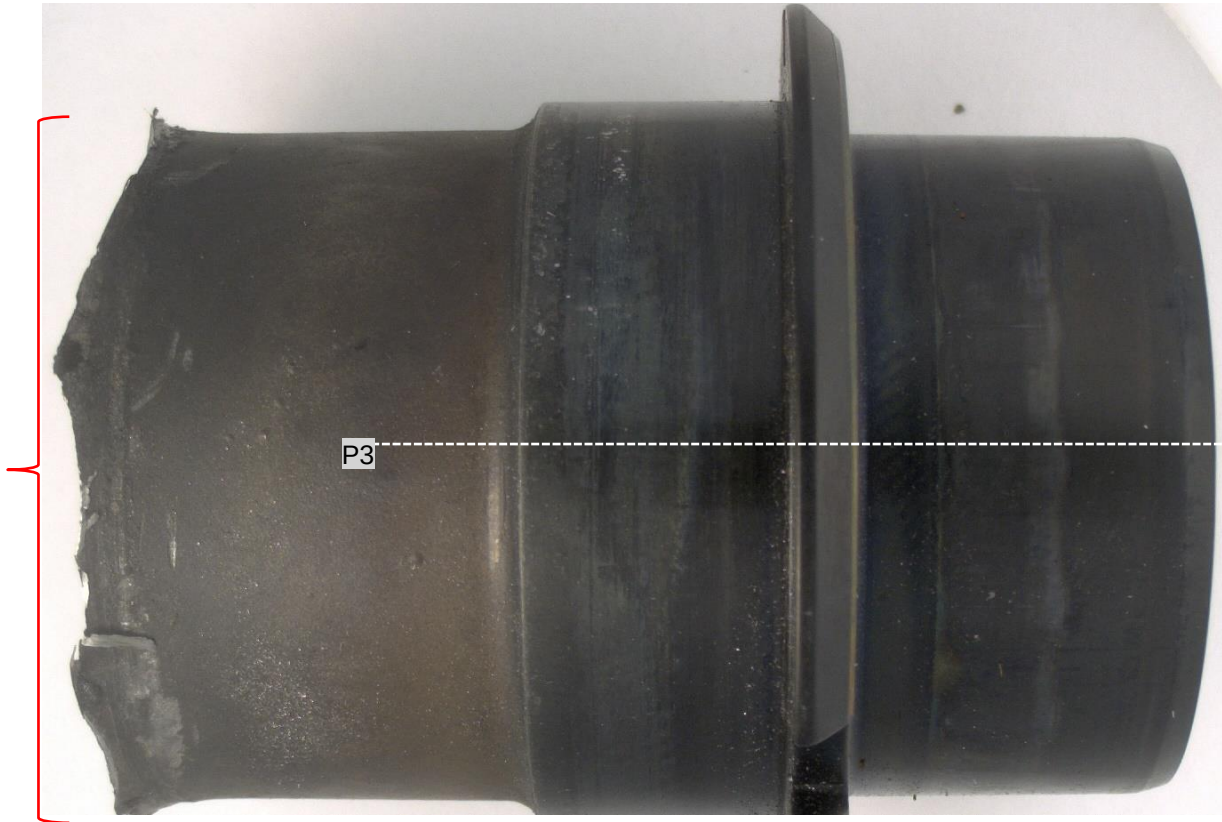
**Figure 21.** Detailed outboard looking inboard view of the PT inner shaft aft remnant following removal from the 3<sup>rd</sup> stage turbine wheel. The red brace indicates laboratory cuts made to excise the PT inner shaft from the 3<sup>rd</sup> stage turbine wheel bore. The white dashed line indicates the approximate cross-section (P3) selected for metallographic examination of the PT inner shaft shown in Figure 22.

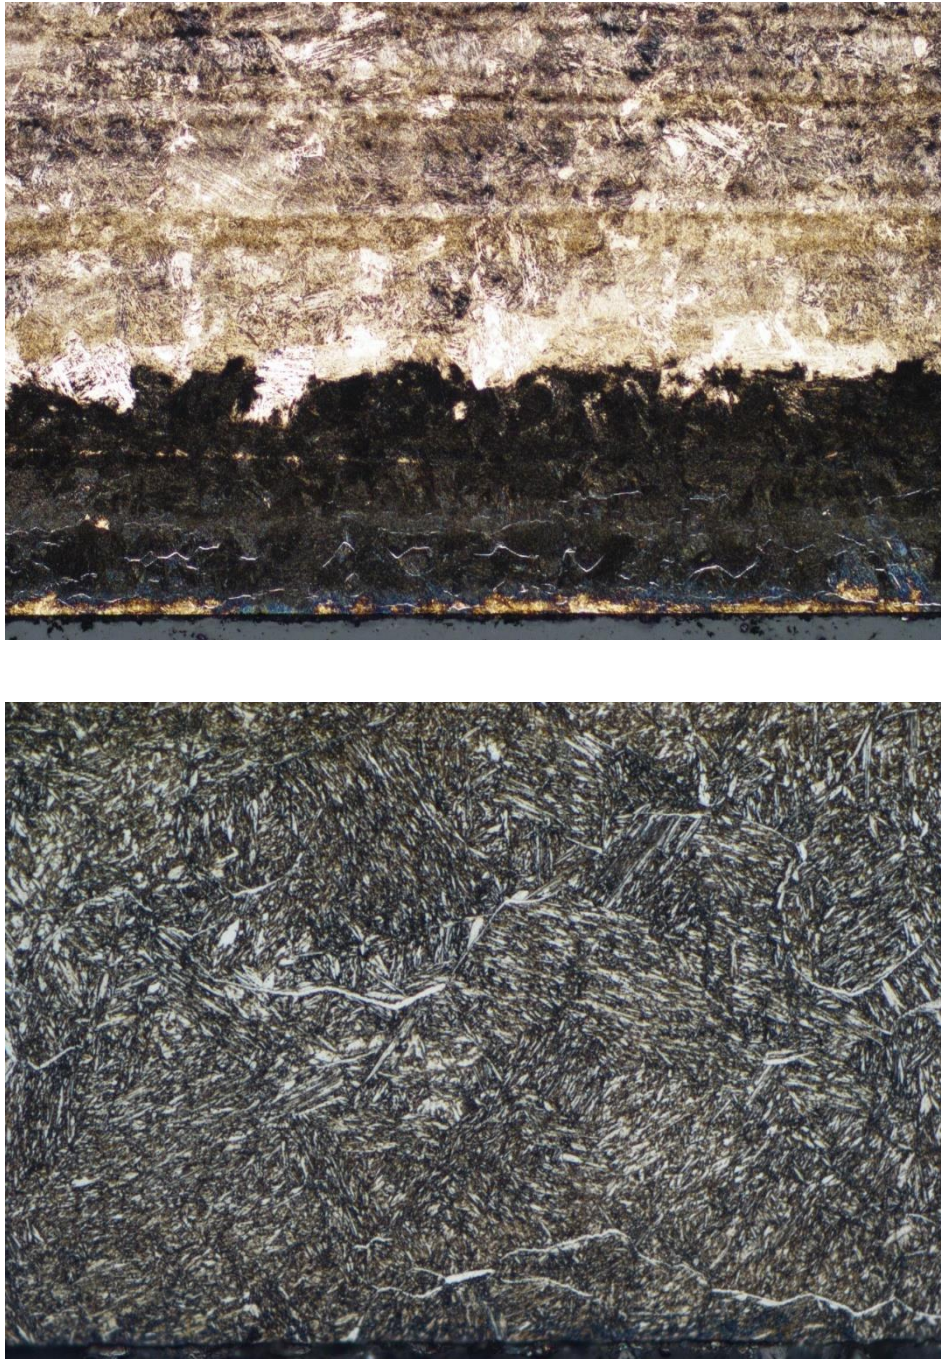
**Figure 22.** Detailed metallographic images of the PT inner shaft nitride case material from cross-section P3 (see Figure 21).  
Etchants: Top: Marbles; Bottom: Nital.

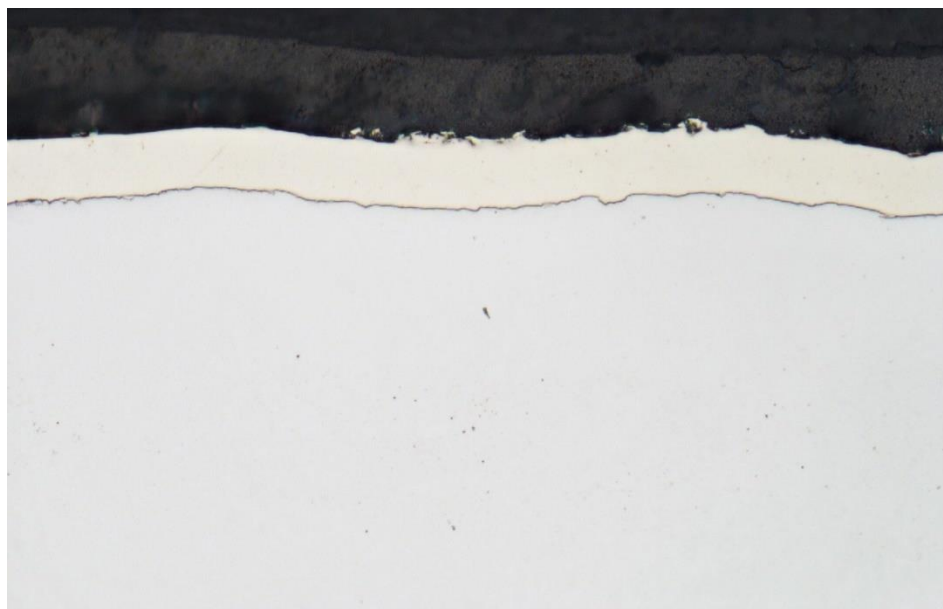
**Figure 23. Metallographic image of the PT inner shaft nickel plating from cross-section P3 (see Figure 21). Etchant: None.**

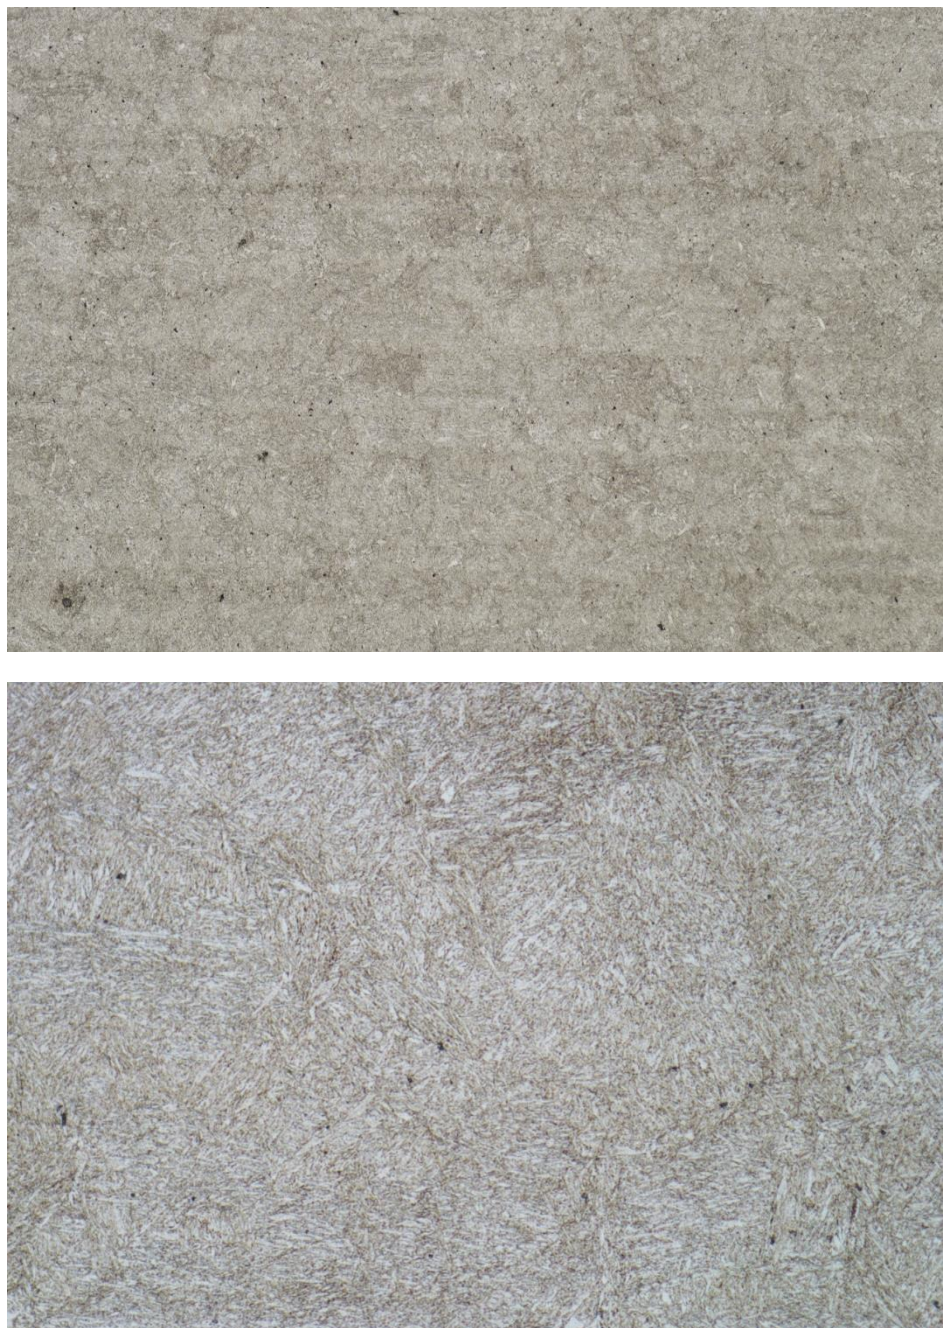
**Figure 24. Representative microstructure of the PT inner shaft core material from cross-section P3 (see Figure 21). Etchant: Nital.**

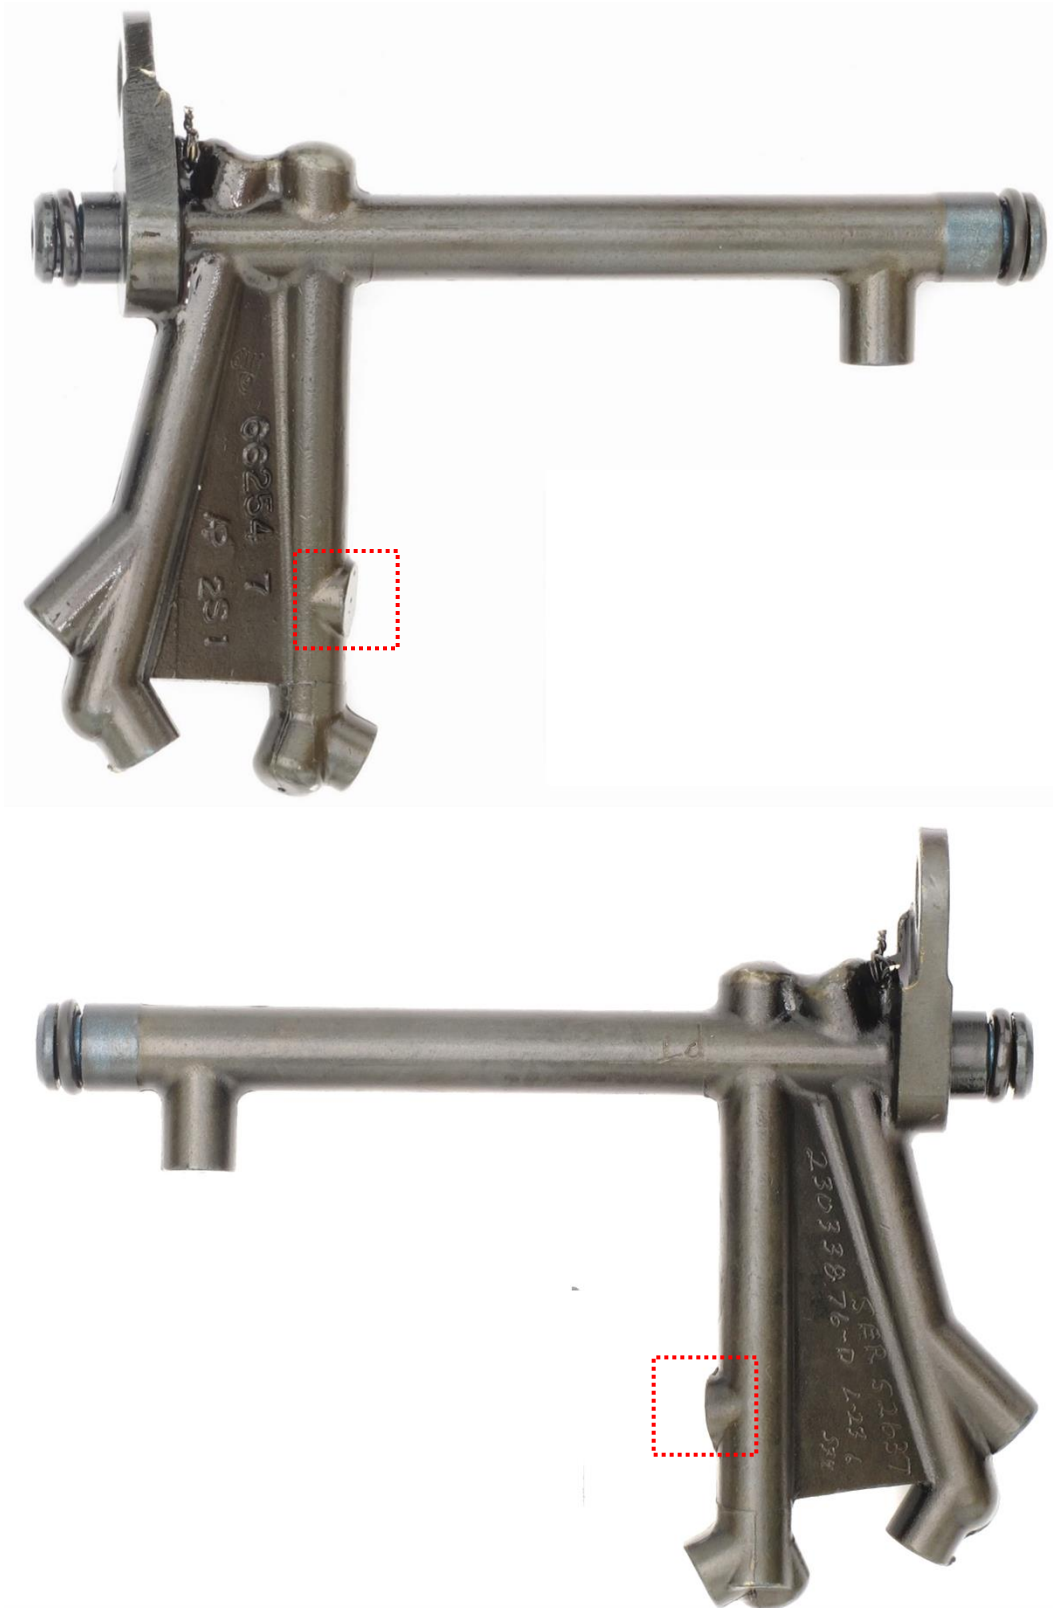
Overall views of oil delivery tube are shown in Figure 28 in the as-received condition. The oil delivery tube was subjected to the computed topography (CT) examination at the Rolls-Royce Corporation Non-destructive Testing Department in Indianapolis, IN. CT revealed a blocked passage in the No. 3 bearing oil jet as shown in Figure 29. The blockage exhibited a relatively denser material compared to the residual oil that remained in the passageways. The denser material was also observed built up on the internal cavity walls. No other oil jets exhibited evidence of complete blockages.

**Figure 28. Overall views of the oil delivery tube in the as-received condition. The No. 3 bearing oil jet indicated by the red boxes is shown in more detail in the following figure.**

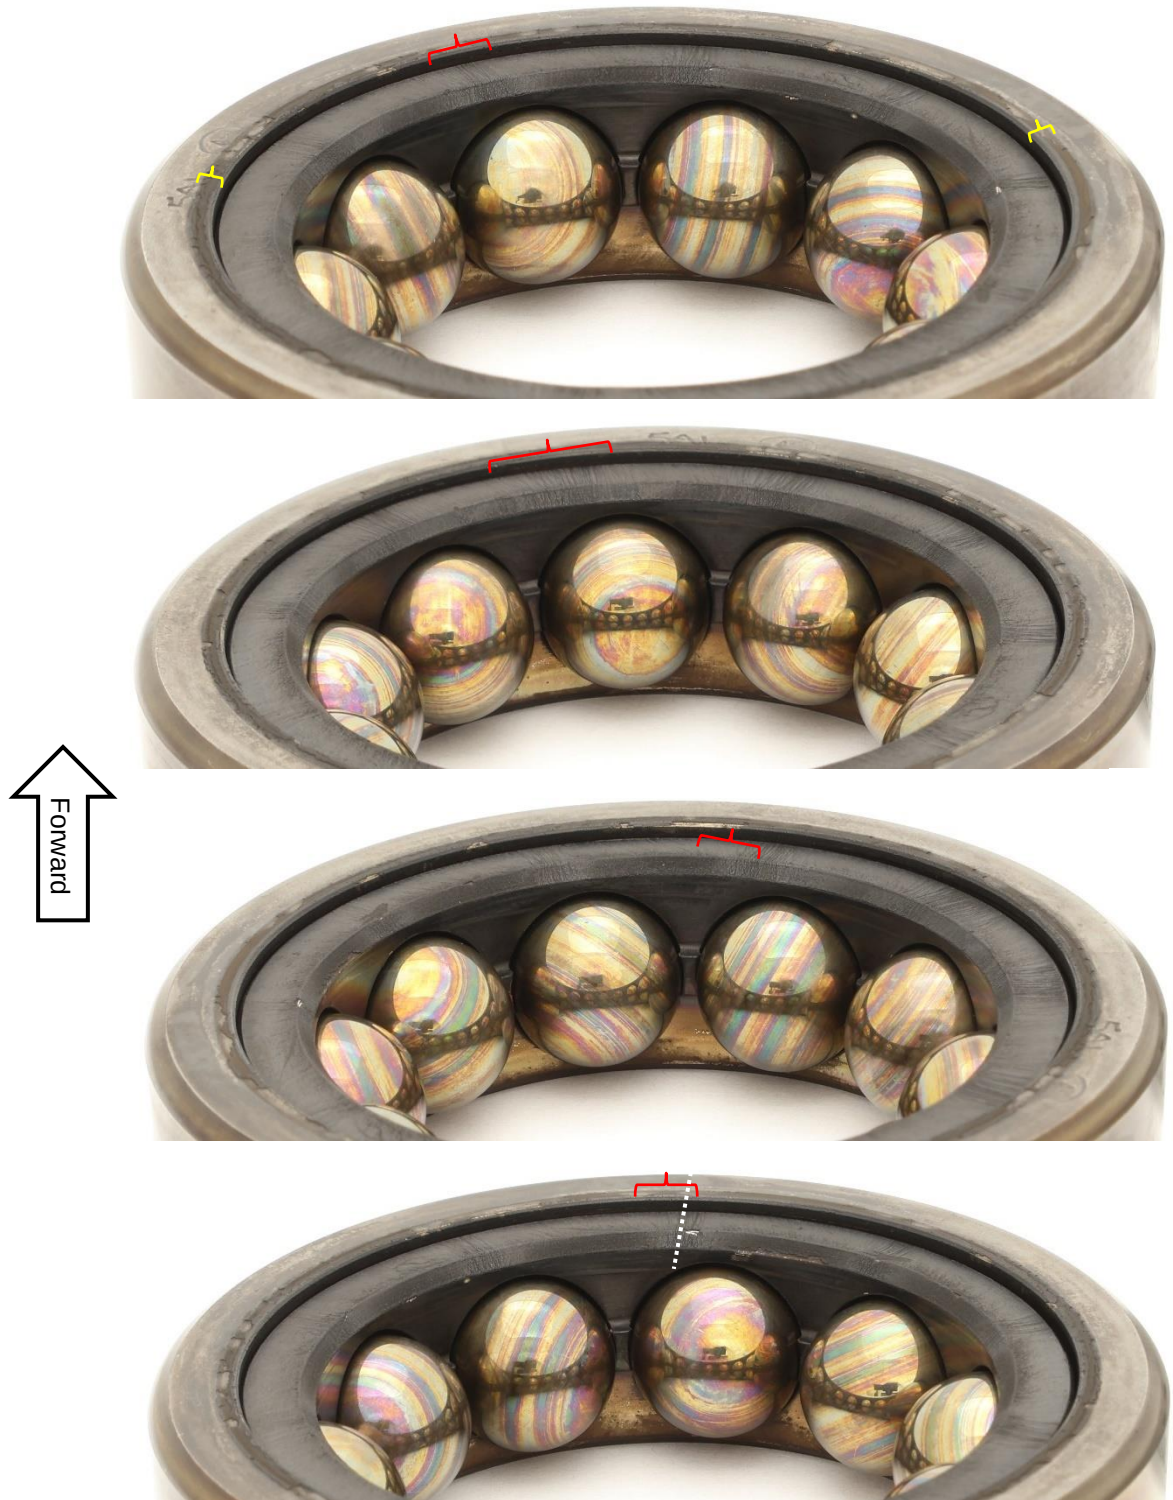
Overall views of the No. 2 bearing are shown in Figure 36 in the as-received condition. The forward side exhibited a darker discoloration in the inner ring and separator. Detailed views of the separator inner diameter and balls are shown in Figure 37. The separator exhibited a dark discoloration that was flaked off in areas consistent with a layer of coked oil material. The coked oil layer spanned from the approximate axial mid-span onto the forward face. The separator forward face at each ball pocket exhibited radially oriented banded features in the coked oil layer. The outer ring forward face exhibited a darker layer of material located approximately 0.13 inch inboard of the outer diameter chamfer. Detailed views of the separator outer diameter are shown in Figure 38. Detailed views of the separator forward and aft rails are shown in Figure 39. The separator outer diameter exhibited a dark discoloration. Detailed views of the outer ring raceway are shown in Figure 40. Detailed views of the forward inner race are shown in Figure 41. A dark discoloration was observed on the forward portion of the raceway and onto the forward shoulder. Detailed views of the aft inner race are shown in Figure 42.

**Figure 37.** Detailed views of the No. 2 bearing outer race, ball, and separator assembly. Each image is rotated approximately 90° from the previous. The separator forward rail exhibited darker discoloration and radially oriented banded features (red braces, not all are noted). A layer of circumferential dark, tinted transferred material on the outer ring forward face is indicated by the yellow braces (top image). The white dashed line indicates the approximate cross-section (P4) of the separator and outer race selected for metallographic examination shown in Figure 43.

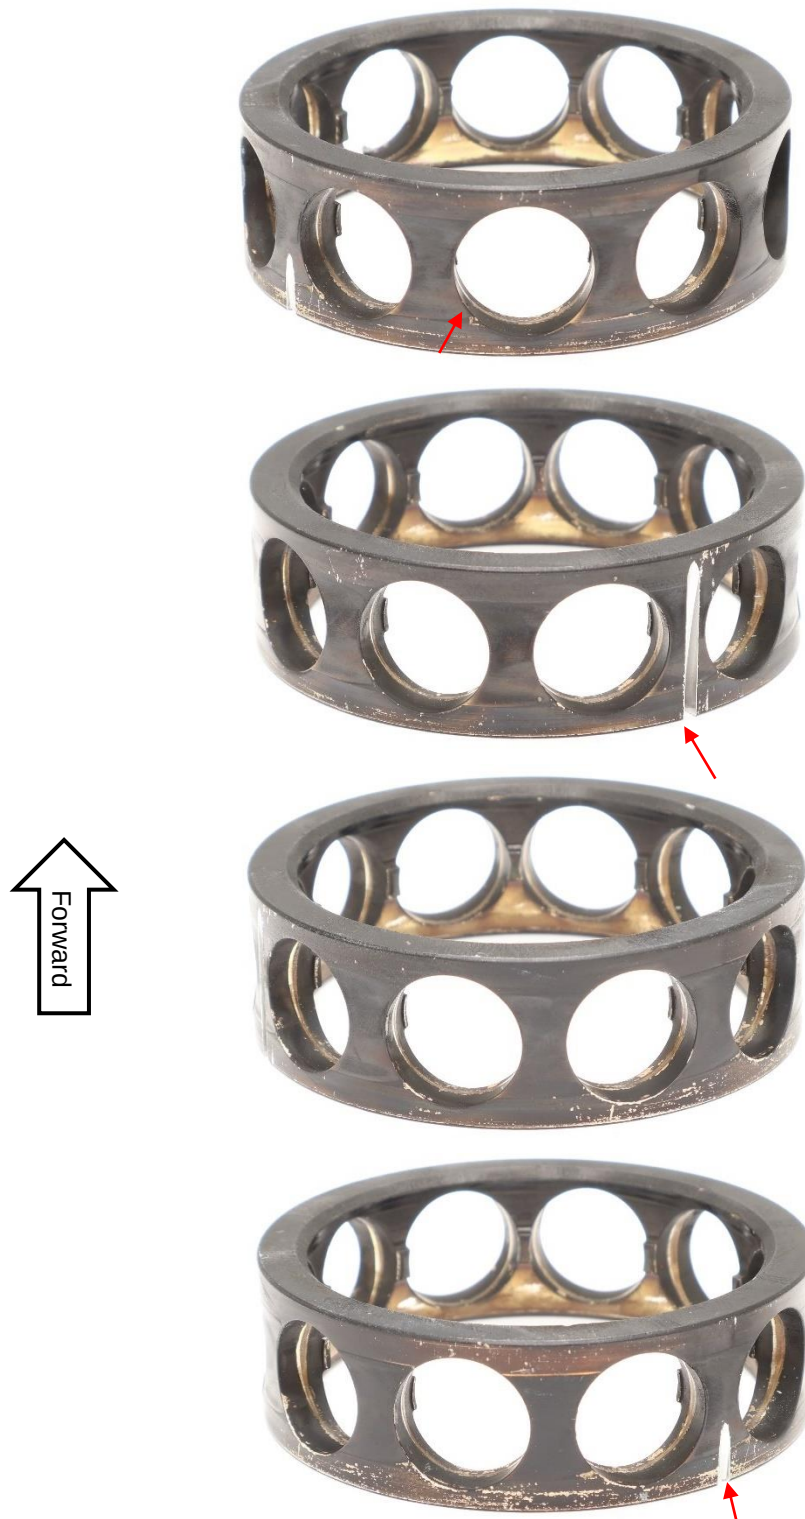
**Figure 38. Photographs showing outer diameter views of the No. 2 bearing separator. The red arrows indicate marks made by the cutting tool used to remove the outer ring.**

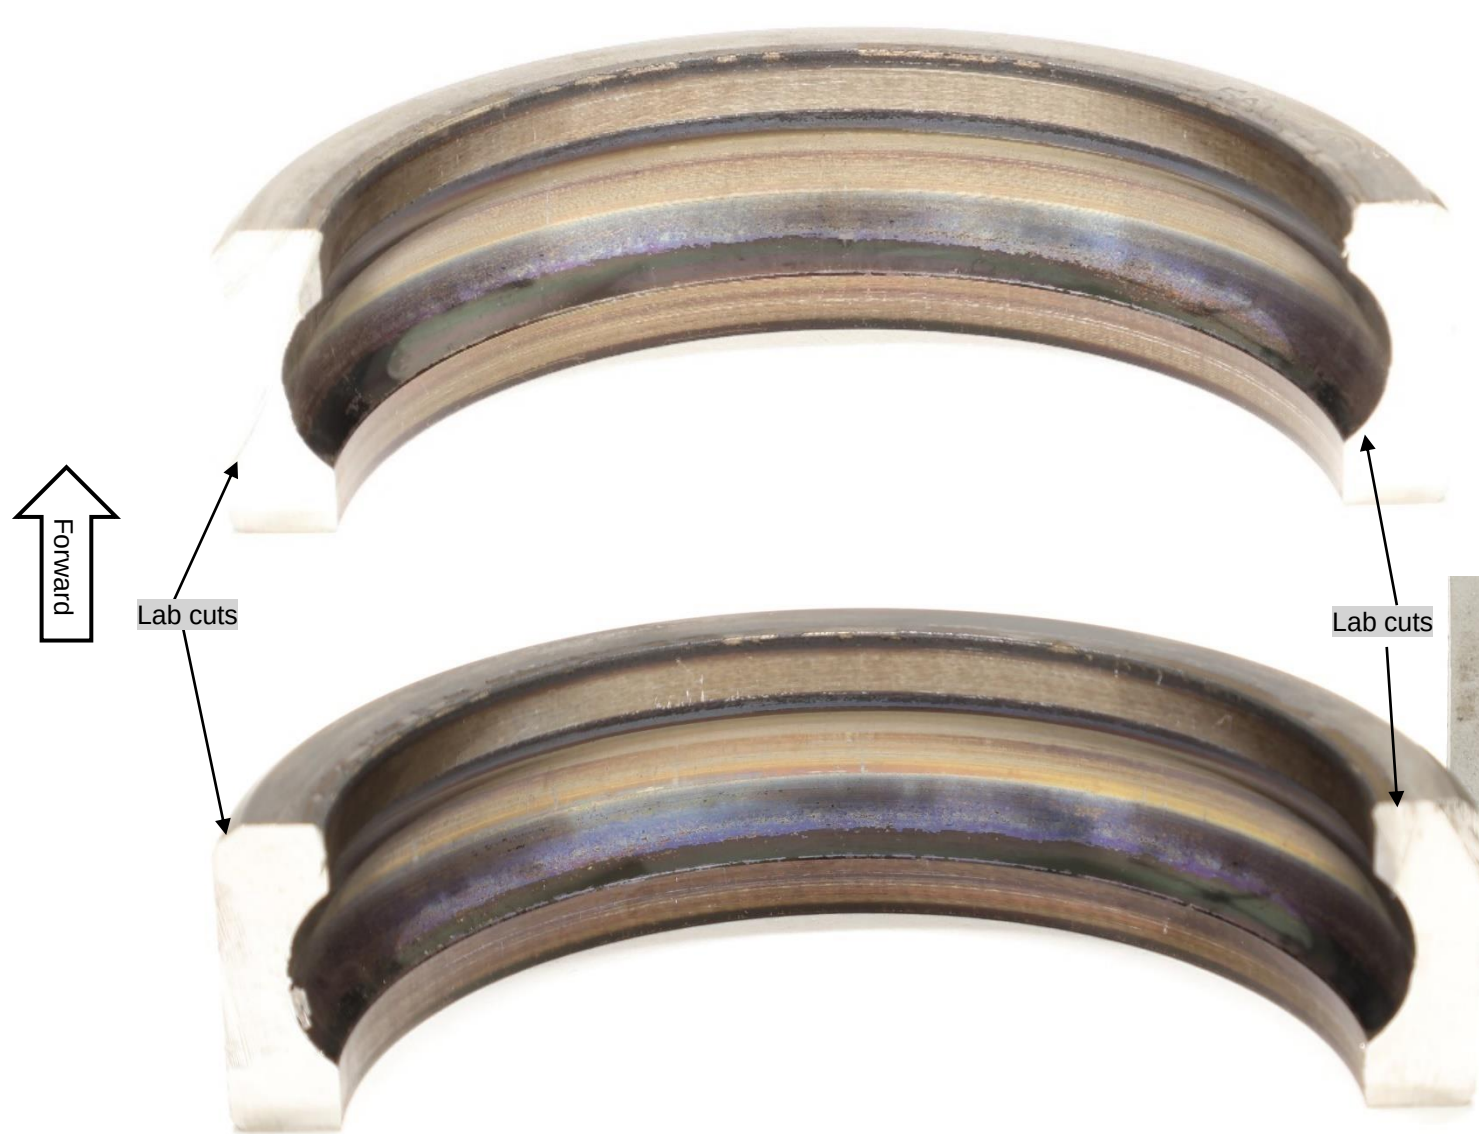
**Figure 40. Overall images of the No. 2 bearing outer ring raceway showing two halves following axial cuts made to disassemble the bearing.**

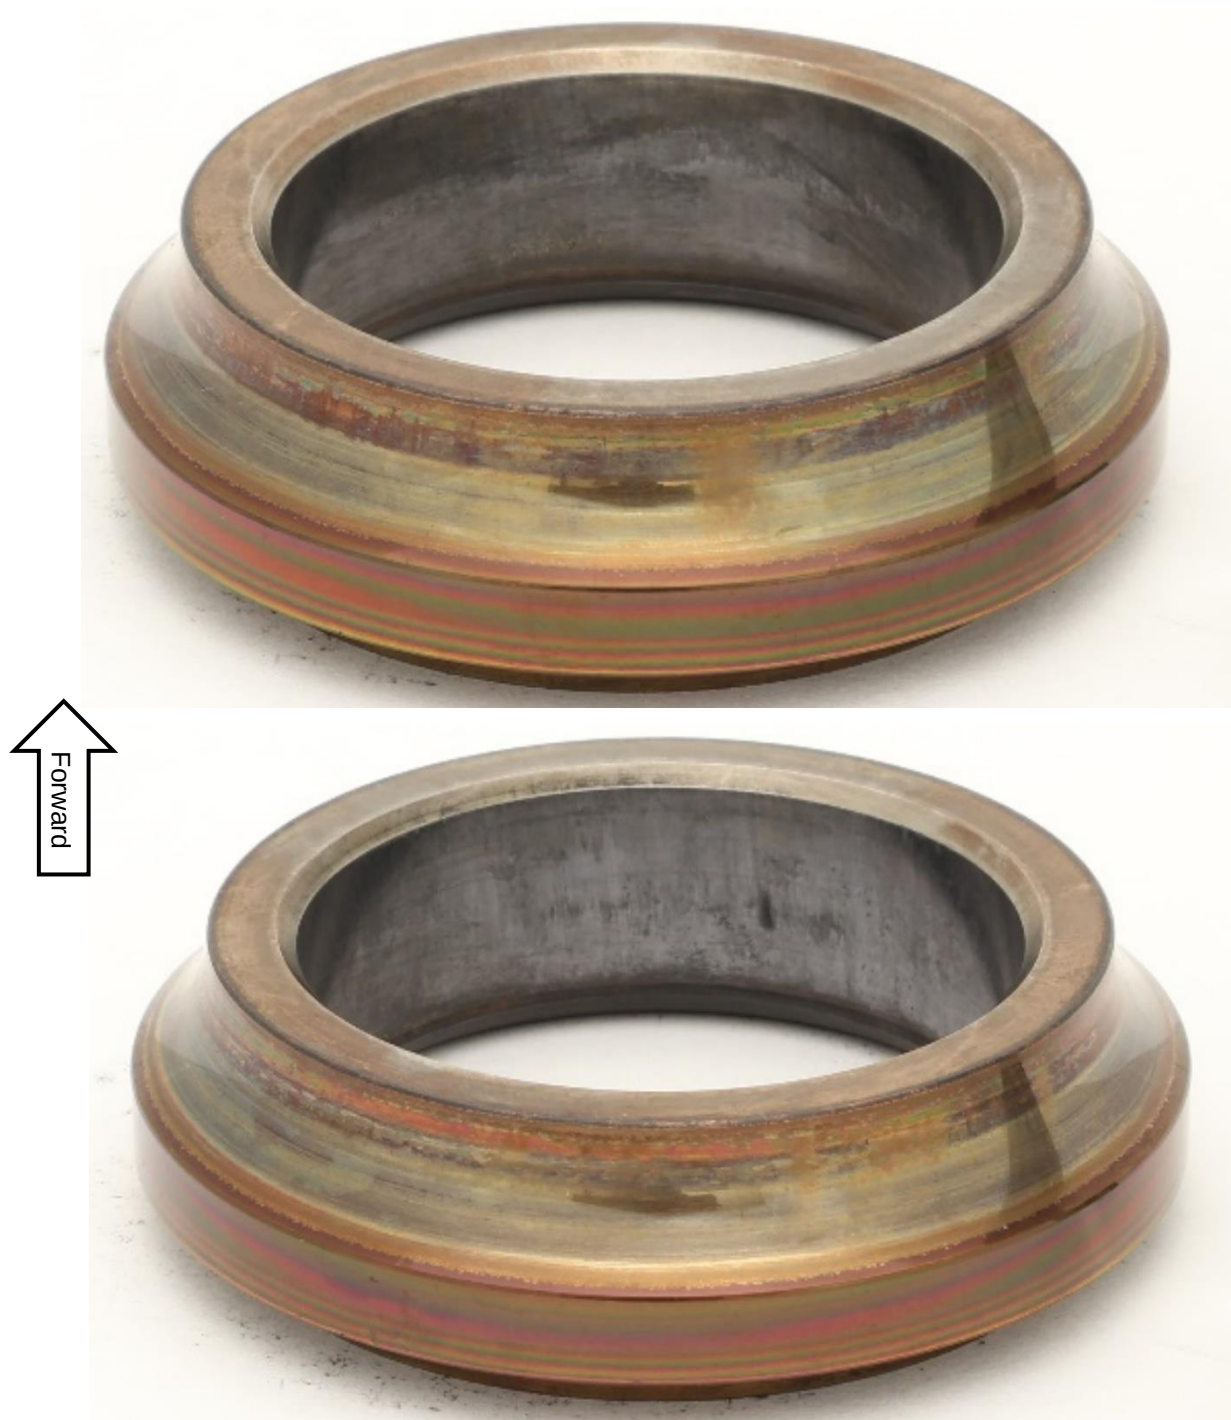
**Figure 42.** Detailed views of the No. 2 bearing aft inner race. Each image is rotated approximately 180° from the previous.

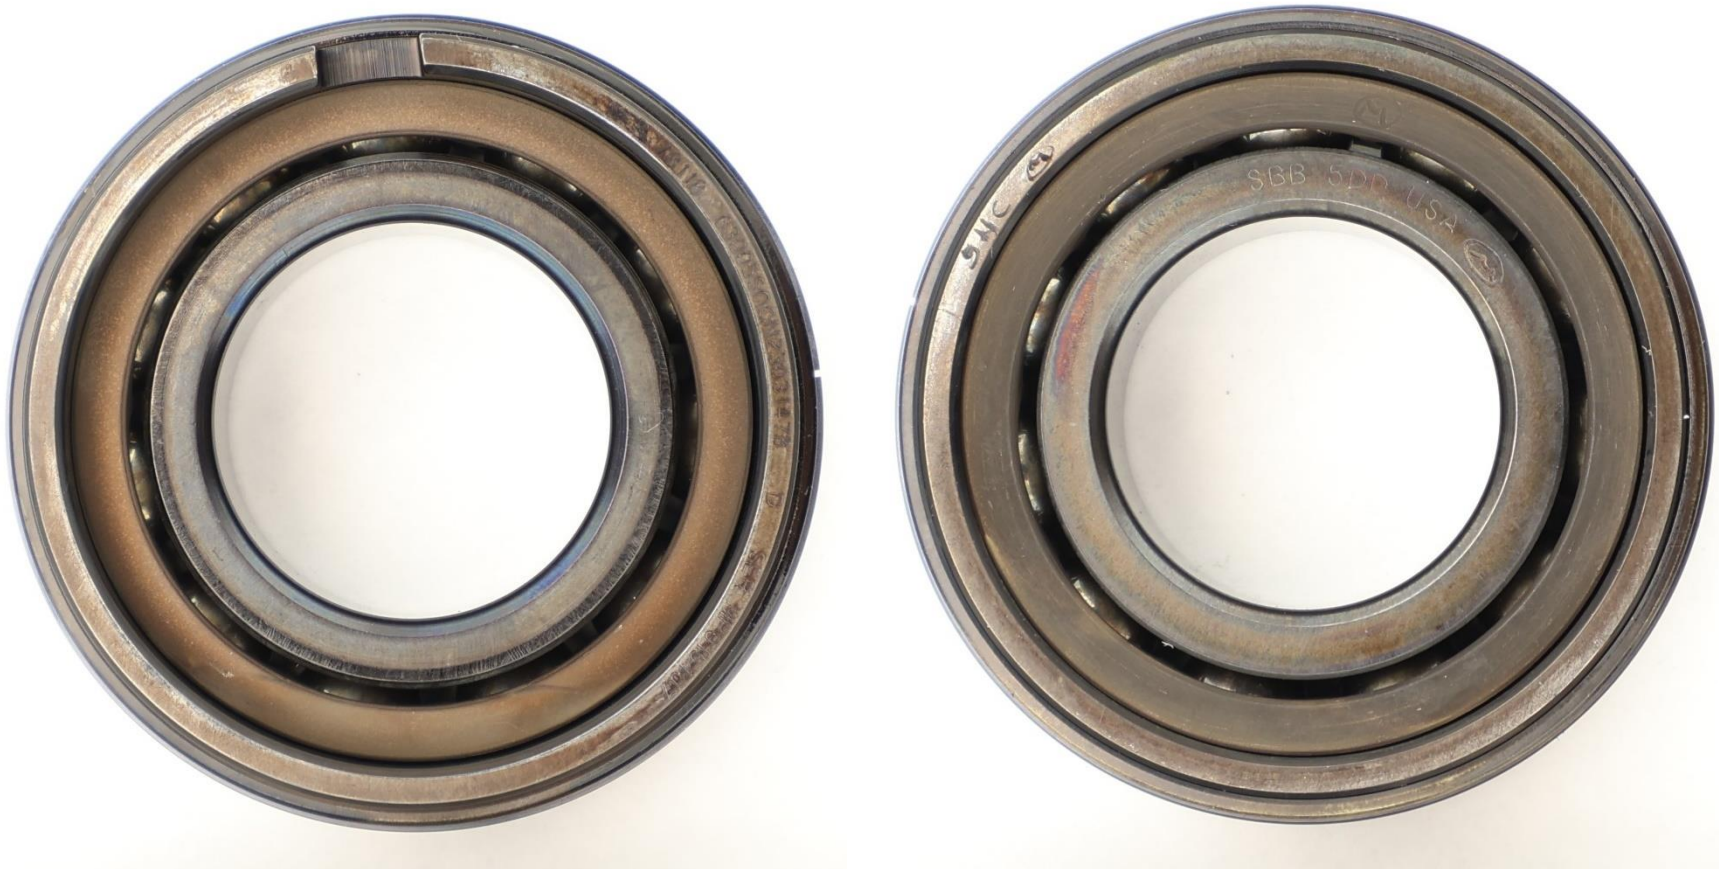
Overall views of the No. 8 bearing are shown in Figure 47 in the as-received condition. The No. 8 bearing rotated freely.

**Figure 47. Overall forward looking aft (left) and aft looking forward (right) views of the No. 8 bearing in the as-received condition.**
