# National Transportation Safety Board

WPR24FA132

## **POWERPLANTS FACTUAL REPORT**

Location: Anaconda, Montana  
Date: April 26, 2024  
Time: 06:59 local time  
Helicopter: Bell B206L-4, Registration Number N988B

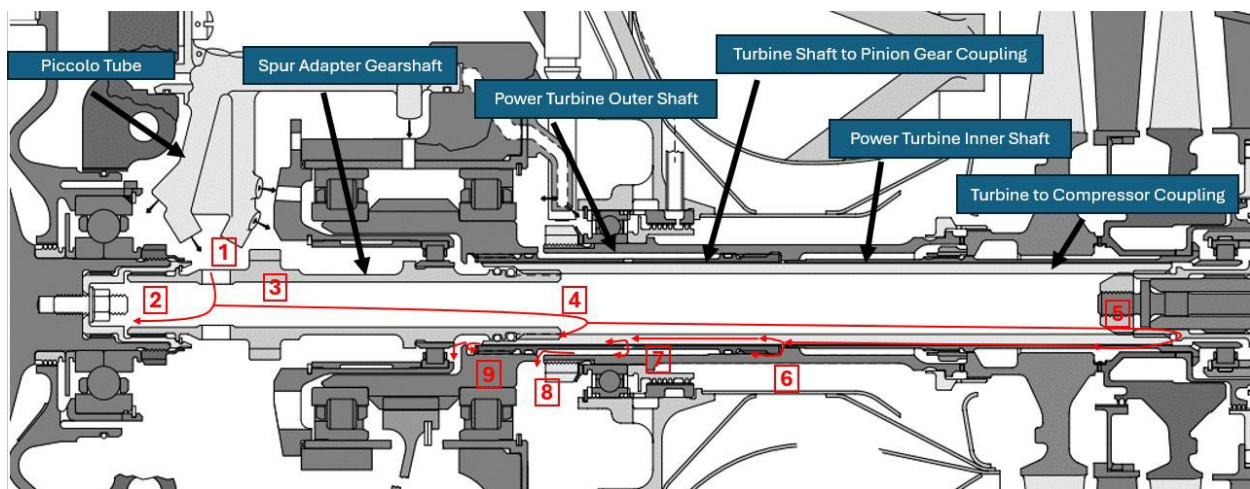
**Figure 2** - Cooling Oil Flow Through Shafts - Courtesy Rolls Royce

One possible cause of turbine-to-compressor coupling failure is linked to missing SAG O-rings. The importance of the SAG O-rings is depicted in **Figure 2**. See the reference numbers **1** to **5** on the figure.

**4** Oil continues from the SAG to the turbine-to-compressor coupling. Some of the oil flows into the spline joint between the SAG and turbine-to-compressor coupling. The O-rings at this interface prevent excessive oil from flowing through the spline joint into the gearbox. Excess oil flows to the turbine-end of the shaft.

**5** Oil flows through the spline joint at the turbine adaptor coupling and spills out at the end of the turbine-to-compressor coupling.

The lower jets in the piccolo tube direct cooling oil flow through the SAG side openings and then along the inner wall to the turbine-to-compressor coupling. If the SAG O-rings are split or missing, the cooling oil flow will leak through the forward SAG splines, causing insufficient cooling oil flow to reach the turbine-to-compressor coupling, causing overheating and failure.

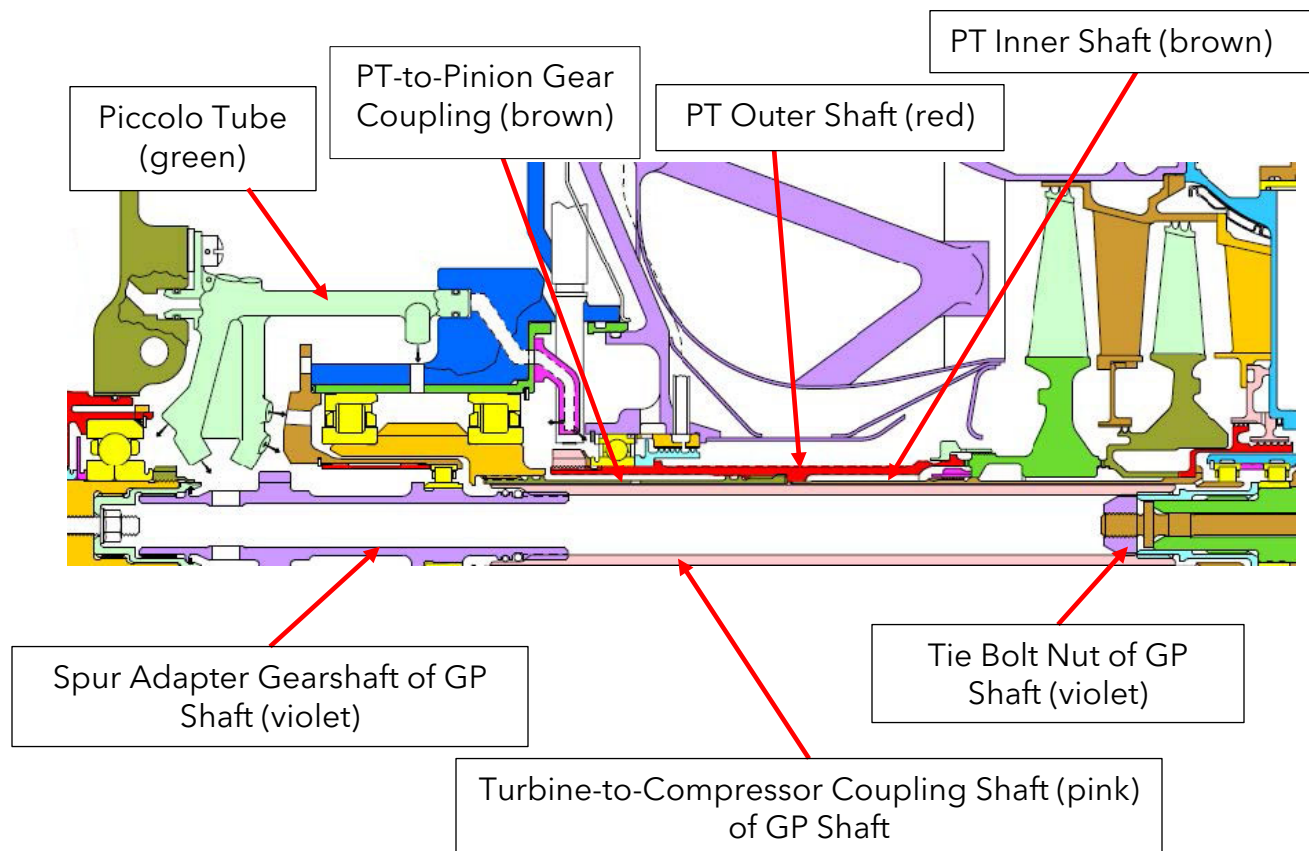
**Figure 3** - Partial Schematic Showing Gearshaft Arrangement - Courtesy RR

The piccolo tube ([See Figure 3](#)) was installed correctly in the AGB ([Photo 16](#)) and the nozzles were externally clean. The piccolo tube features an inlet screen and five nozzles which direct oil to (1) No.2 bearing, (2) 1<sup>st</sup> stage N2 reduction gears (3) No. 3 bearing, (4) SAG holes which lubricate the turbine to compressor coupling splines and (5) No. 2-½ bearing.

The arrangement of the shafts and couplings in the turbine module is shown on **Figure 3**.
