# National Transportation Safety Board

WPR24FA200

## **AIRFRAME & ENGINE EXAMINATION REPORT**

Location: Bluestem, Washington  
Date: June 19, 2024  
Time: 1620 Pacific daylight time  
Helicopter: Robinson R-44 II Raven / N323TT

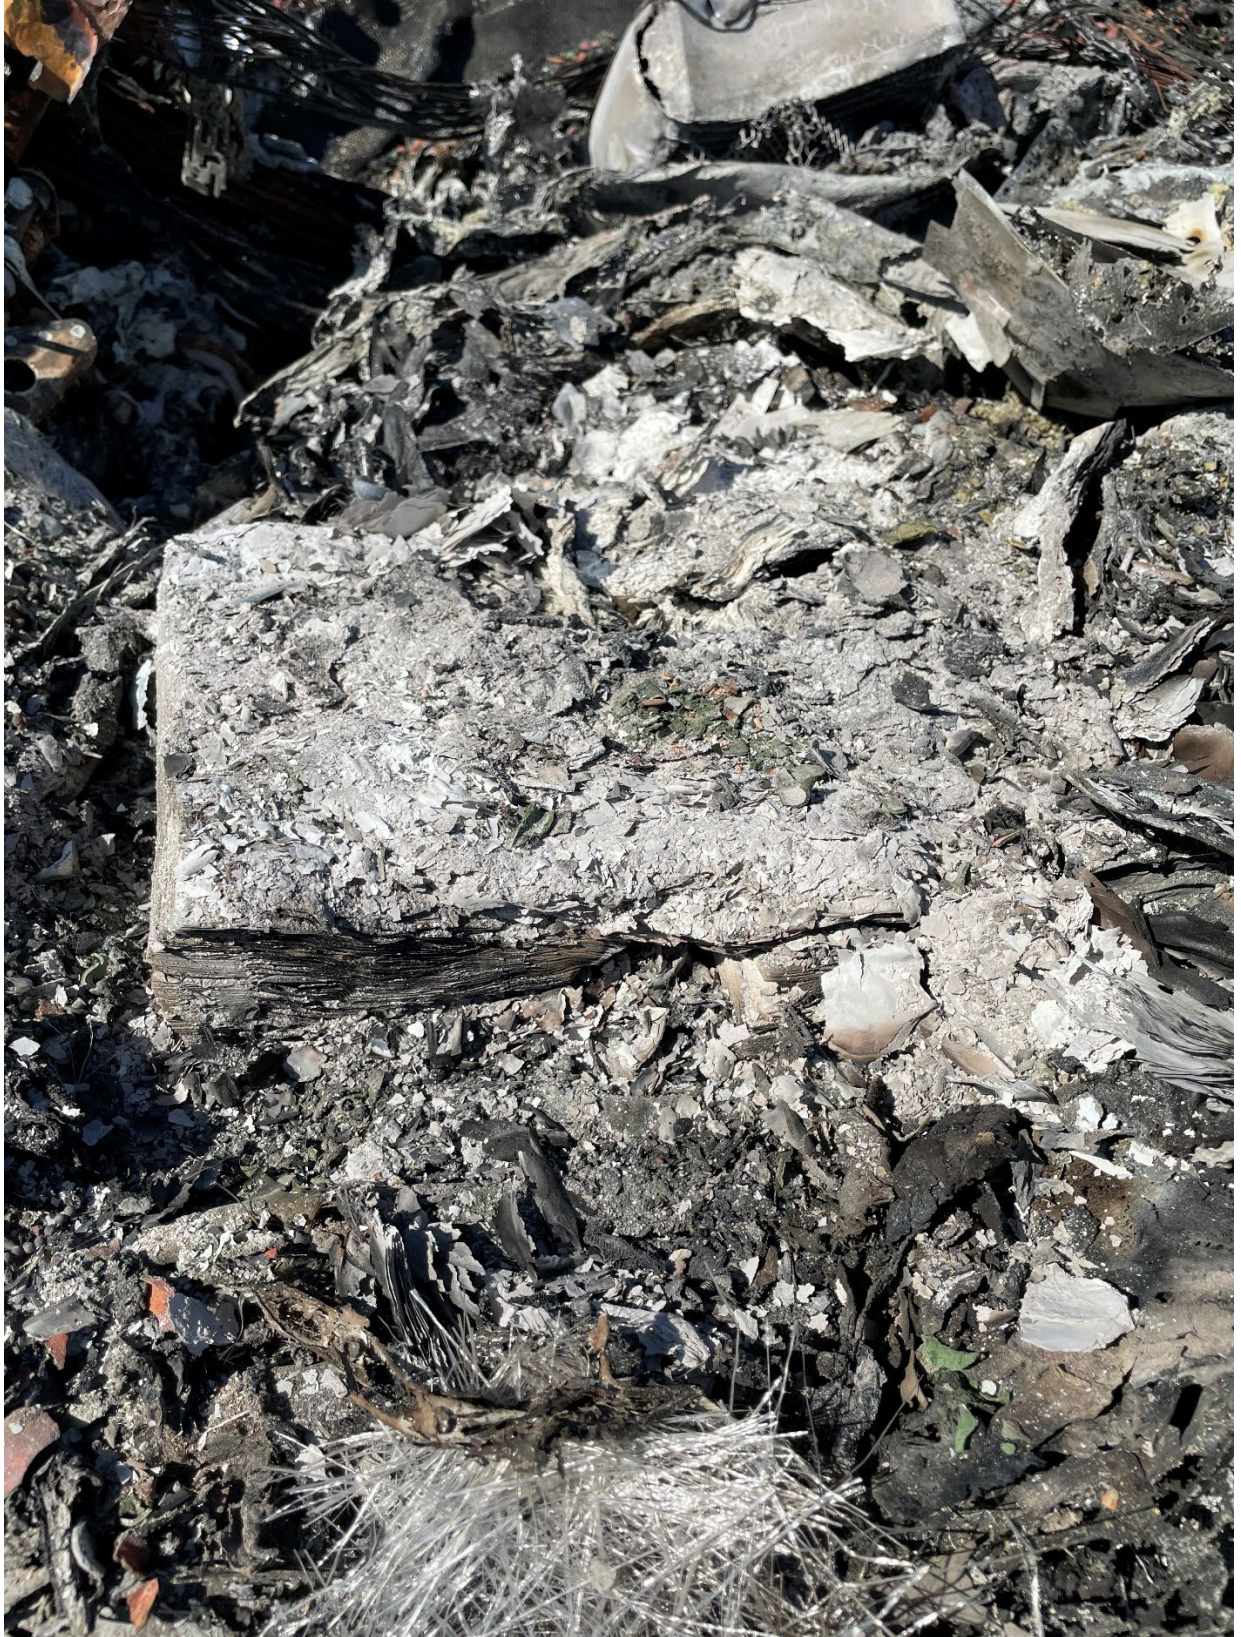
The helicopter was manufactured in 2023. Additional Information According to the Director of Maintenance for Helicopters Northwest, the maintenance records were inside the helicopter (figure 21).

Figure 21. Possible maintenance documents.
