# National Transportation Safety Board

WPR24FA277

## **ENGINE EXAMINATION SUMMARY**

Location: Eureka, Utah  
Date: 07/07/2024  
Time: 1800 Local  
Airplane: N969RC FANTASY AIR SRO

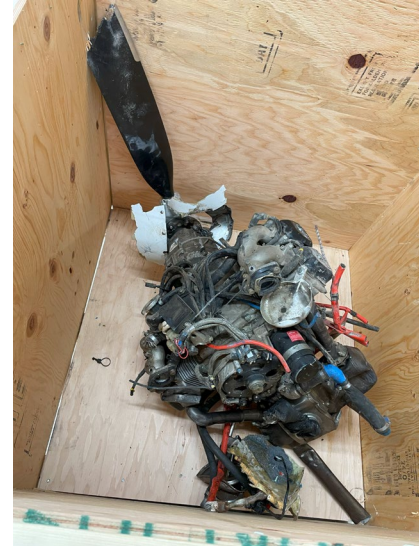
Model number: ROTAX 912 UL  
Serial number: 4408478  
Production Year: 04.05.2007

The engine was removed from the main wreckage under NTSB oversight at the co-owner's hanger in Spanish Fork, UT, crated and shipped from Utah Helicopters in Spanish Fork, UT. The engine was shipped to Rotech Motor Ltd, at the Vernon Regional Airport, Vernon, British Columbia, in Canada. The follow-up examination was conducted on March 25, 2025, with the NTSB-IIC and Rotax investigator in attendance. The shipping box was undamaged in Canada.
