# National Transportation Safety Board

WPR24FA238

## **FIELD REPORT**

Location: Helena, Montana  
Date: July 10, 2024  
Time: 12:10 mountain daylight time  
Airplane: N10122, Air Tractor AT-802

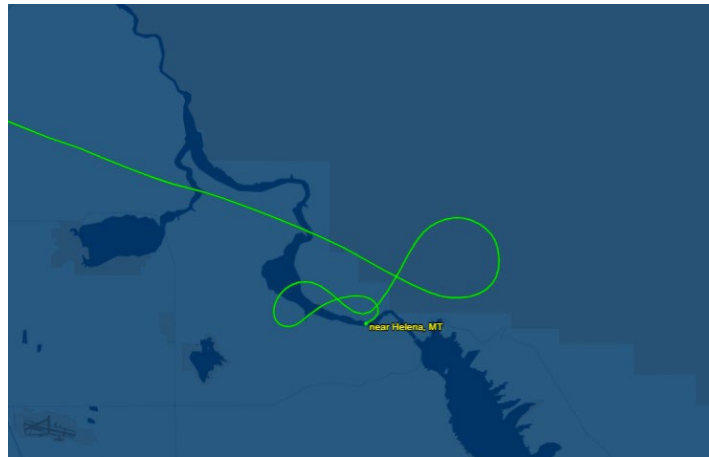
Figure 1. Accident Airplane Flight Track. (Photo Courtesy of Flight Aware)

Automatic Dependent Surveillance-Broadcast (ADS-B) data showed the airplane's flight track from Coeur d'Alene to Hauser Lake near the accident location.

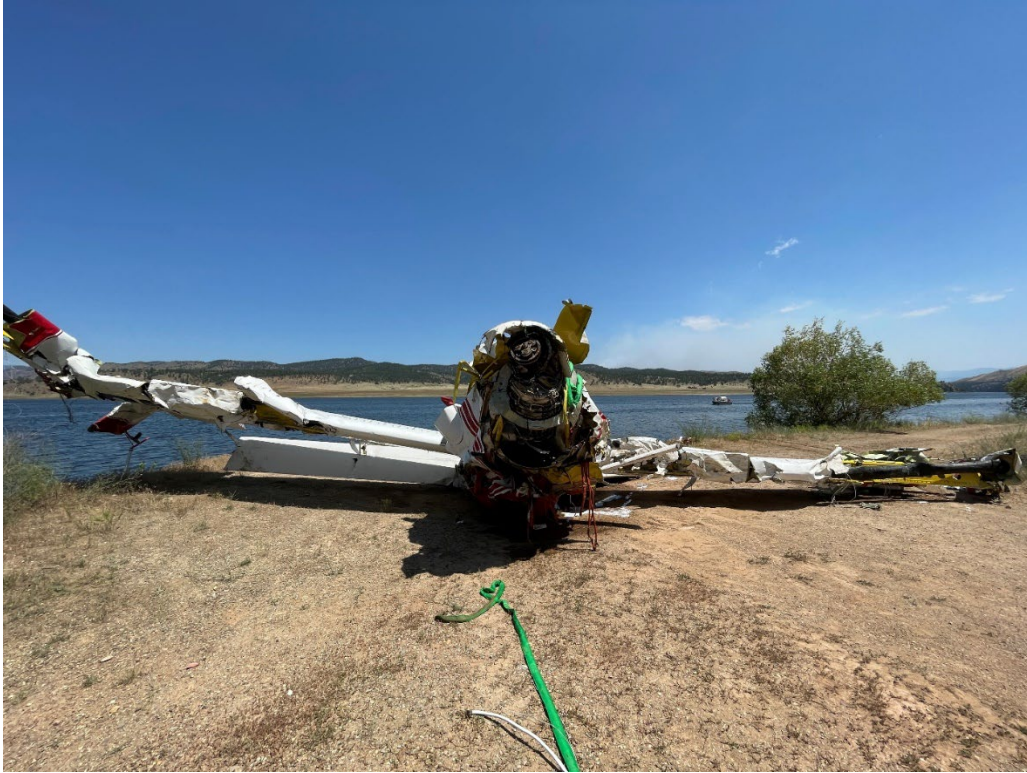
The airplane remained mostly intact. The engine, both wings, the empennage and tail sections remained attached to the fuselage. Flight control continuity was established to all flight control positions.

Figure 4. Forward View of Airplane.
