# National Transportation Safety Board

WPR24FA255

## **FIELD NOTES & EXAMINATION SUMMARY**

Location: Izee, Oregon  
Date: 7/25/2024  
Time: 1830 local (PDT)  
Airplane: N850DG

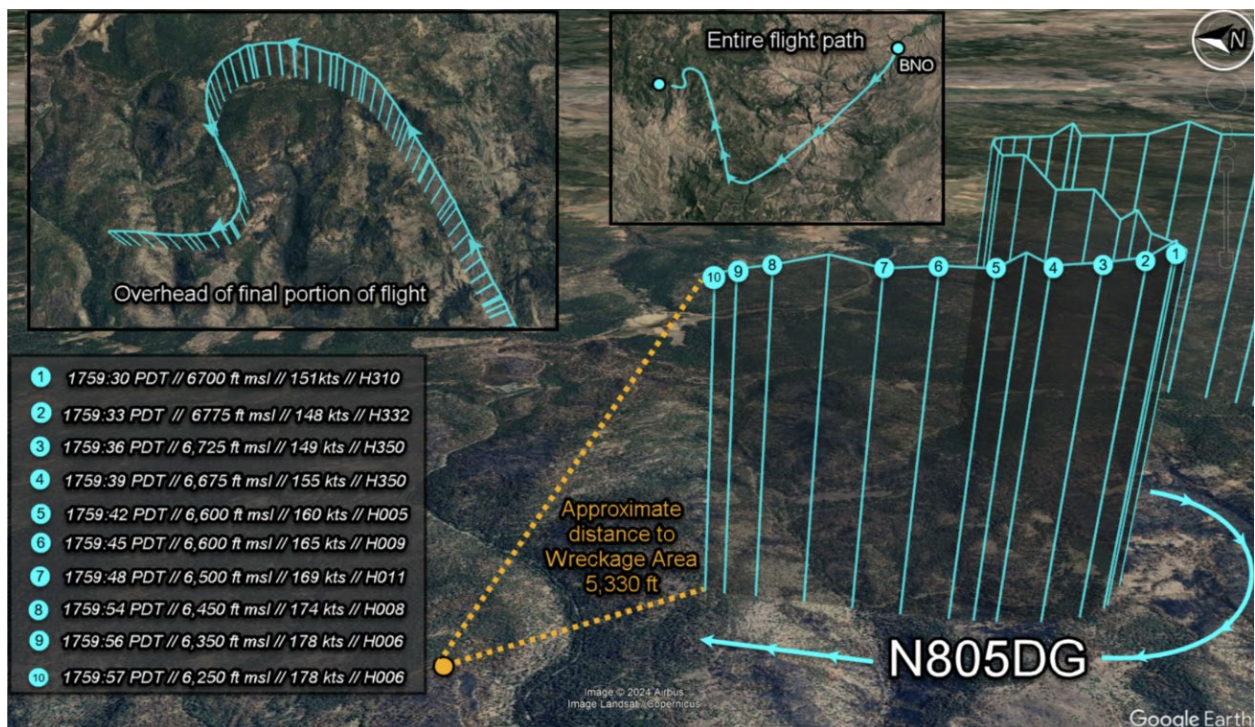
**Figure 8. Google Earth map with ADS-B data overlay, showing the last 10 targets. Left photo shows overhead of final portion of the flight track; the upper photo depicts the entire flight path from BNO to the accident site.**

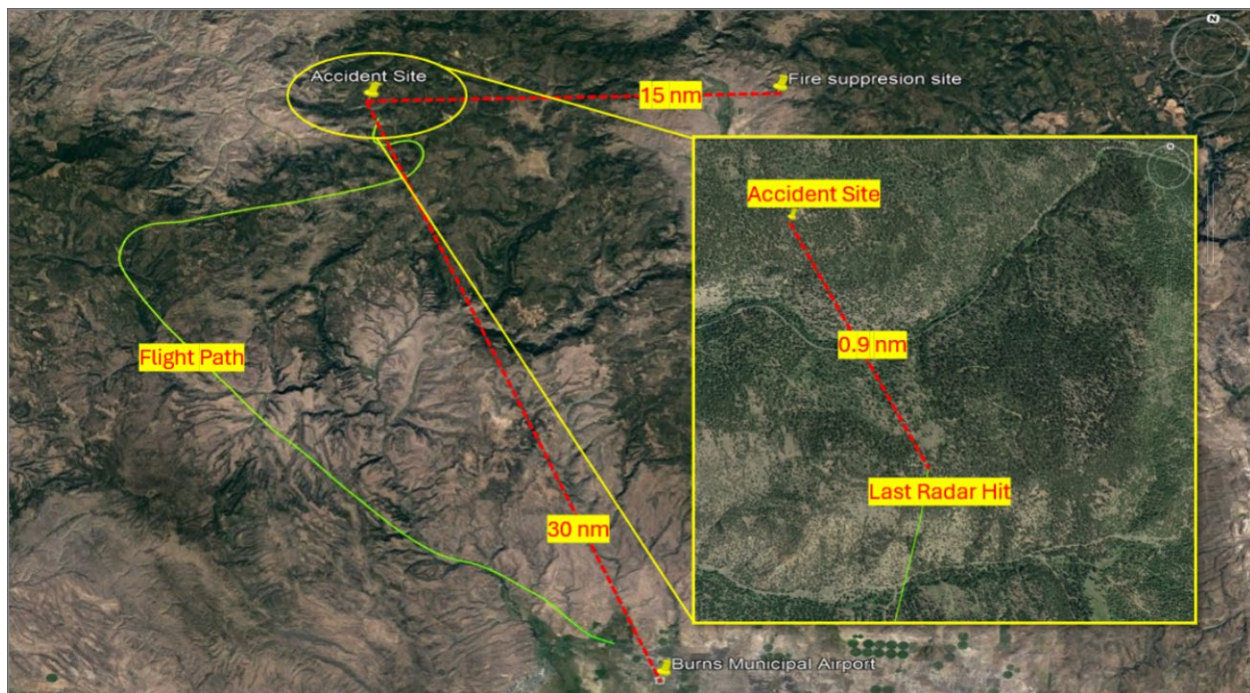
**Figure 9. ADS-B flight track of N805DG overlaid over Google Earth, depicting the accident site, departure airport, and fire suppression site locations.**

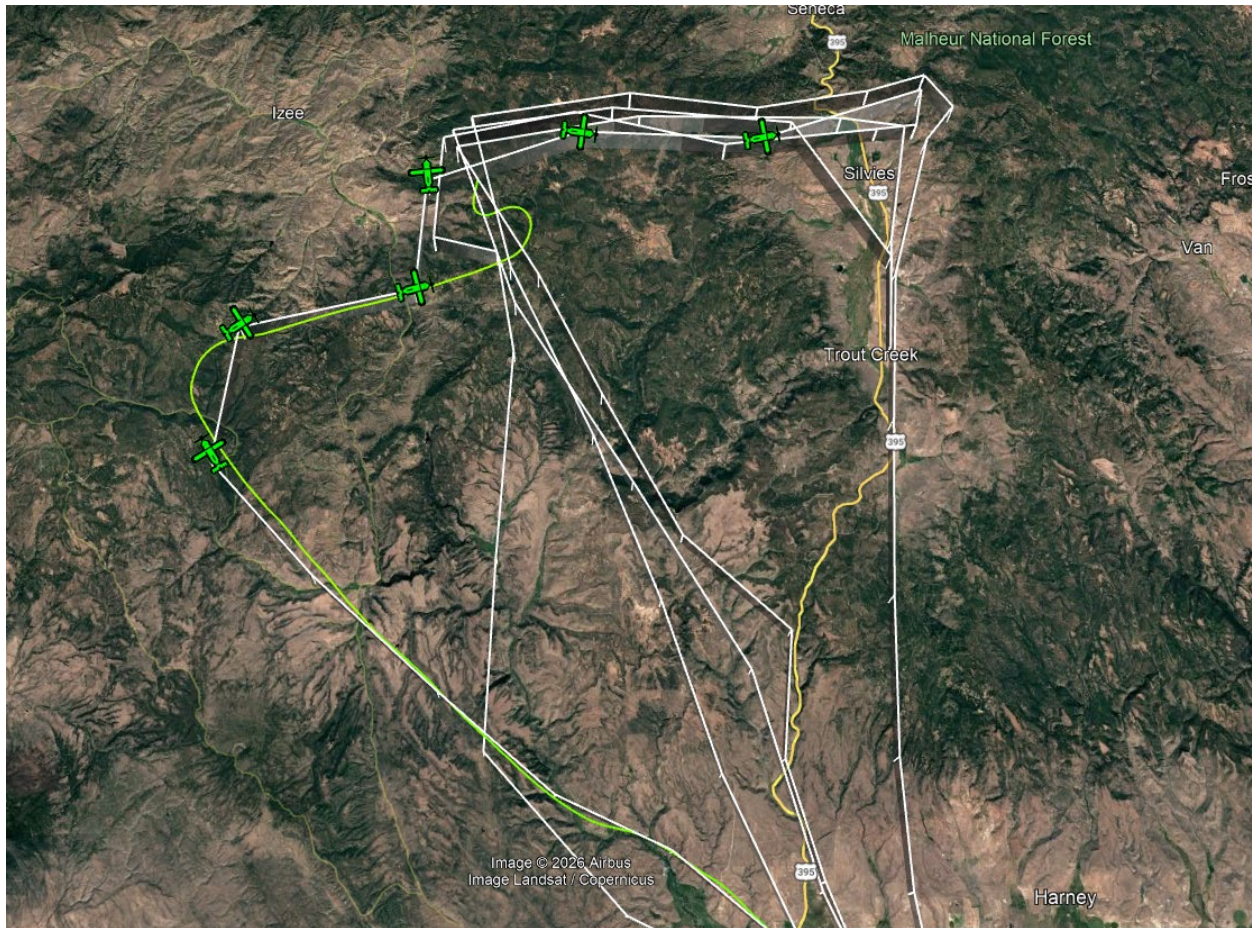
**Figure 10. Overlay of 2nd SEAT's flight track (white track) in with the accident airplane's flight track (green track).**
