# National Transportation Safety Board

WPR24FA287

## **WRECKAGE FOLLOW-UP EXAMINATION SUMMARY REPORT**

Location: Santa Paula, California  
Date: August 25, 2024  
Time: 1224 Pacific Daylight Time  
Airplane: Pitts S-1 (N42JF)

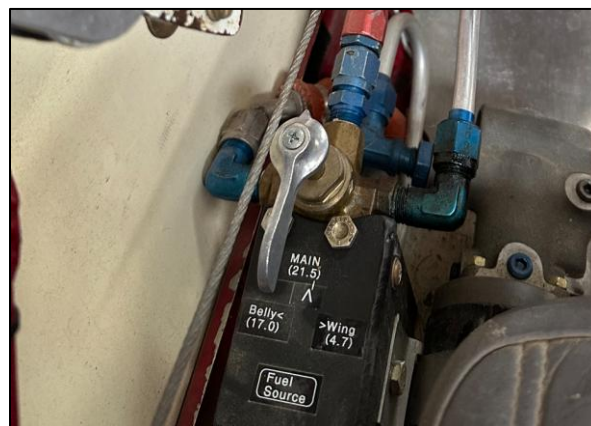
The fuel selector was found separated from mounting bracket and lines. The handle melted from the control shaft and the control shaft was found near the "wing" (3 o'clock) tank position. The valve was disassembled and no anomalies were noted.

**Figure 6-Fuel selector valve (preaccident), mounted left of the pilot's seat.**
