# National Transportation Safety Board

WPR24LA030

## EXAMINATION REPORT

Location: Firebaugh, California  
Date: November 4, 2023  
Time: 1200 Pacific daylight time  
Helicopter: Arrow Falcon Exporters UH-1H, N3053Q

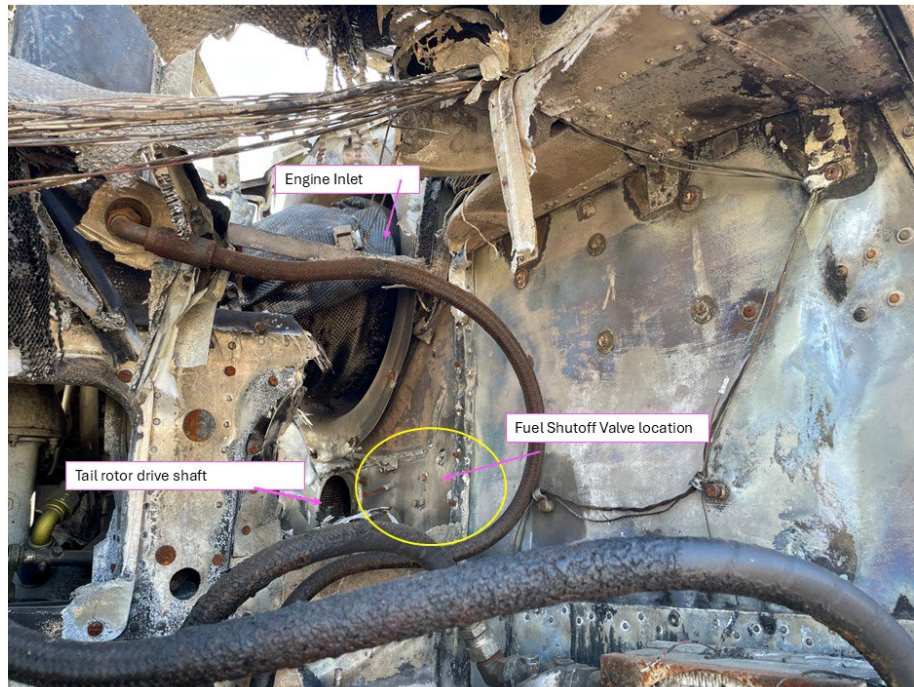
Photograph 7. Location of Fuel Shutoff Valve

The fuel lines on the airframe side located by the fuel shutoff valve are on-condition items to be replaced as needed. At the last annual inspection, the fuel lines on the airframe side were torqued at the fuel valve. There was no logbook entries found that identified that the fuel shutoff valve had been replaced and the operator believed the part to be original equipment manufacturer (OEM). The fuel shutoff valve is an "on-condition" item, which would require replacement only when the component failed to operate.
