**National Transportation Safety Board**

WPR24LA046

**EXAMINATION SUMMARY**

Woodward 8210-140 (s/n 15226599)

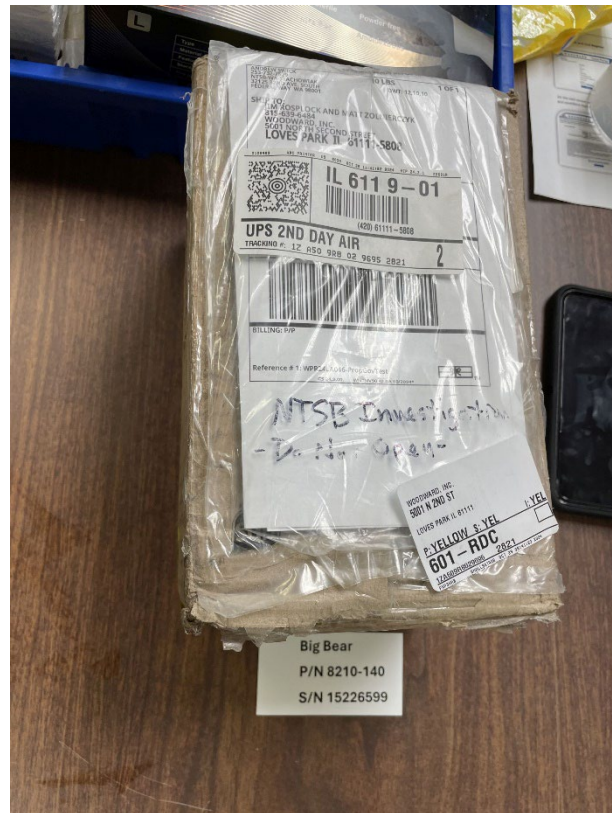
The propeller governor was received in a sealed carton. The unit exhibited impact related damage such as localized gouges on the housing, bent fittings, and a

broken off max speed lever.<sup>1</sup> The driveshaft and air bleed lever appeared undamaged and rotated freely using hand pressure. The brass relief valve seal is damaged. Installed lockwire, lockwire seals, and torque sealant were not from the manufacturer. The customer-installed Py inlet fitting was secure but was damaged and bent.<sup>2</sup> A third-party linkage remained attached to the bleed air lever.

Figure 1 - Shipment (As Received)
