**From:** [REDACTED]  
**To:** [REDACTED]  
**Subject:** N4769K  
**Date:** Thursday, June 6, 2024 5:03:33 PM

## N4769K

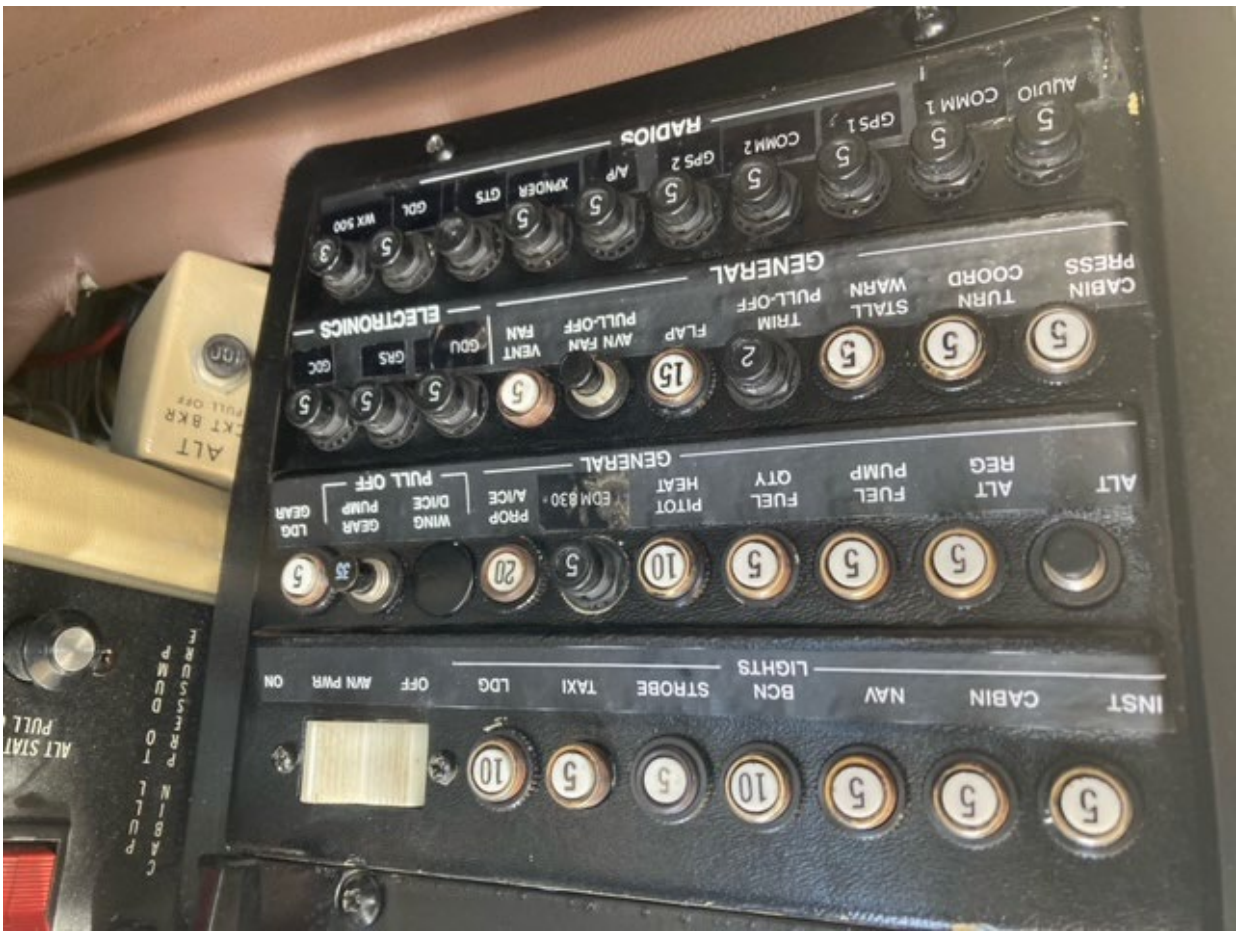
Upon initial inspection the alternator main circuit breaker had been tripped (fig 1) (100ampere). After re-setting breaker voltage was observed at the field terminal of the alternator with master on and field switch on.
