# National Transportation Safety Board

WPR24LA159

## **WRECKAGE EXAMINATION**

Factual Report

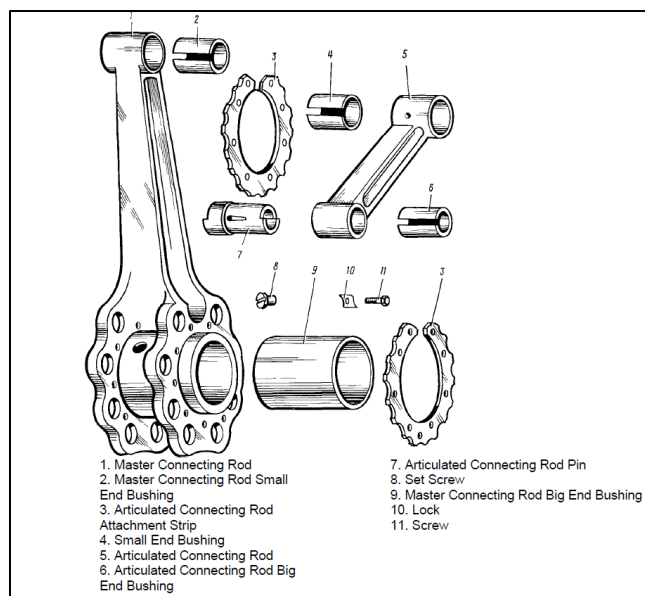
**Figure 9-Master connecting rod assembly. (Courtesy of the M-14 Maintenance Manual)**

Four connecting rods were removed from the main-connecting rod to gain access to the main bearing set screw areas. The connecting rod ends near the set screw areas had mechanical damage and deformation. The set screw holes were mechanically damaged and deformed and showed 3 installation chiseled strike marks. (See figures 9 and 10)
