# National Transportation Safety Board

WPR24LA240

## **WRECKAGE EXAMINATION SUMMARY**

Location: Soldier, ID  
Date: July 13, 2024  
Time: 07:50 MDT  
13:50 UTC  
Airplane: 1959 Cessna 182B (SN: 51917)

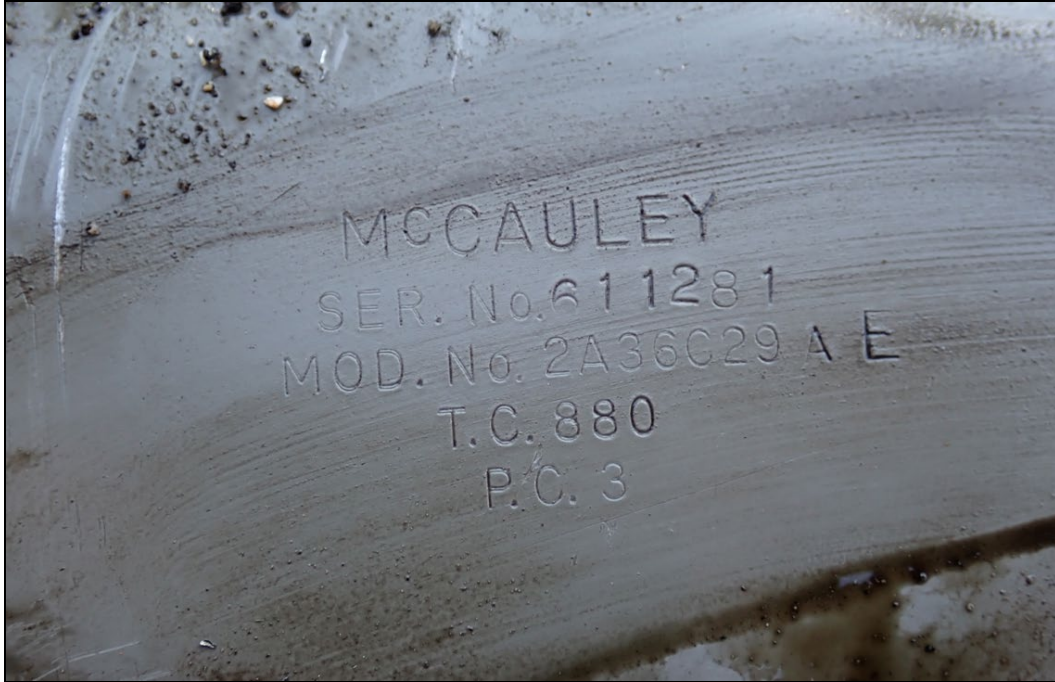
**Figure 25:** View of propeller hub data stamp

Manufacturer: McAuley  
SN: 611281  
Last Inspection: April 26, 2024  
TTP: 3,244.56 hours  
SPOH: 1,044.56 hours

The 2-blade propeller sustained impact damage to both blades. There were no leading-edge gouges, or chordwise scratches observed on the propeller. The propeller blades remained attached to the hub, which remained attached to the propeller flange, which remained attached to the crankcase.
