# National Transportation Safety Board

WPR24LA265

## **POWERPLANTS**

Group Chair's Factual Report

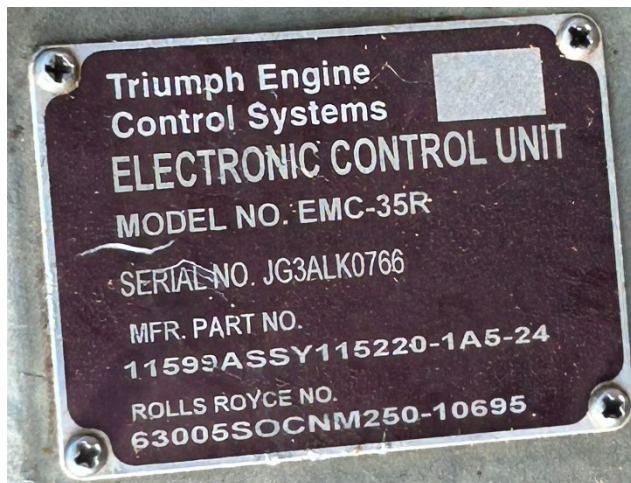
According to the engine maintenance records, the ECU was PN M250-10695, SN JG3ALK0766; this was confirmed with the data plate (**PHOTO 3**) that indicated that it was a Triumph Engine Control Systems, model No. EMC-35R, manufacture PN 11599ASSY115220-1A5-24. Normally the ECU data can be downloaded easily by the operator or by someone with the proper software and electrical connections; however, the on-scene engine evaluation deemed that of the ECU was damaged and would need to be shipped to Triumph Engine Controls in West Hartford, Connecticut, for readout.

**PHOTO 3: ACCIDENT ENGINE ECU DATA PLATE**

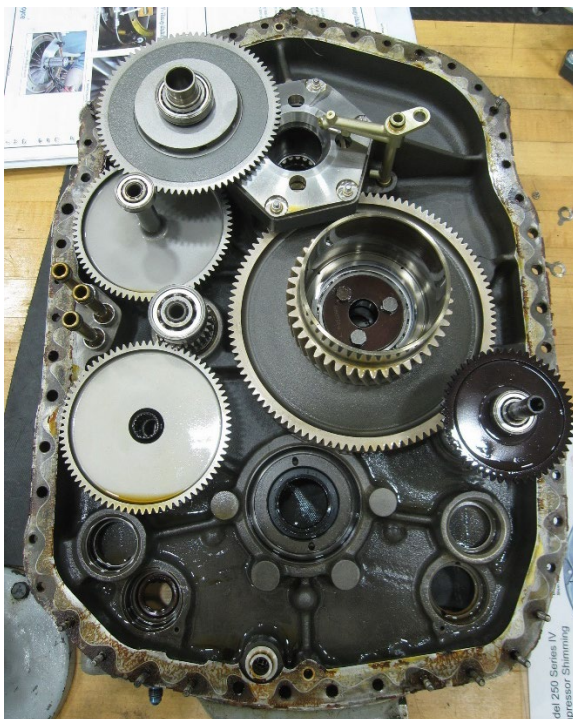
The accessory gearbox assembly consists of a gearbox housing, gearbox cover, GP gear train, PT gear train, oil pump assembly, oil filter assembly, and the necessary oil tubes to carry pressure and scavenge oil as required by the lubrication system. The gearbox housing and cover were separated to expose the various gears and bearings (**PHOTOS 27** and **28**). All the gears and bearings were in good condition, oil wetted, and rotated smoothly without resistance.

**PHOTO 27: PT DRIVEN GEAR TRAIN IN ACCESSORY GEARBOX COVER**

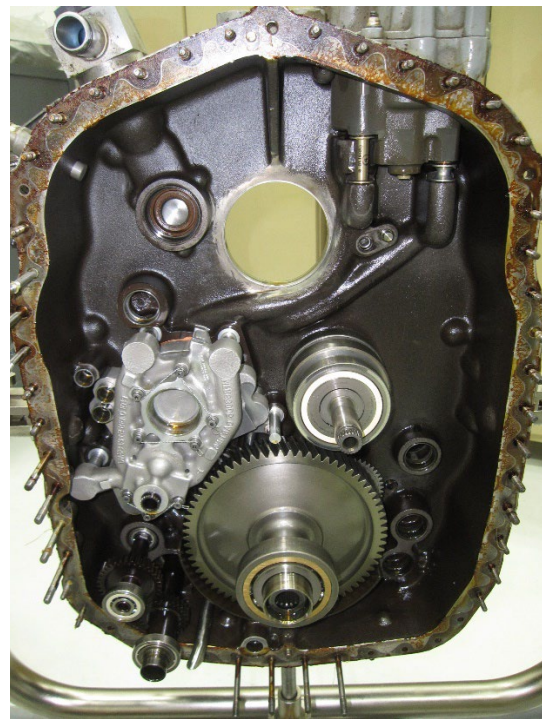
**PHOTO 28: GP DRIVEN GEAR TRAIN IN ACCESSORY GEARBOX HOUSING**

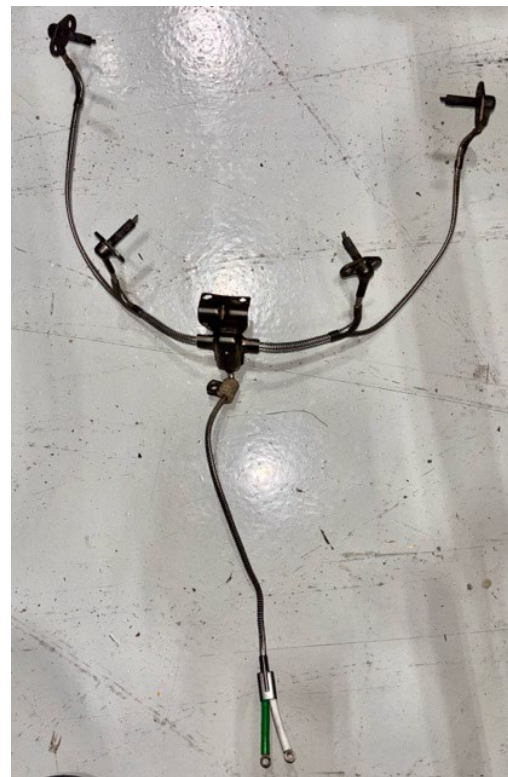
**PHOTO 37: ACCIDENT ENGINE MGT THERMOCOUPLE HARNESS ASSEMBLY**  
Photo Courtesy of Rolls-Royce

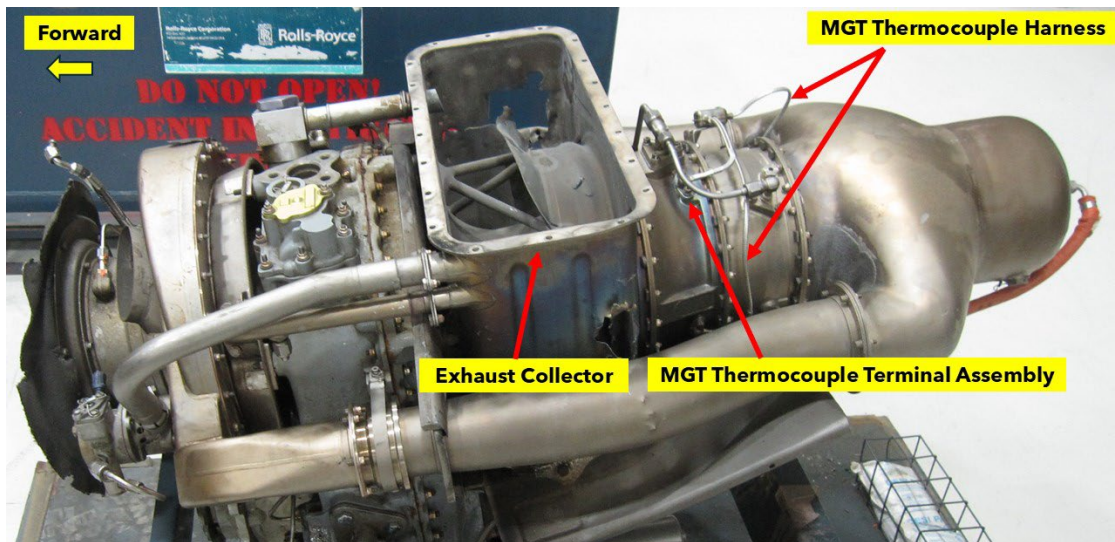
consists of a single element assembly with a bare wire junction. The equally spaced thermocouple probes extend outside of the power turbine support for the harness. The bare wire junction of each thermocouple probe extends through the power turbine support and the outer band of the stage 3 turbine nozzle shield and into the gases leaving the GPT rotor. Each thermocouple probe generates a direct current (DC) voltage which is directly proportional to the gas temperature it senses. The thermocouples and thermocouple harness are wired in parallel. This provides an average of the four voltages representative of the gas producer turbine outlet temperature. The flexible thermocouple harness consists of two branches of equal resistance connecting the four probes and a terminal branch, with two eyelet terminals, for connection to the airframe mounted ECU and the helicopter furnished MGT indicator circuit (**FIGURE 8** and **PHOTO 37**). An engine furnished thermocouple terminal assembly (also referred to as a terminal block) is secured to the right side of the exhaust collector support shield, just forward of where the firewall shield slips into the exhaust collector support shield (**PHOTO 38**).

**PHOTO 38: THERMOCOUPLE HARNESS AND THERMOCOUPLE TERMINAL ASSEMBLY (BLOCK) LOCATION**

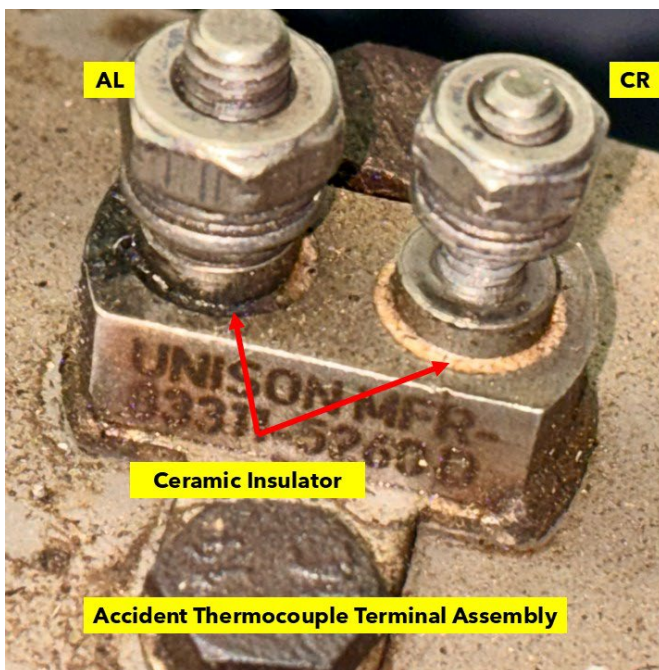
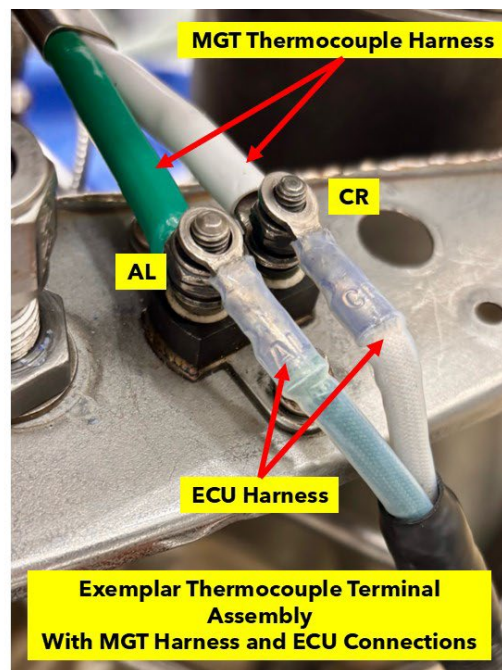
The thermocouple terminal assembly has a 10-32 almel (AL) stud and an 8-32 chromel (CR) stud. The thermocouple harness, the engine harness and the accessory harness almel and chromel eyelet terminals fit over the almel and chromel studs on the thermocouple terminal assembly. Self-locking nuts retain the eyelet terminals on the studs (**PHOTO 39**). A ceramic insulator is provided to prevent the MGT thermocouple harness shorting with the thermocouple terminal assembly. On the accident thermocouple terminal assembly, the ceramic insulator appeared intact.

**PHOTO 39: THERMOCOUPLE TERMINAL ASSEMBLY**
