# National Transportation Safety Board

WPR25LA037

## **EXAMINATION SUMMARY**

Location: Los Angeles, CA  
Date: November 14, 2024  
Time: 0704PST  
0004UTC  
Airplane: (N46028) 1968 Cessna 172I, S/N: 17256998

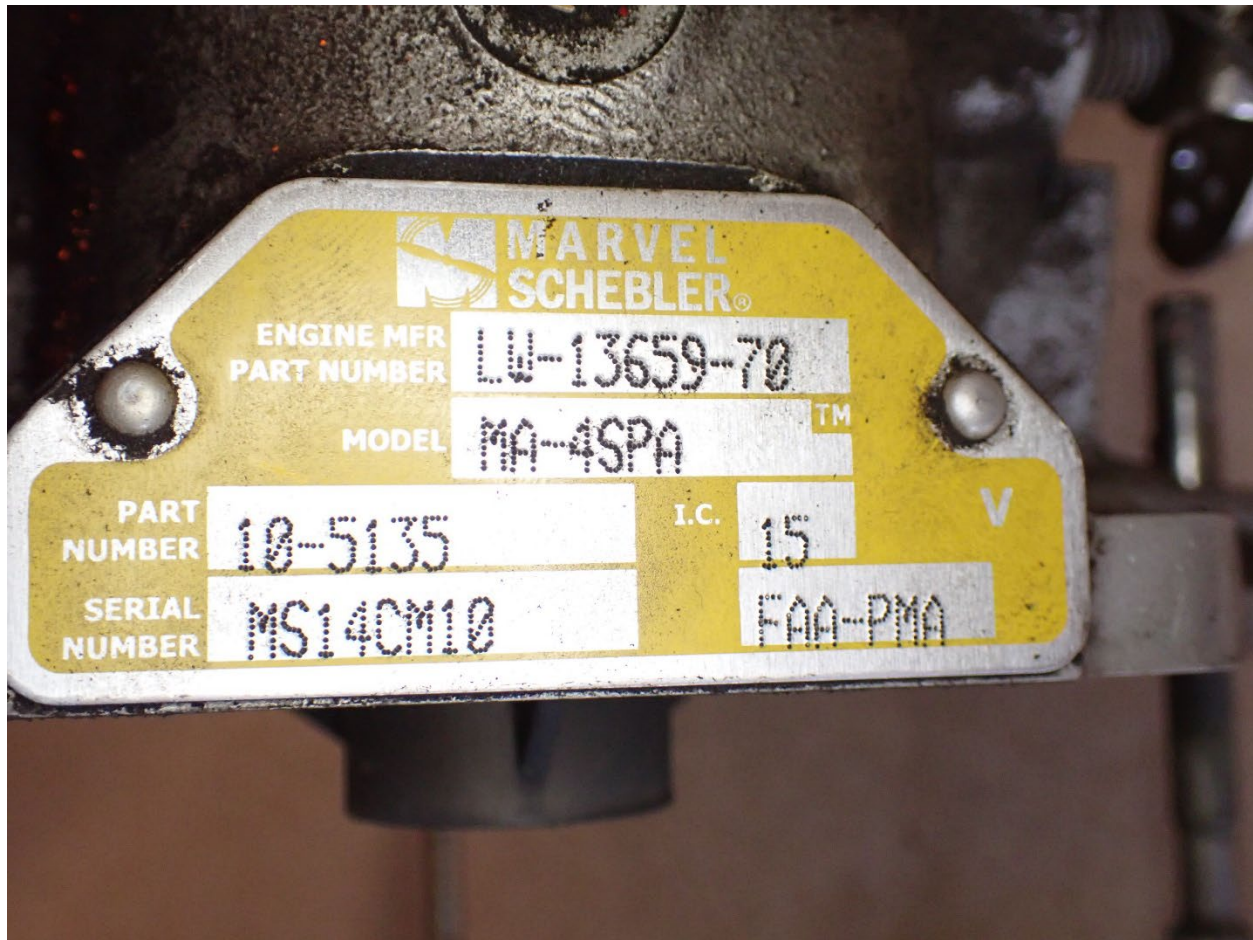
The throttle shaft bushings in the carburetor had minimal play. The carburetor fuel inlet screen assembly was clean. The carburetor was disassembled. The fuel bowl was clean, and the float was tested for leaks. The accelerator pump inlet screen was clean. Compressed air was applied and passed through the passage from the mixture metering sleeve and the discharge nozzle to verify there were no obstructions or debris.

**Figure 8:** View of N46028's carburetor data plate

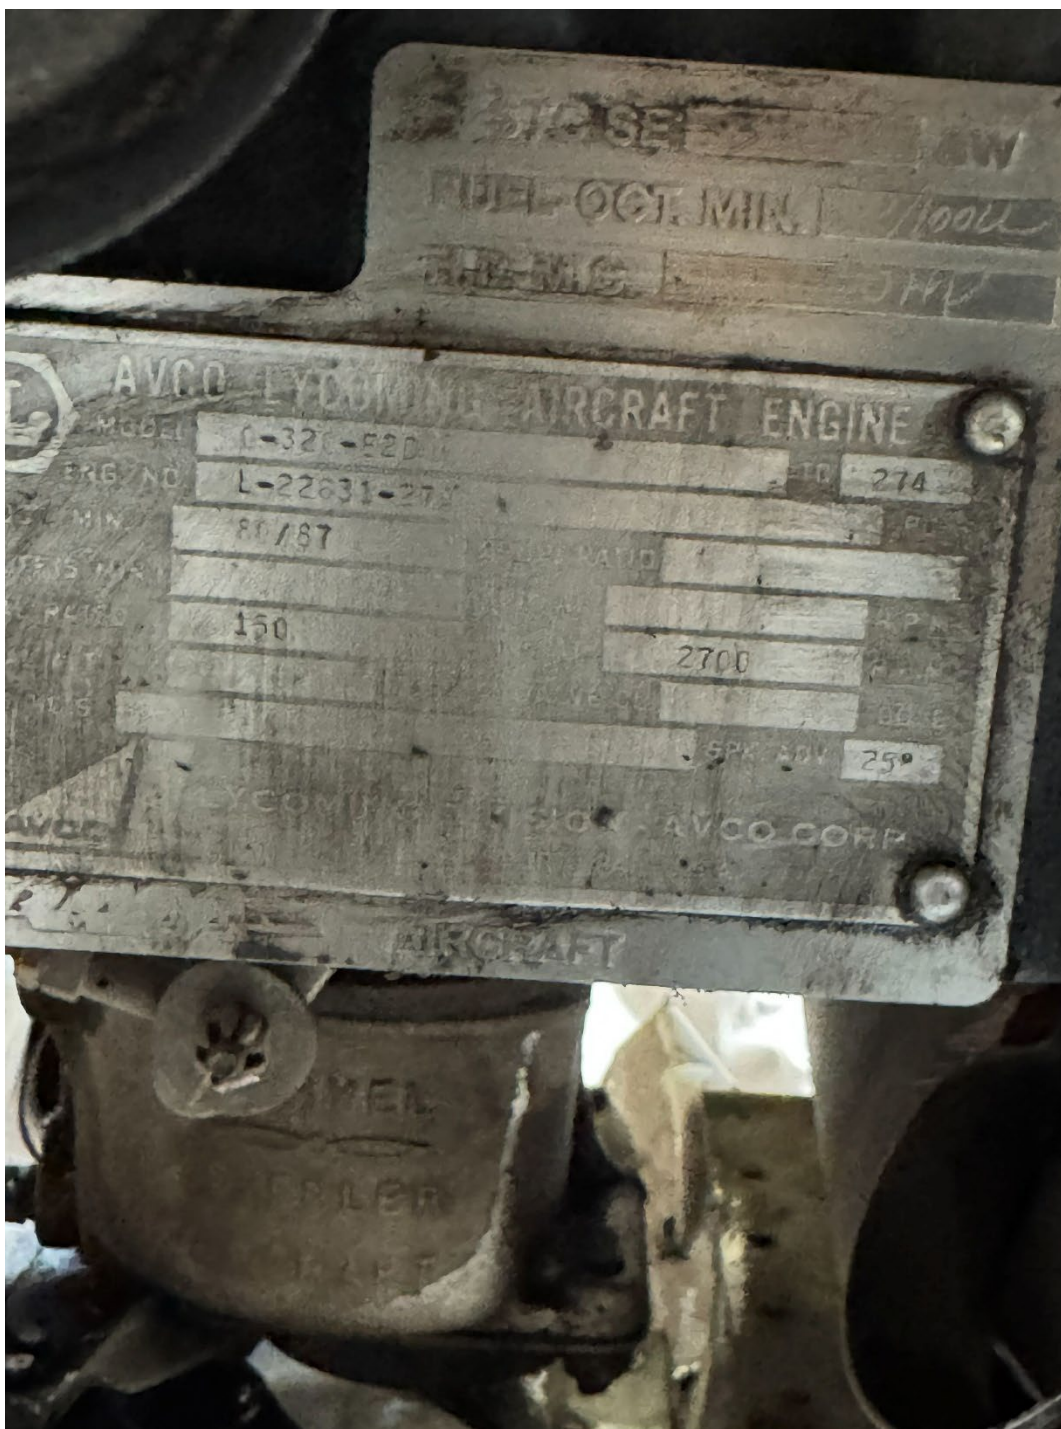
**Figure 10:** View of N46028's engine data plate
