# National Transportation Safety Board

WPR25LA053

## **ENGINE EXAMINATION**

Location: Spokane, Washington  
Date: December 2, 2024  
Time: 1530 Pacific daylight time  
Airplane 1: N29GA, Gulfstream AM CORP COMM DIV690D

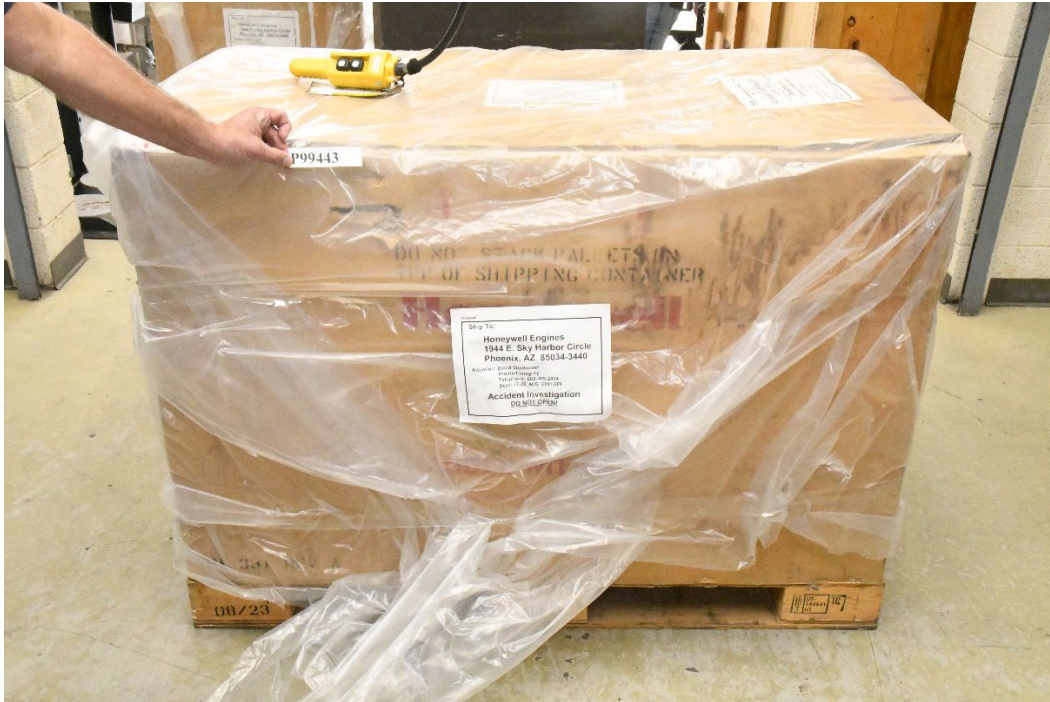
- Damage to the threads of the temperature compensator was observed.
- Rubbing was observed to the upper section of the 3<sup>rd</sup> stage turbine shroud.
- Damage to the starter/generator gear shaft and seal was observed.

**Figure 1: View of left engine create at examination site.**

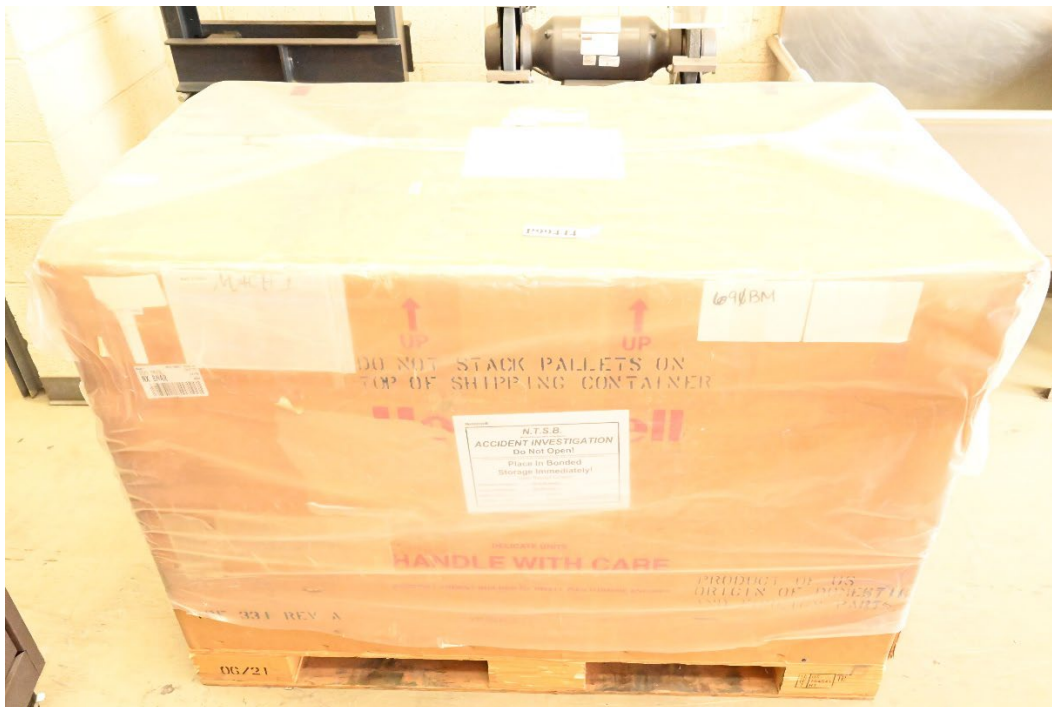
- Damage to the threads of the temperature compensator was observed.
- Rubbing was observed to the upper section of the 3<sup>rd</sup> stage turbine shroud.

**Figure 6: View of right engine crate at examination site.**
