# National Transportation Safety Board

WPR25LA175

## **WRECKAGE EXAMINATION**

Location: Hyampom, California  
Date: June 13, 2025  
Time: 10:30 Pacific daylight time  
Airplane: Cessna 182P, N78720

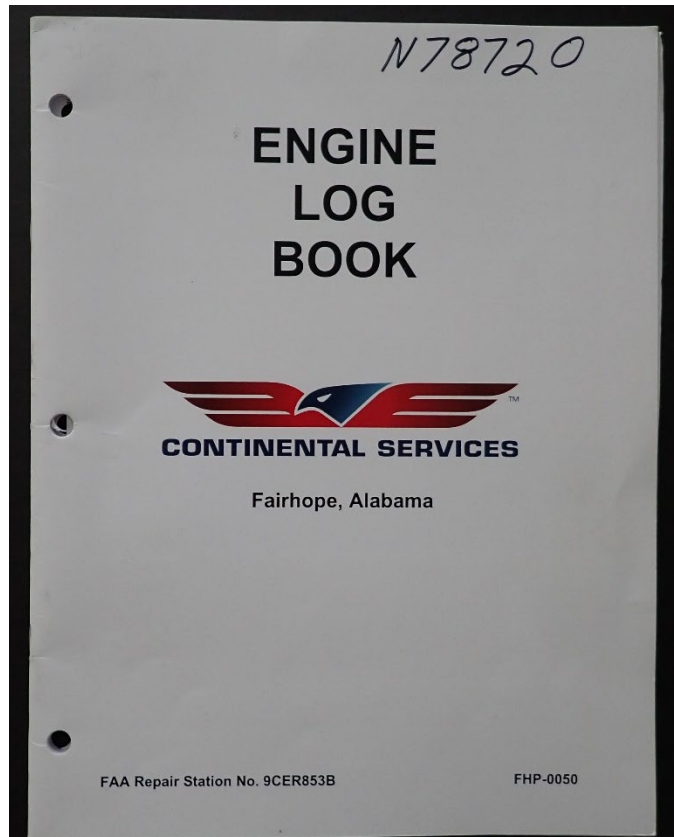
A review of the airplane logbooks revealed that, the most recent annual inspection was conducted on June 1, 2024. At the time of the exam the aircraft total time was 4714.7 hours. According to the engine logbook, the engine was overhauled to manufacture's new parts limits on October 16, 2019.

Figure 9: View of front cover of engine logbook.
