# National Transportation Safety Board

## Safety Recommendation

**Date:** August 15, 2013

**In reply refer to:** A-13-025 through -027

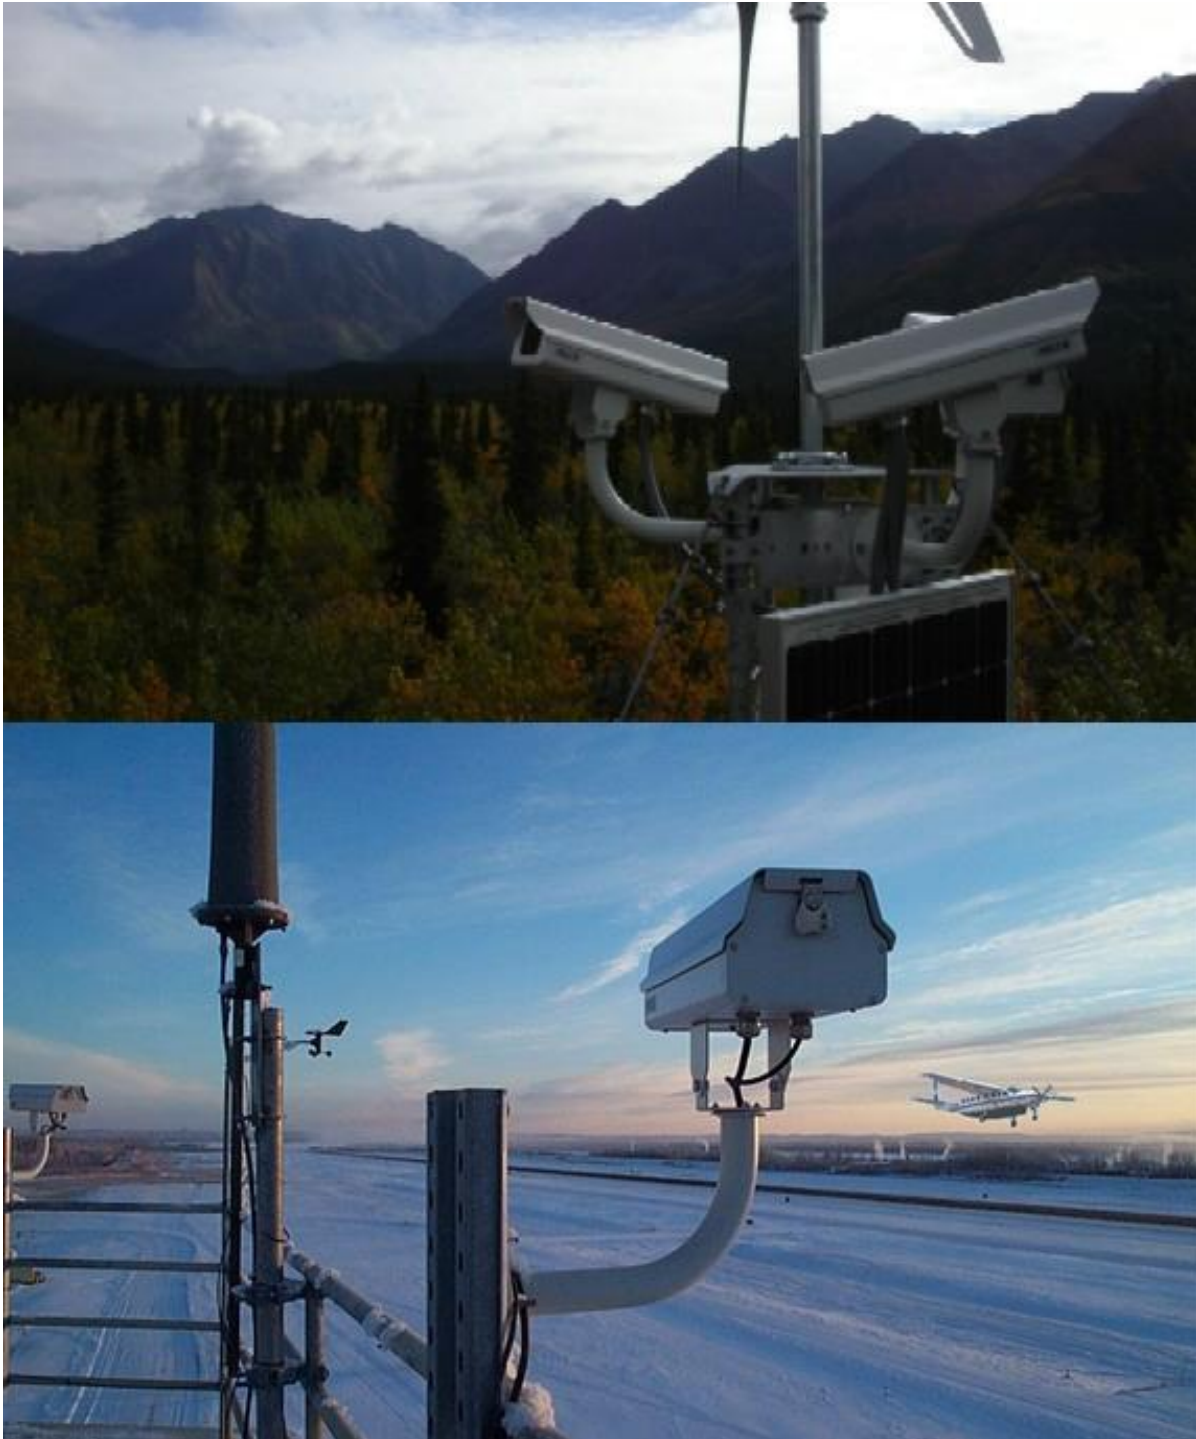
**Figure 1.** Photographs of aviation weather camera installations in Alaska.

The dangers of operating in and near adverse weather amidst challenging terrain have also been well documented in Alaska. In 1995, the NTSB conducted a safety study of Alaska's aviation environment to identify risk factors and safety deficiencies and recommend practical measures for managing the risks to flight operations.<sup>4</sup> Of the 23 recommendations issued as a result of this safety study, Safety Recommendations A-95-128 and -140, which were addressed to the FAA and the NWS, respectively, sought to determine the technical feasibility and safety benefit of remote color video weather observing systems in Alaska.<sup>5</sup> In 1999, the FAA began the Alaskan Aviation Camera Program after determining that "pilots [in Alaska] operating under [VFR] would benefit from actual views of current weather conditions."<sup>6</sup> Further, on July 31, 2008, the NTSB issued Safety Recommendation A-08-59, which asked the FAA to "install and maintain weather cameras at critical areas of air tour routes within the Misty Fjords National Monument and other scenic areas in Southeast Alaska that are frequently traveled by air tour operators."<sup>7</sup> As of September 2012, aviation weather cameras have been installed in 185 locations in Alaska under the program, with a total of 221 locations scheduled to be completed by 2014.<sup>8</sup> Each aviation weather camera site may contain up to four individual cameras positioned to provide a near-complete view of an area (see figure 1). Camera images, both live (which are

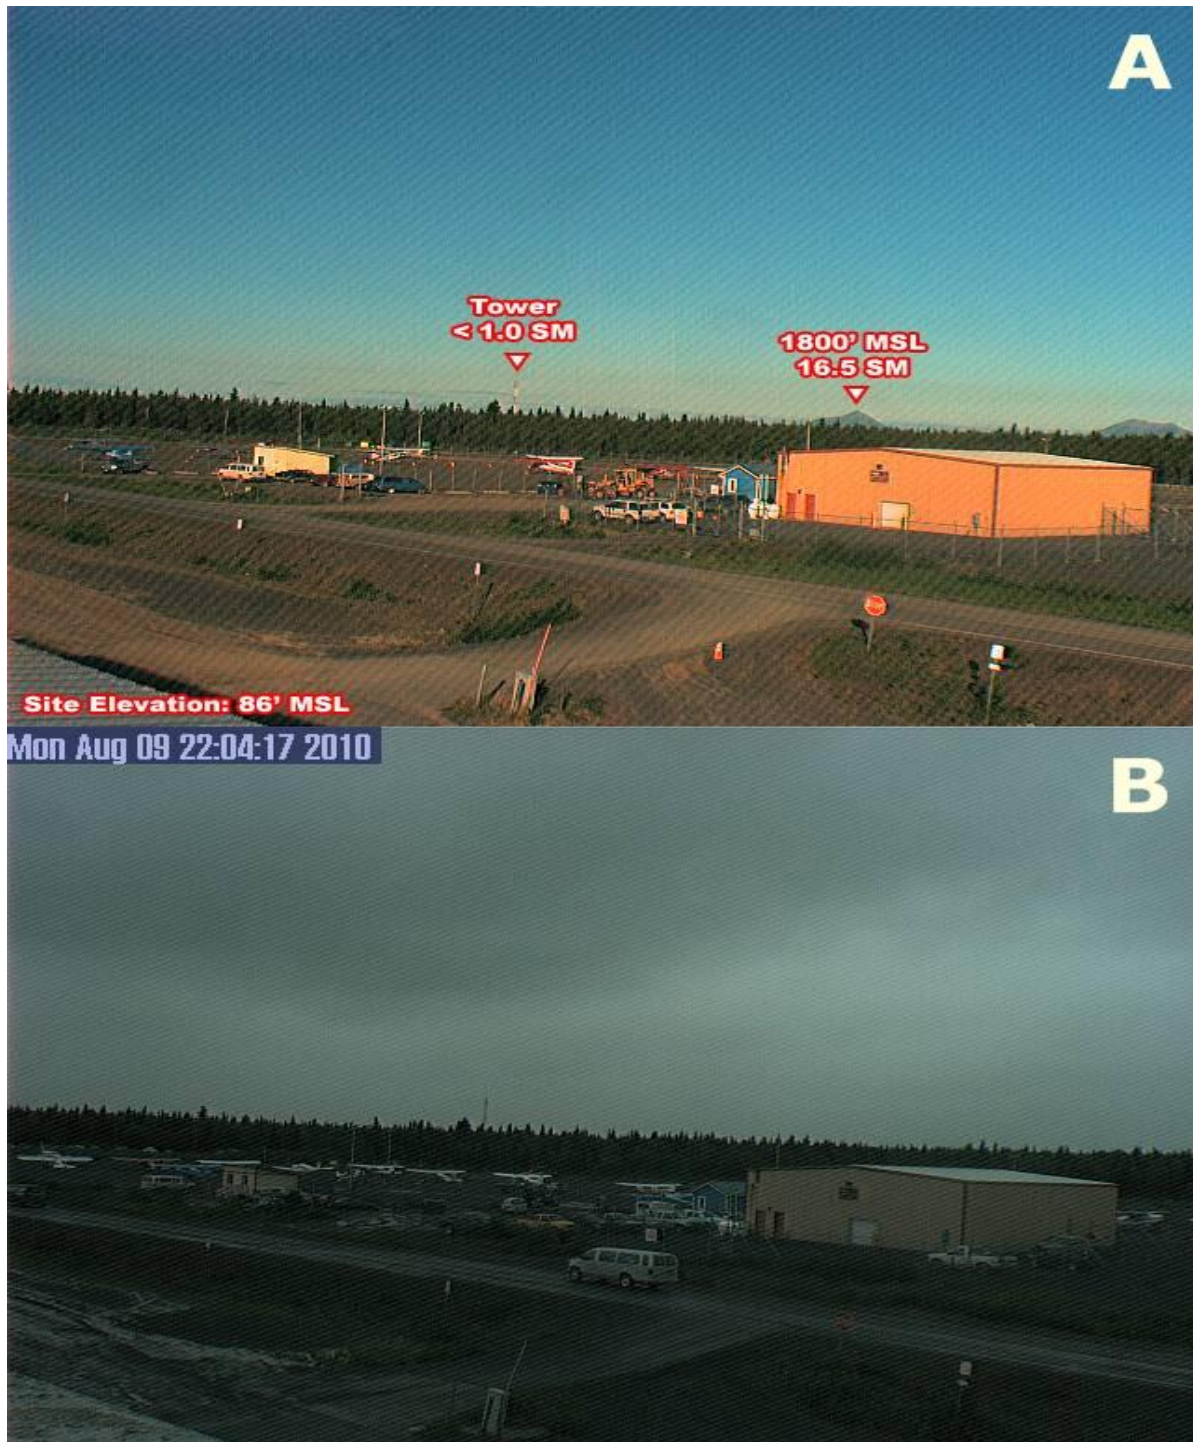
**Figure 2.** “Clear day” (A) and live (B) imagery from the Dillingham, Alaska, southwest-facing camera.

updated every 10 minutes) and “clear day,”<sup>9</sup> are available on the FAA’s website at <http://akweathercams.faa.gov> (see figure 2).

<sup>9</sup> The “clear day” image is not live but is a canned image used for reference when looking at the live image.
