# Continental Motors

## ENGINE FIELD RUN REPORT

| ENGINE MODEL | IO-520-BA12A, Modified by<br>Tornado Alley |
| FILE NUMBER | 15-094 |

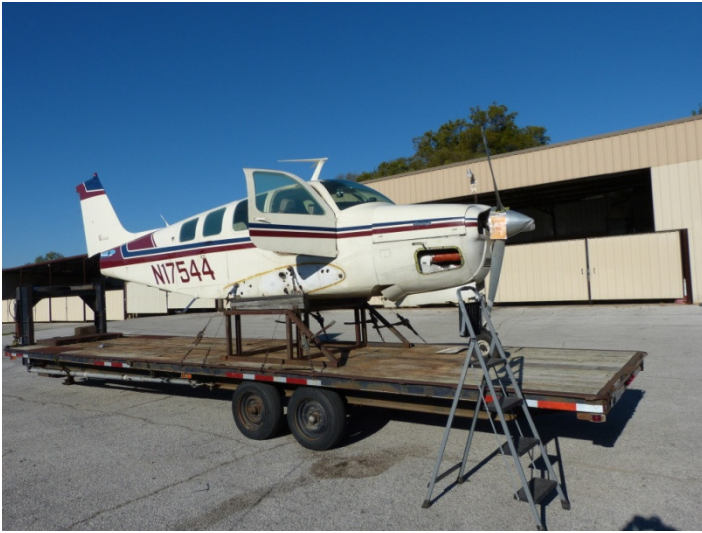
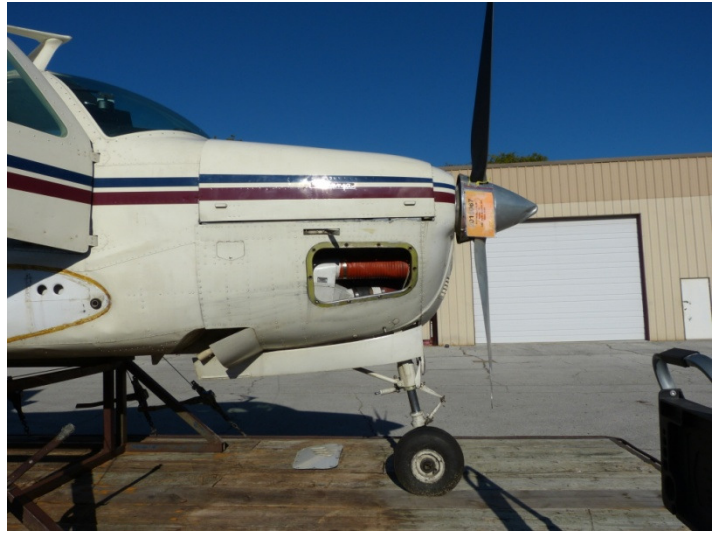
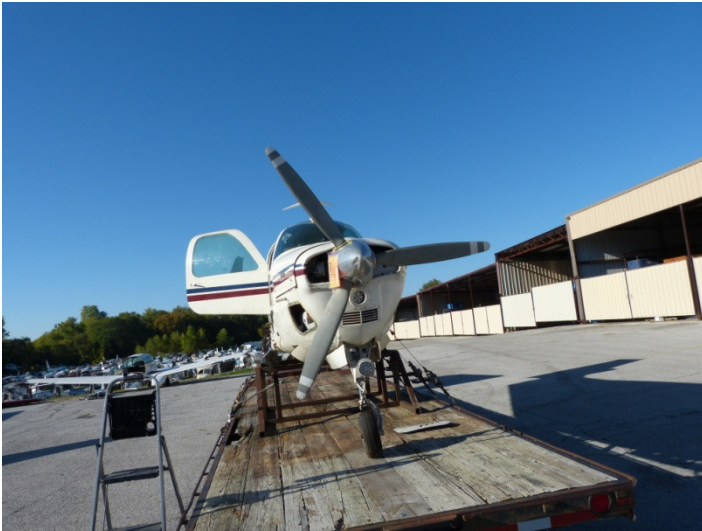
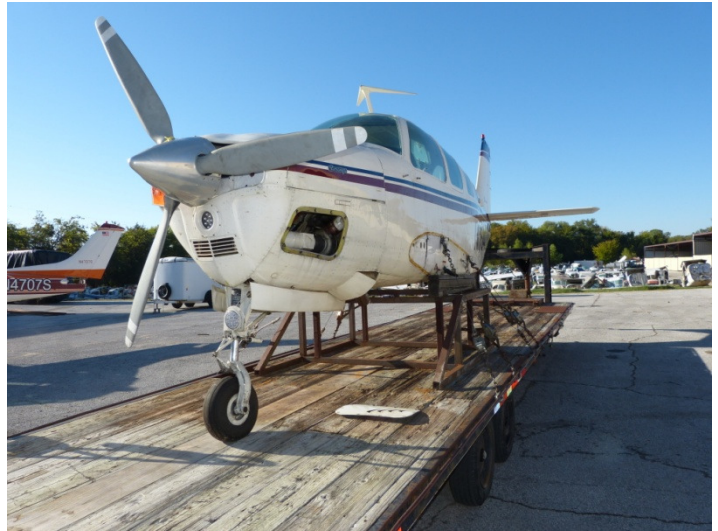
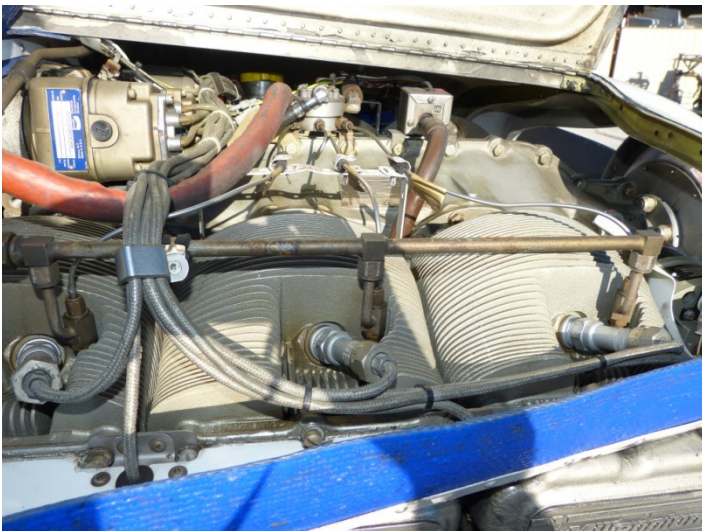
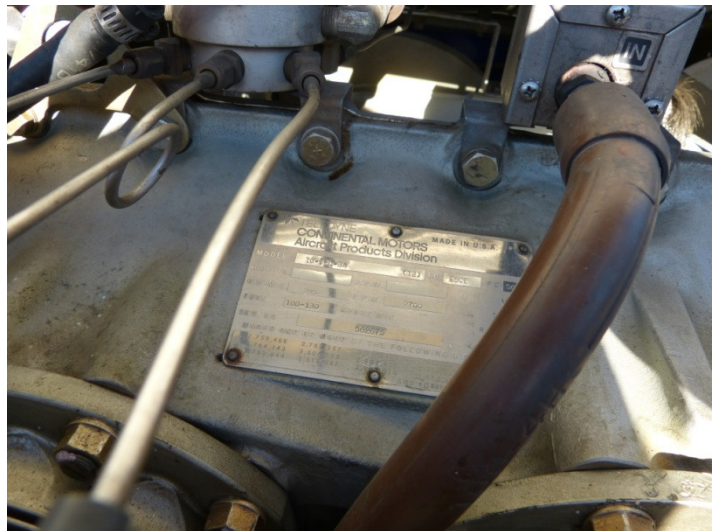
PAGE 4 of 8

The engine was not damaged, and was run on the airframe using the original propeller. The clamp on the right side of the balance tube was not properly installed and had been leaking intake gas.

The top spark plugs were removed and examined before the run. They had normal wear and dark deposits in the electrode areas when compared to the Champion Check-A-Plug comparison card. They were Champion RHB-32E spark plugs.

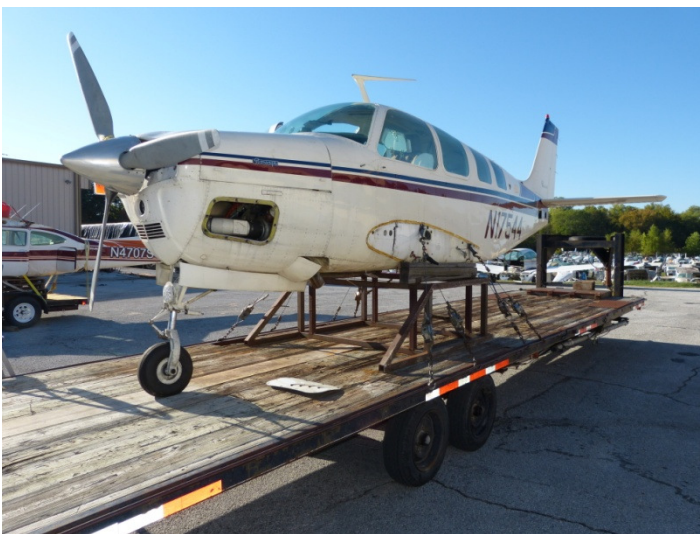
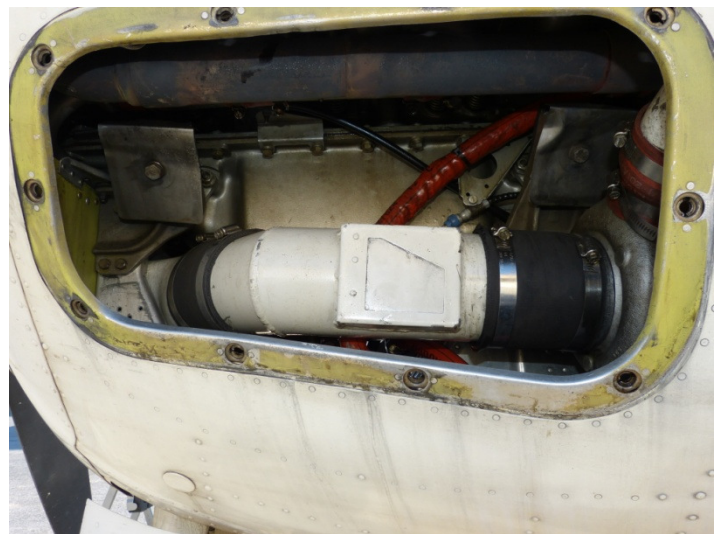
After the run it was determined that the engine was equipped with the wrong fuel pump. The aircraft fuel screen was removed and examined and it was properly installed and was clean and clear. At this time the investigation was terminated. Please see the Air Salvage of Dallas Run Sheet for details of the runs. Please see the run video to observe the run.
