# Continental Motors

## ENGINE FIELD RUN REPORT

| ENGINE MODEL | TSIO-360-LB1B |
| AIRCRAFT MAKE & MODEL | Mooney M20K |

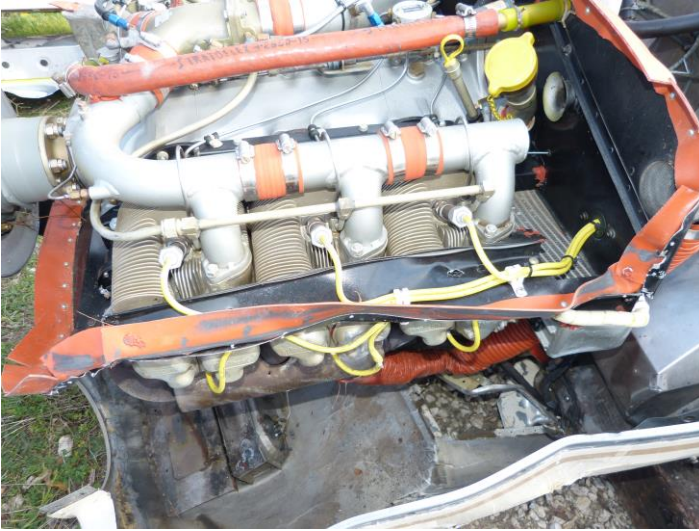
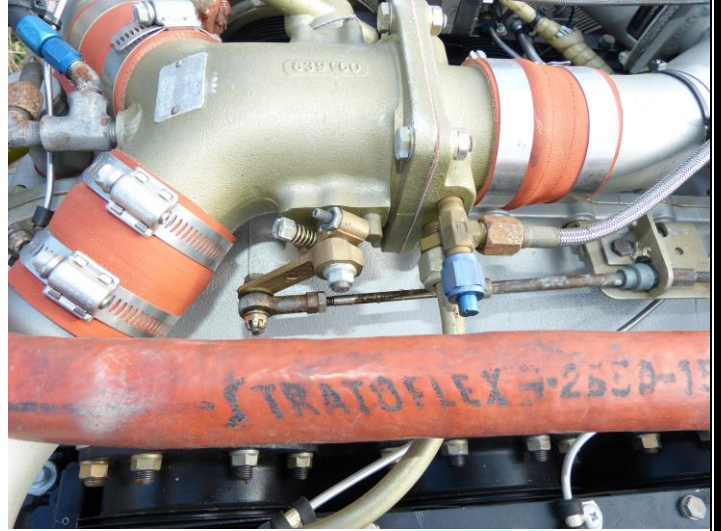
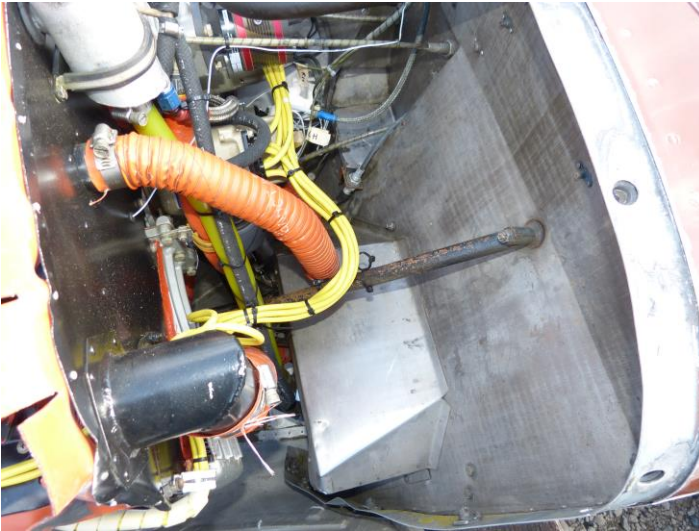
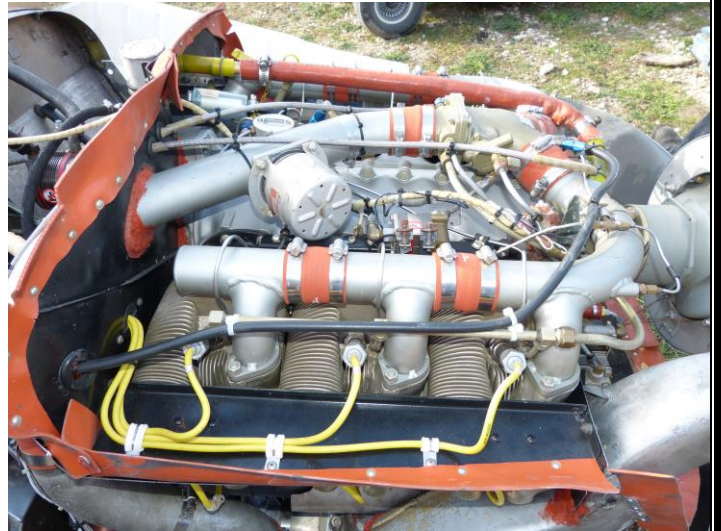
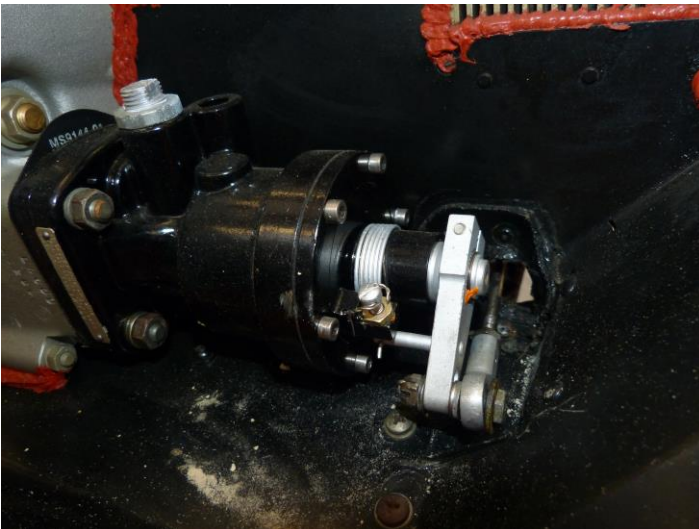
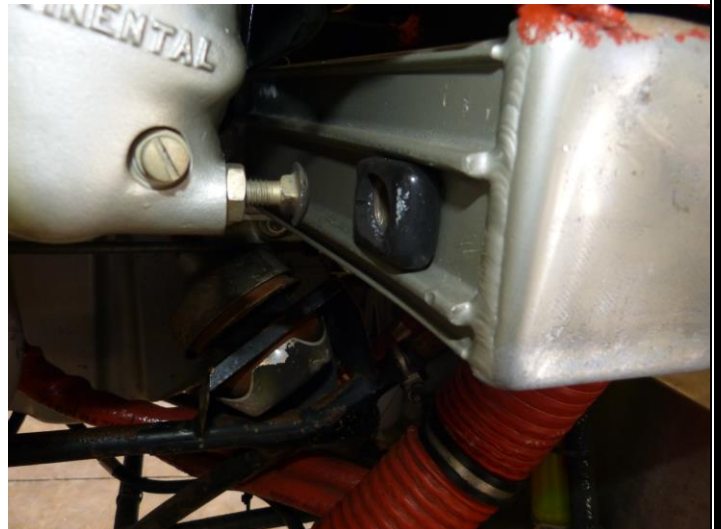
The engine was intact with minor impact damage. The throttle, mixture, and propeller governor controls were hooked up and free to move. The oil cooler had impact damage and was pushed to the rear. The number four exhaust rocker cover was dented, and the number four bottom spark plug lead was damaged. A reference line to the Merlyn Controller was separated.
