## Merlyn Products, Inc. Findings Report

MPi 18-1 N2890T SN: 28-7921088  
Kit SN: 1893090533  
Unit SN: 1893090533 A0849  
TT: Total time not given  
NTSB Accident #: CEN19LA317  
FSDO Tear down and Inspection at MPi facility

Date: January 16, 2020  
Inspection Date: January 16, 2020  
**Preliminary Report**  
Ref: SO8417/—/JI4069  
Inspected by: Philip Griffis, ASI  
with H. Evans Jonathan  
Nordhagen, Tanya Livers, S.  
Evans  
Report by: S. Evans

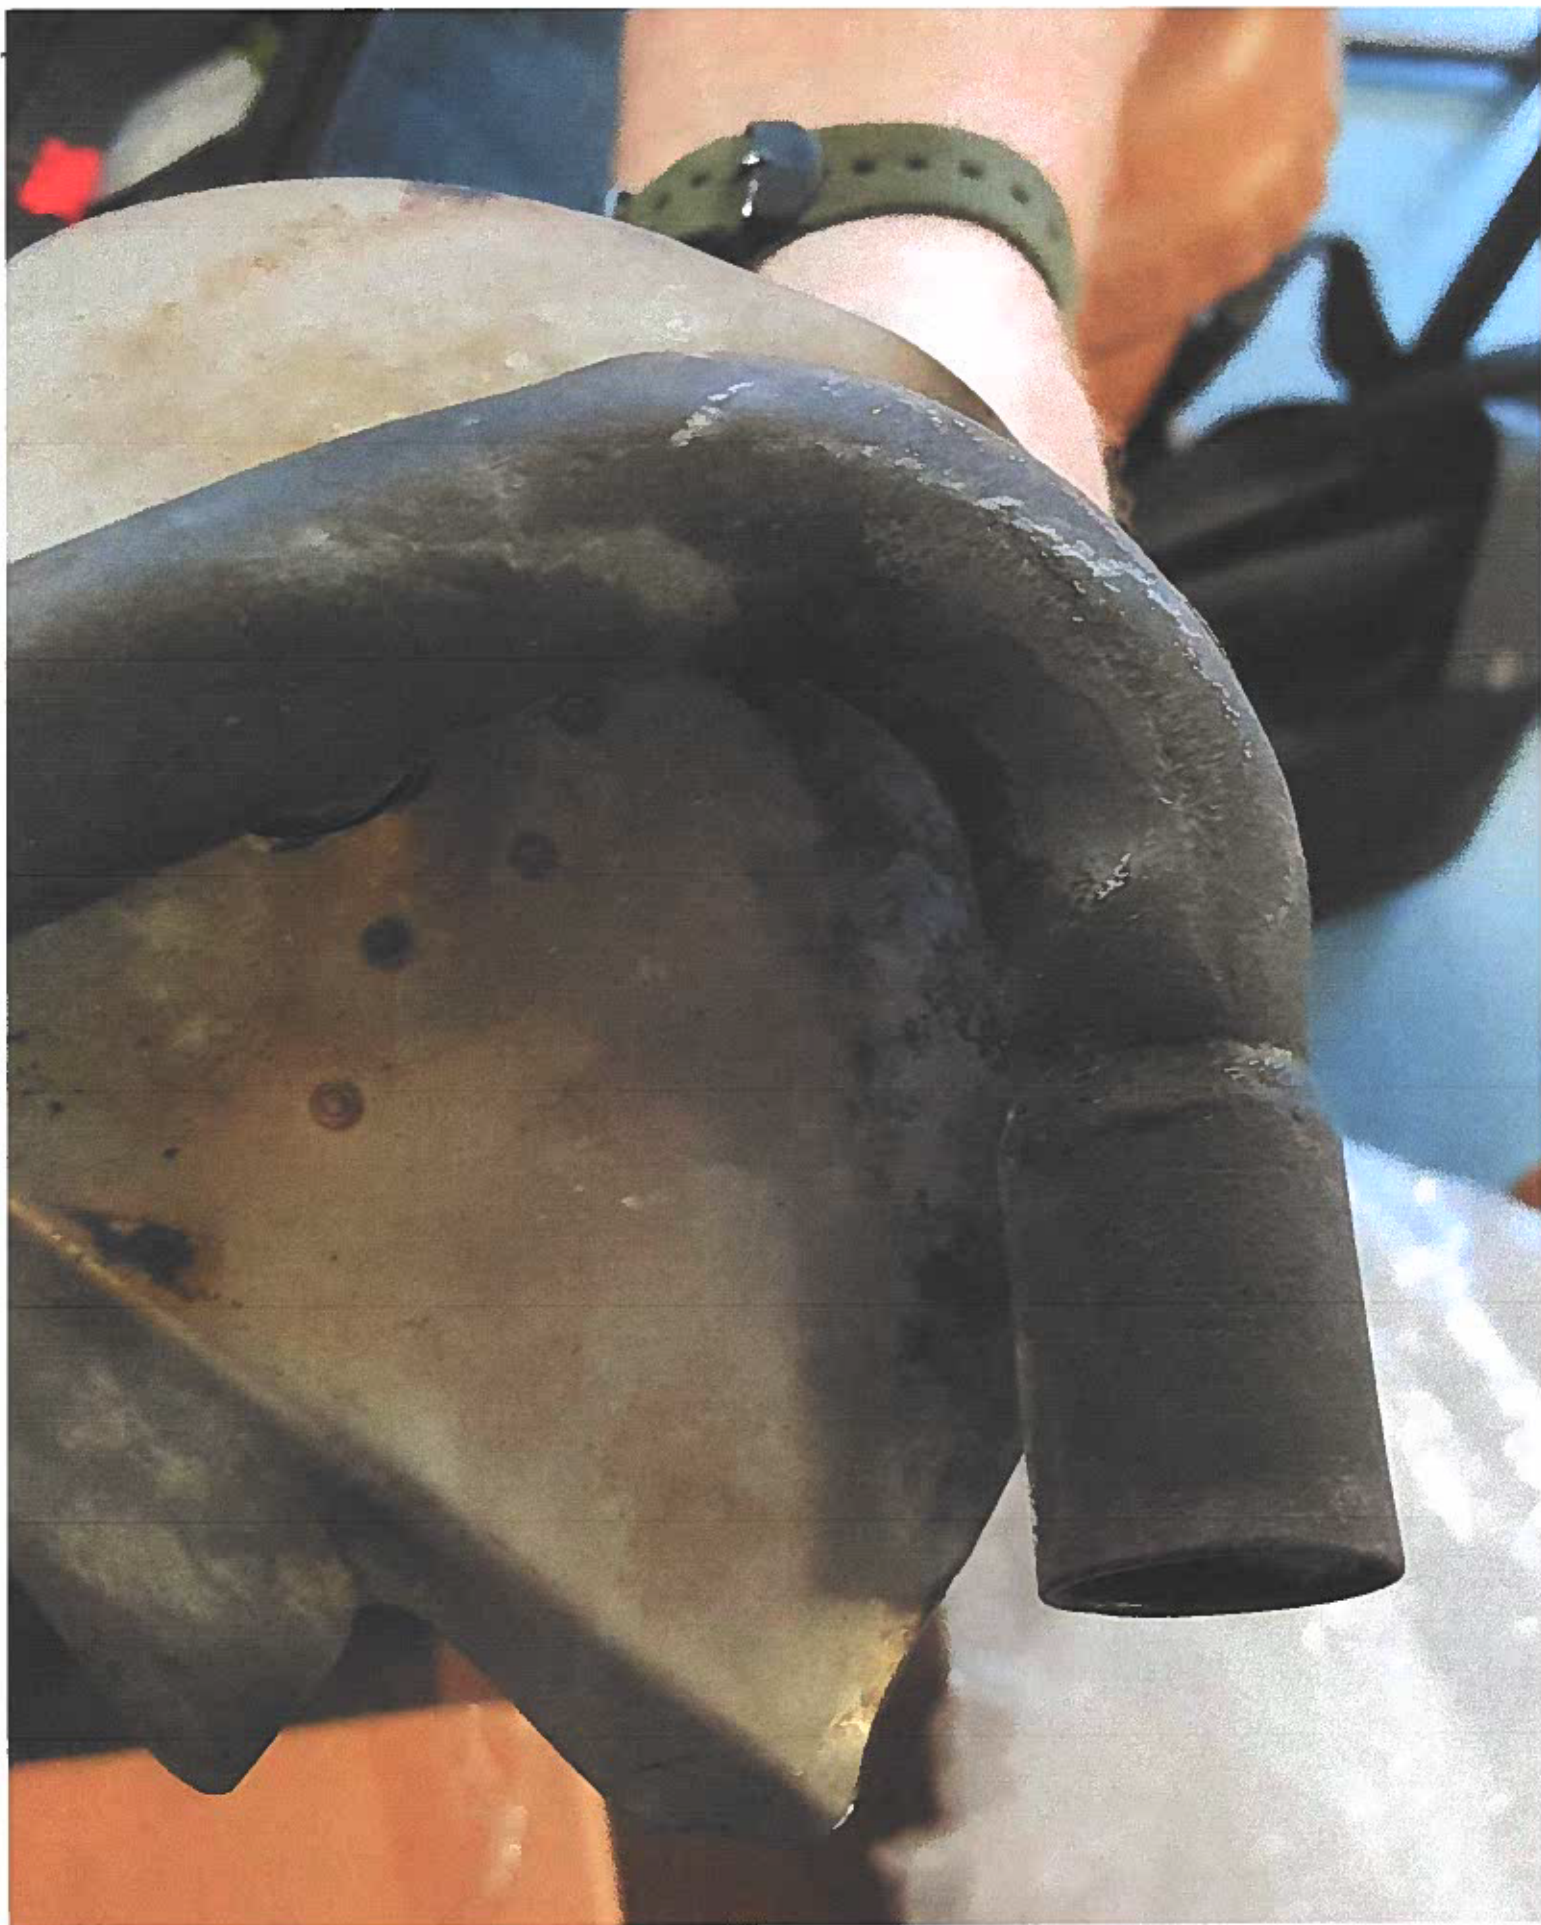
Kit SN: 1893090533

of used UDP  
g FB

Evidence disassembly

*Defect wire cut inside*

visual damage

Measured DATA

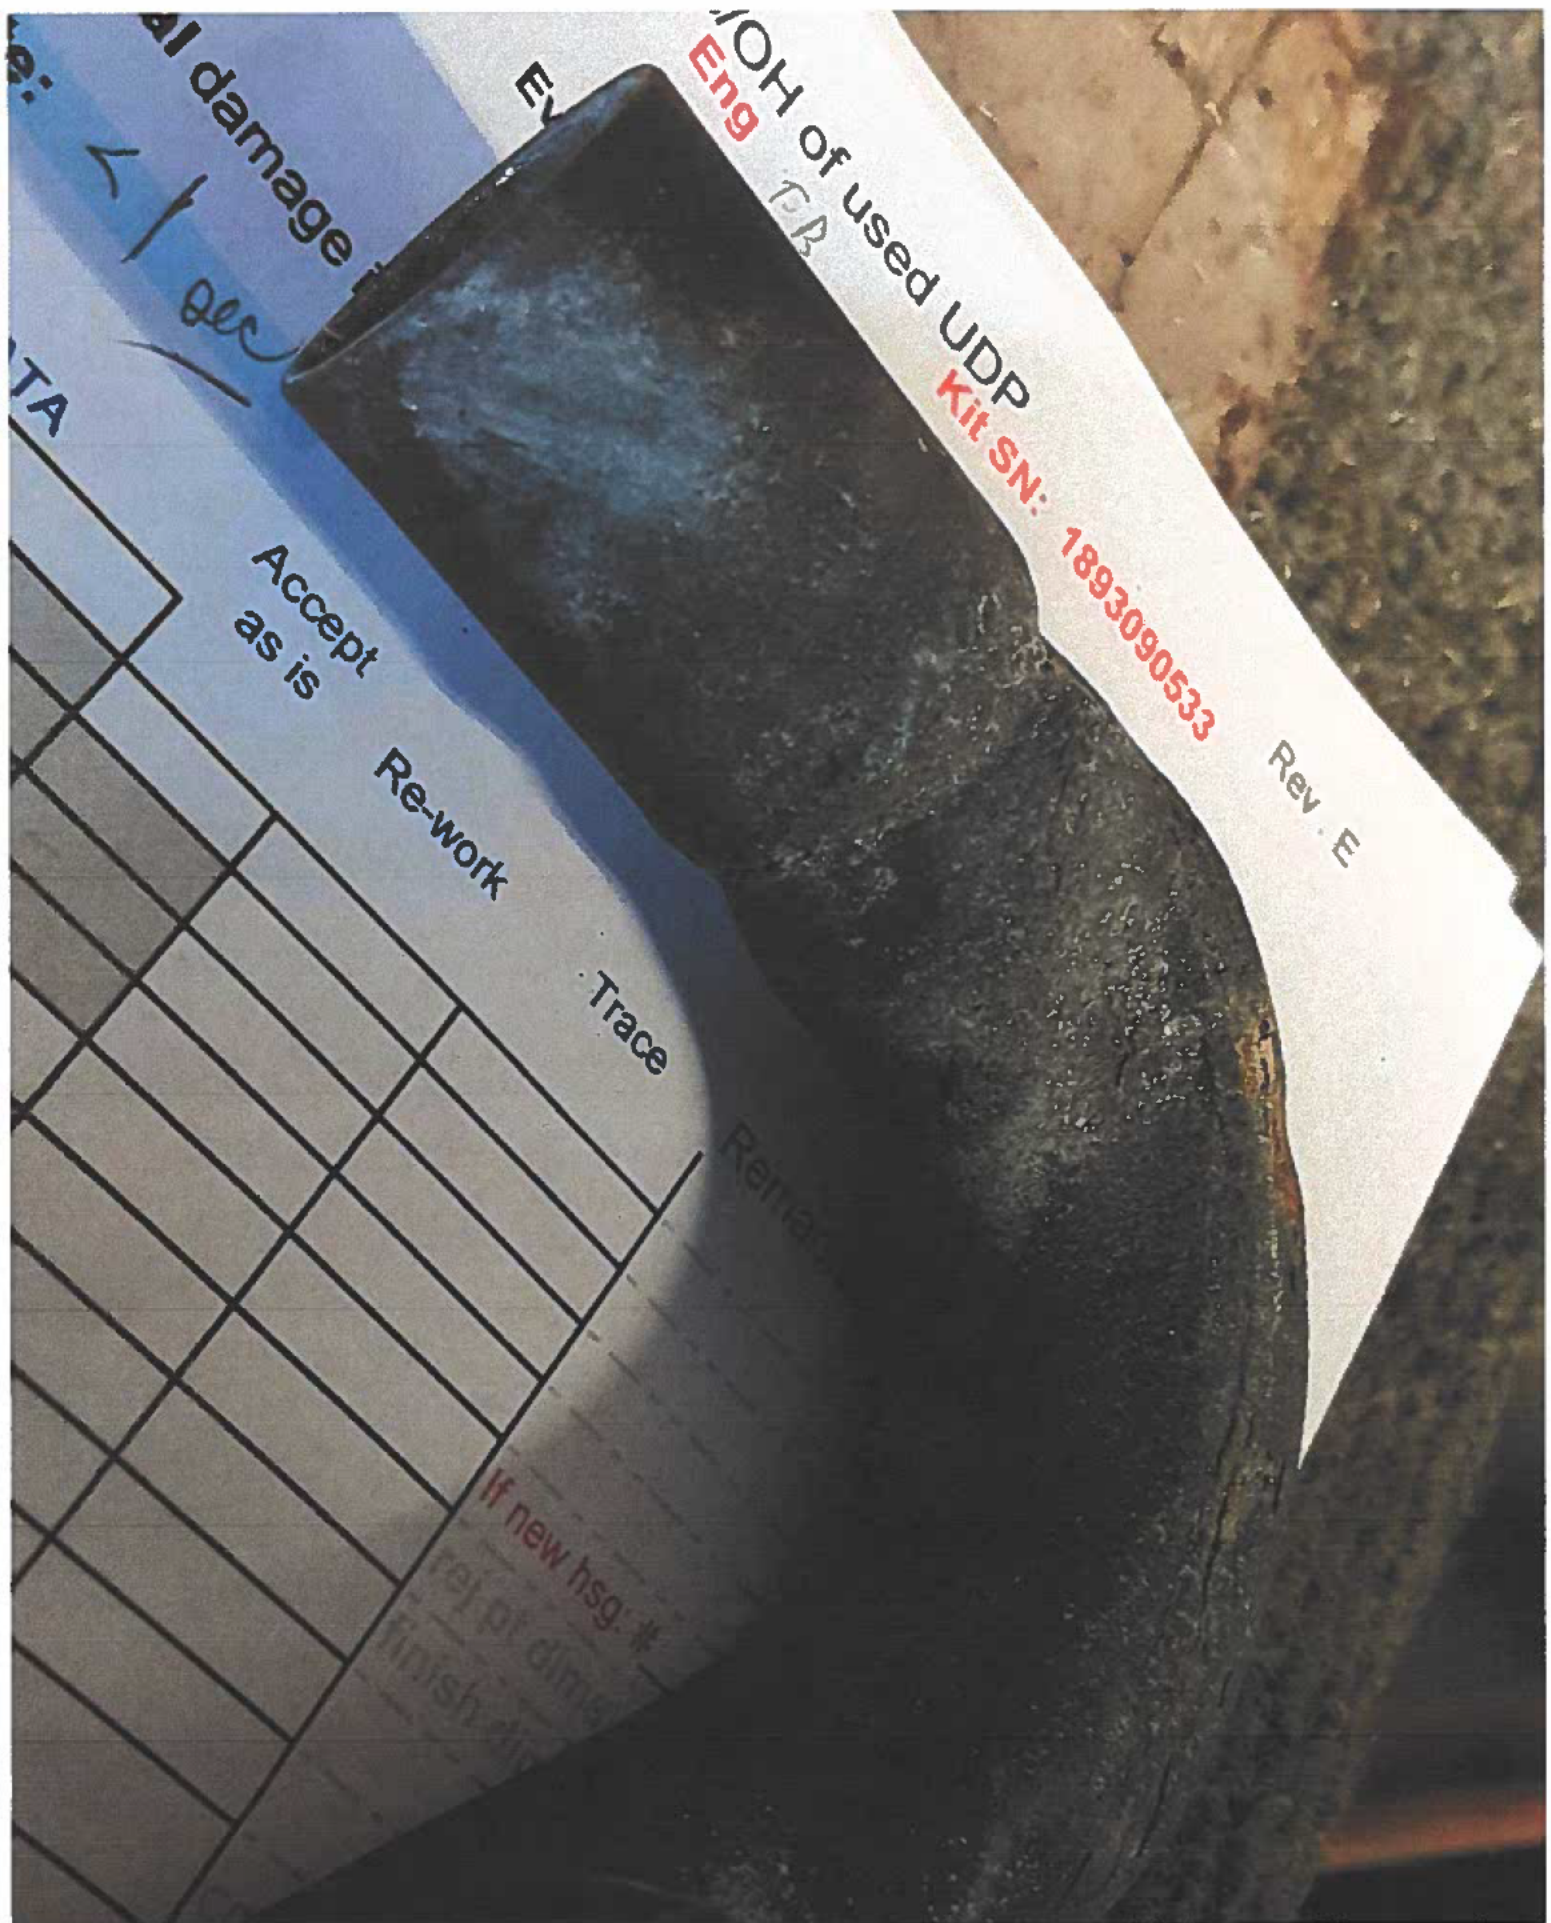
Kit SN: 1893090533

MOH of used UDP  
Eng

Remarks

If new hsg: #

rej pt dms

finish dms

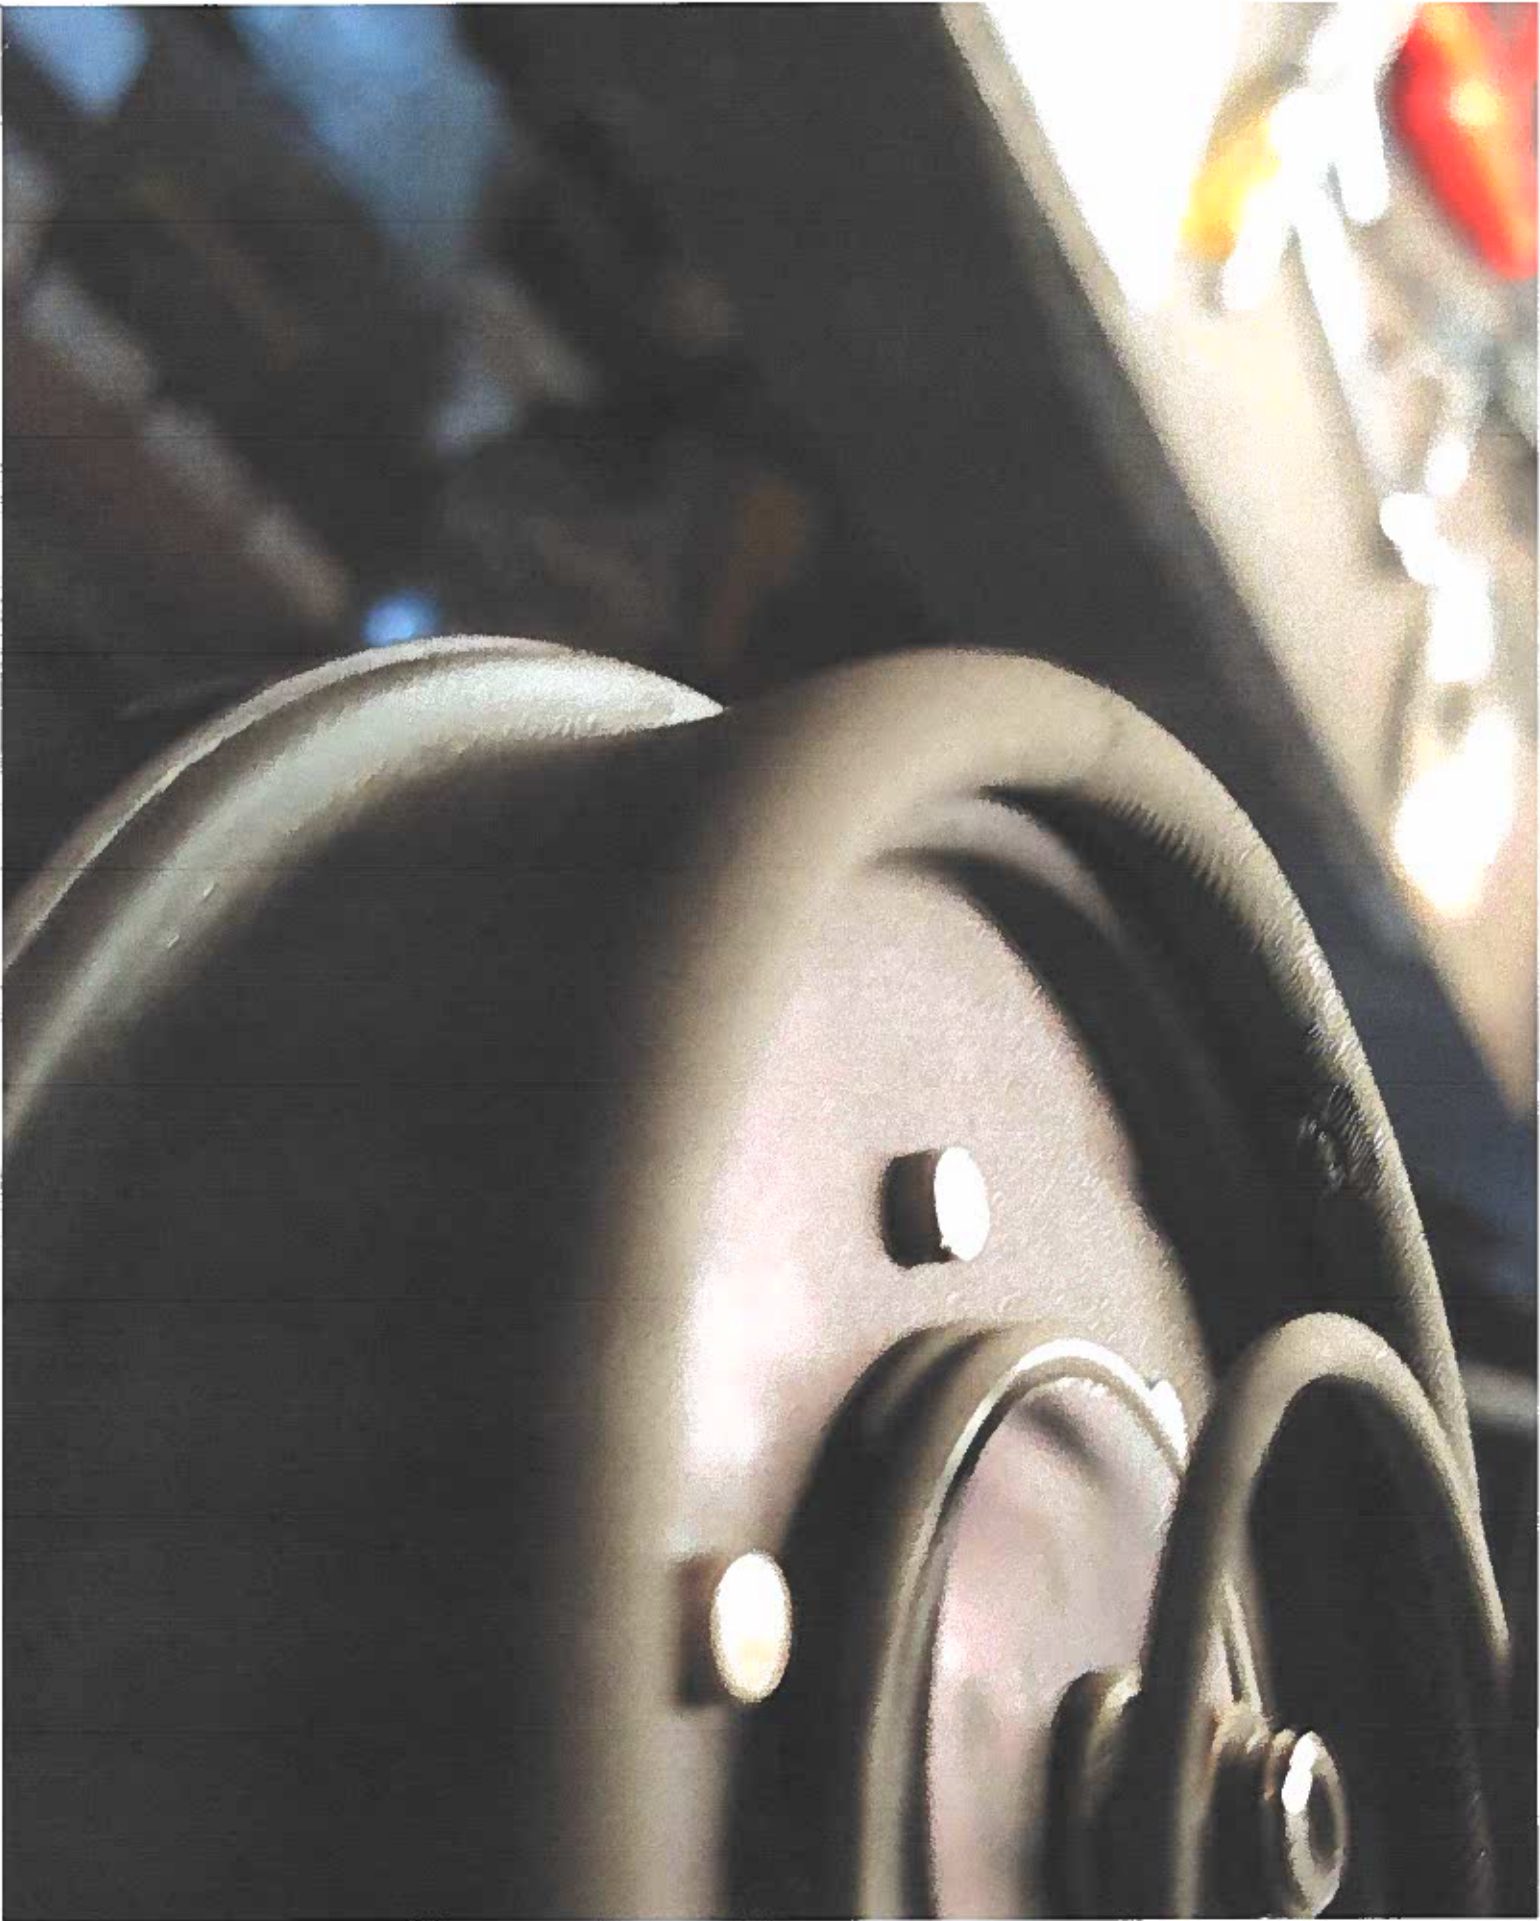
Return factory new & 1 removed

heat creep, box  
rp, etc.

list issues

concentricity
