## **NATIONAL TRANSPORTATION SAFETY BOARD**

### **Specialist's Report**

## **OPERATIONAL / HUMAN PERFORMANCE**

**CEN20LA215**

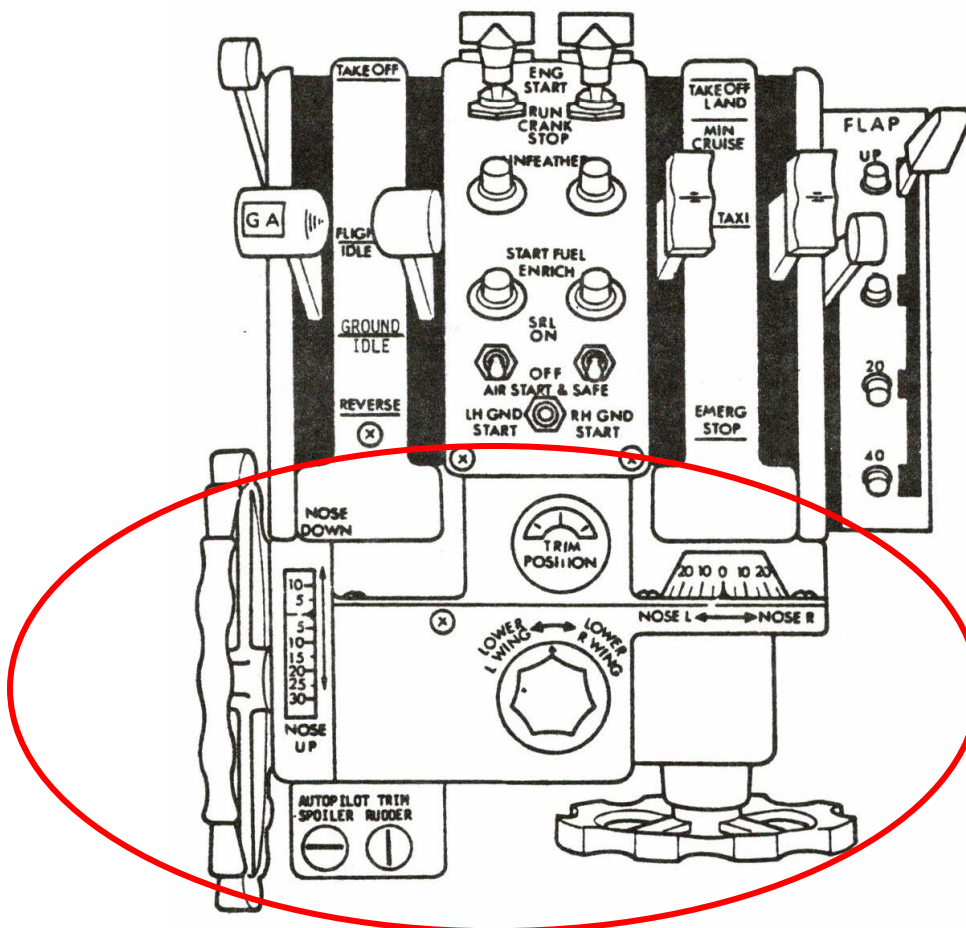
Figure 1: Center Pedestal of the MU-2.

Trim controls existed for aileron, rudder and elevator trim surfaces and are cable and chain operated through actuators mounted beneath the trim surface. The actuators had irreversible jackscrews which can be measured post-accident for reliable trim positions at the time of the accident. Figure 1 shows the location of the trim controls with a red circle as located on the center pedestal.
