## **CEN21LA404 – NTSB Examination Report**

N9114W (Cessna 182D airplane with a Continental Motors O-470 engine) was examined at Smiling Aviation in Delta, CO, on 12/14/2021. Present during the examination was Mike Hodges, NTSB investigator-in-charge, Casey Love, air safety investigator, from Textron Aviation, Wichita, KS, and various staff members from Smiling Aviation.

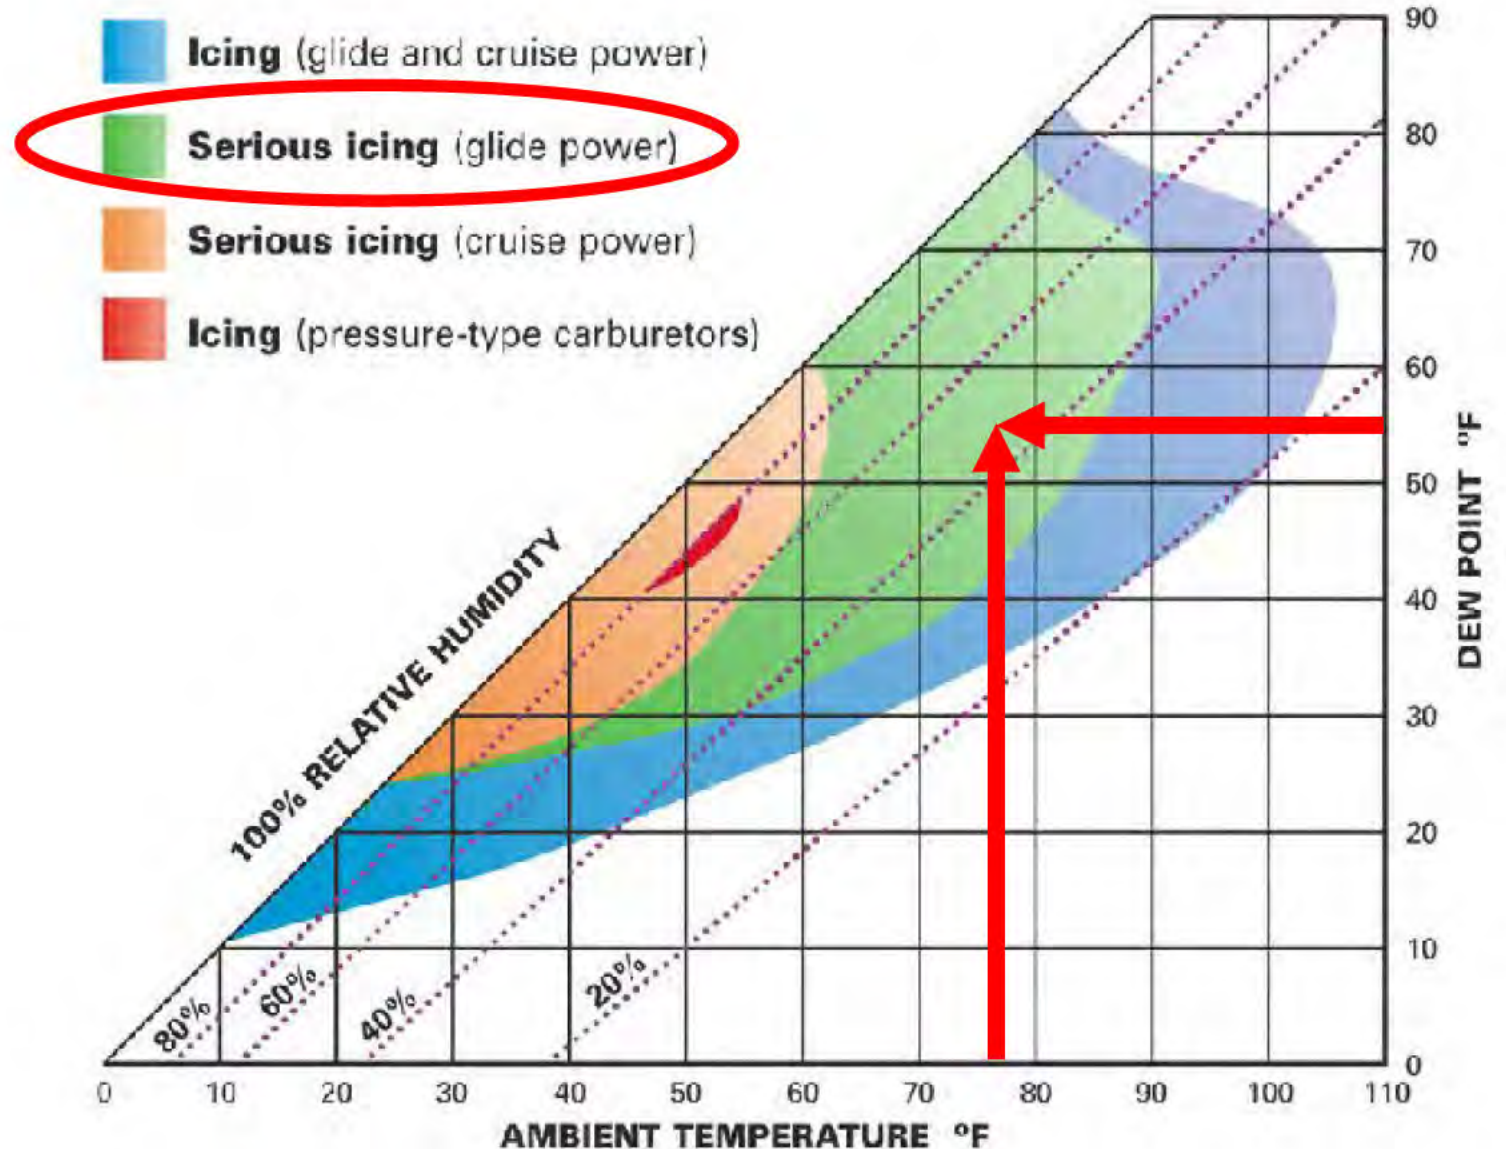
Special Airworthiness Information Bulletin CE-09-35

Carburetor Icing Prevention
