## **NATIONAL TRANSPORTATION SAFETY BOARD**

### **Specialist's Report**

# **OPERATIONAL FACTORS**

CEN22FA096

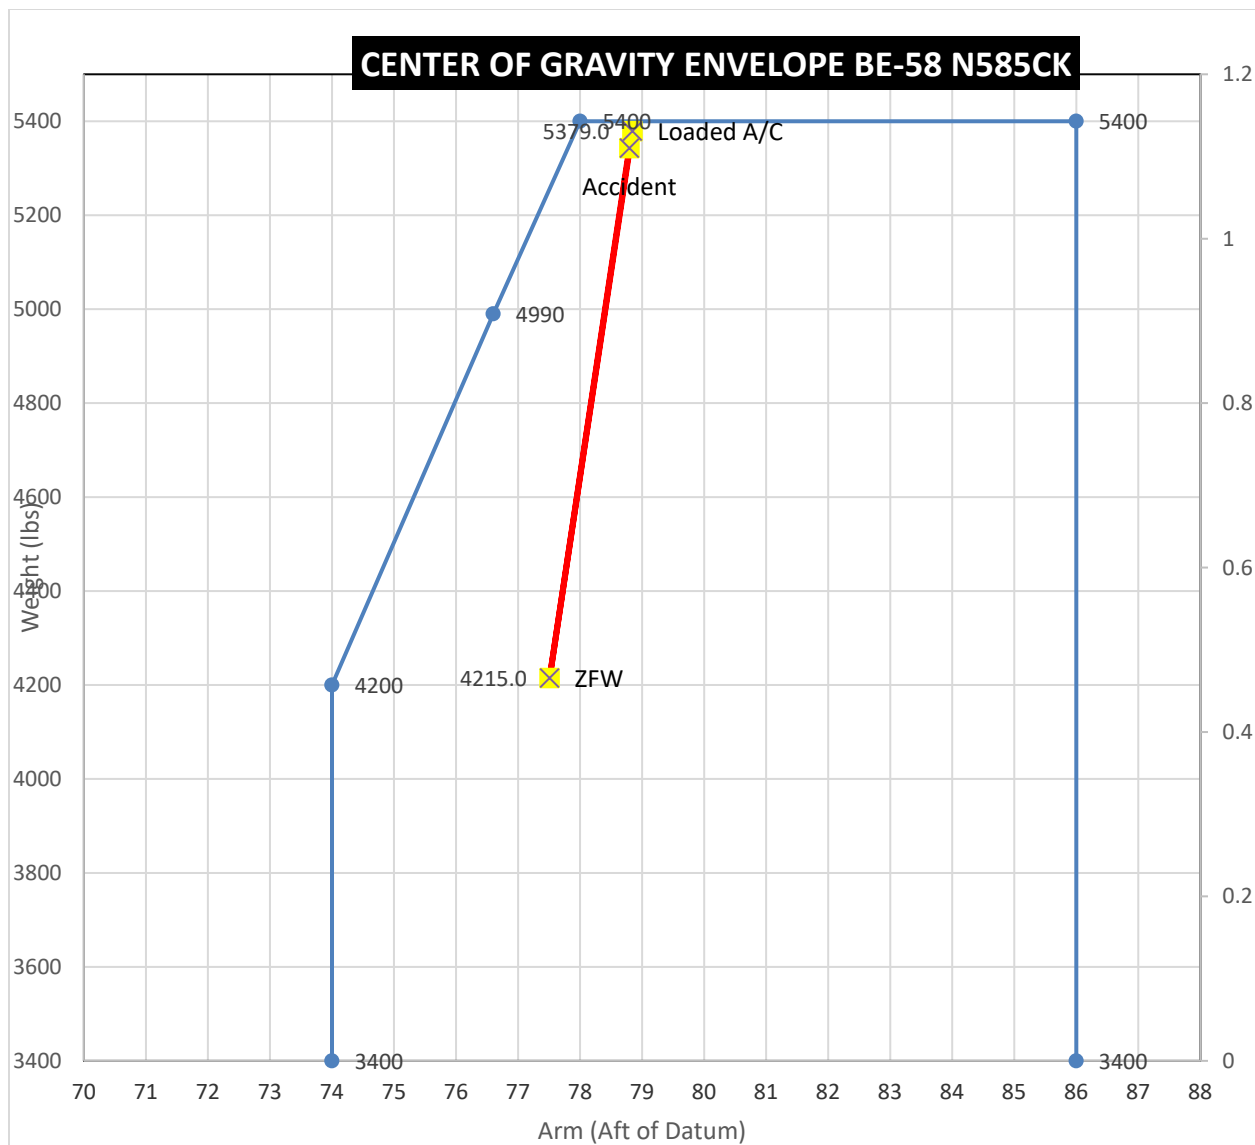
**Figure 4: Center of Gravity Envelope.**

the aircraft limitations from Section 2 “Limitations” of the POH<sup>26</sup>. The “Aft CG<sup>27</sup> Limit” was 86.0 inches Aft of Datum.<sup>28</sup> Figure 2 below shows the CG envelope range. The weights in *italics* were estimated weights. All weights are in lbs.

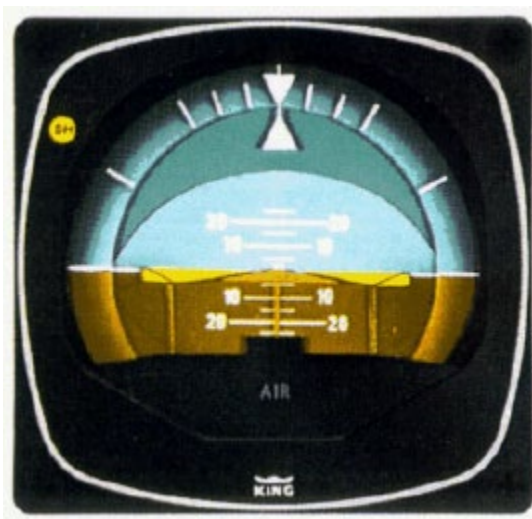
The Flight Command Indicator (FCI) contained an air driven vertical gyro, at least one engine must be running, the pressure system must be operating, and the gyro was "up to speed" before the system would operate. The FCI displayed the following information:

- Pitch and roll attitude
- Pitch and roll commands
- DH (Decision Height) annunciation when used with radar altimeter

**Photo 2: KI 256 Flight Command Indicator**  
(Source: Bendix King Pilot's Guide)

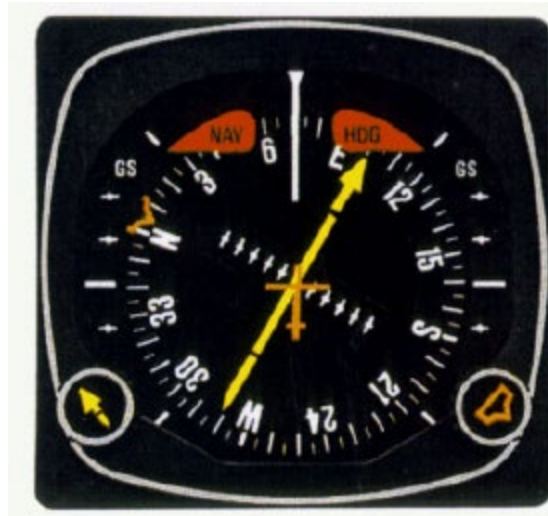
The Pictorial Navigation Indicator displayed constantly slaved gyro magnetic heading information, along with VOR/LOC/RNAV course deviation and glideslope deviation indications.

**Photo 3: KI 525A Pictorial Navigation Indicator**  
(Source: Bendix King Pilot's Guide)

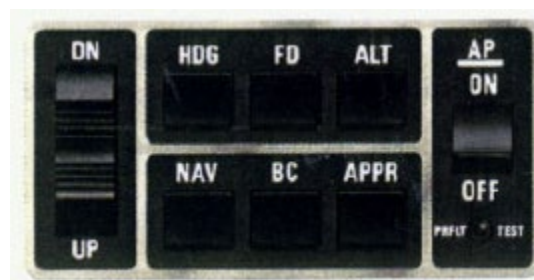
The Mode Controller contained six pushbutton switches for turning on the Flight Director and selection of all flight director modes. It also included a solenoid-held switch for autopilot engagement, a vertical trim rocker switch, and a preflight test button. On a similar aircraft as the accident aircraft, this was located on the lower left side of the instrument panel below the flight instruments.

**Photo 4: KC 290 Mode Controller**  
(Source: Bendix King Pilot's Guide)

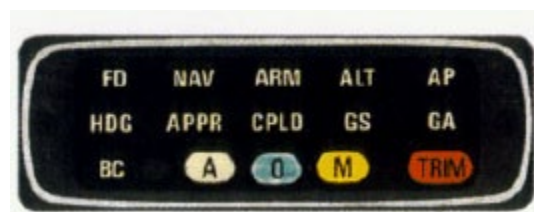
The KA 285 Annunciator Panel annunciated all vertical and lateral Flight Director/Autopilot system modes, including all “armed” modes prior to capture. It indicates to the pilot when the selected mode has been received and accepted by the system and if an “armed” mode was selected when capture has been initiated. It also is equipped with marker beacon lights and trim failure warning.

**Photo 5: KA 285 Annunciator Panel**  
(Source: Bendix King Pilot's Guide)

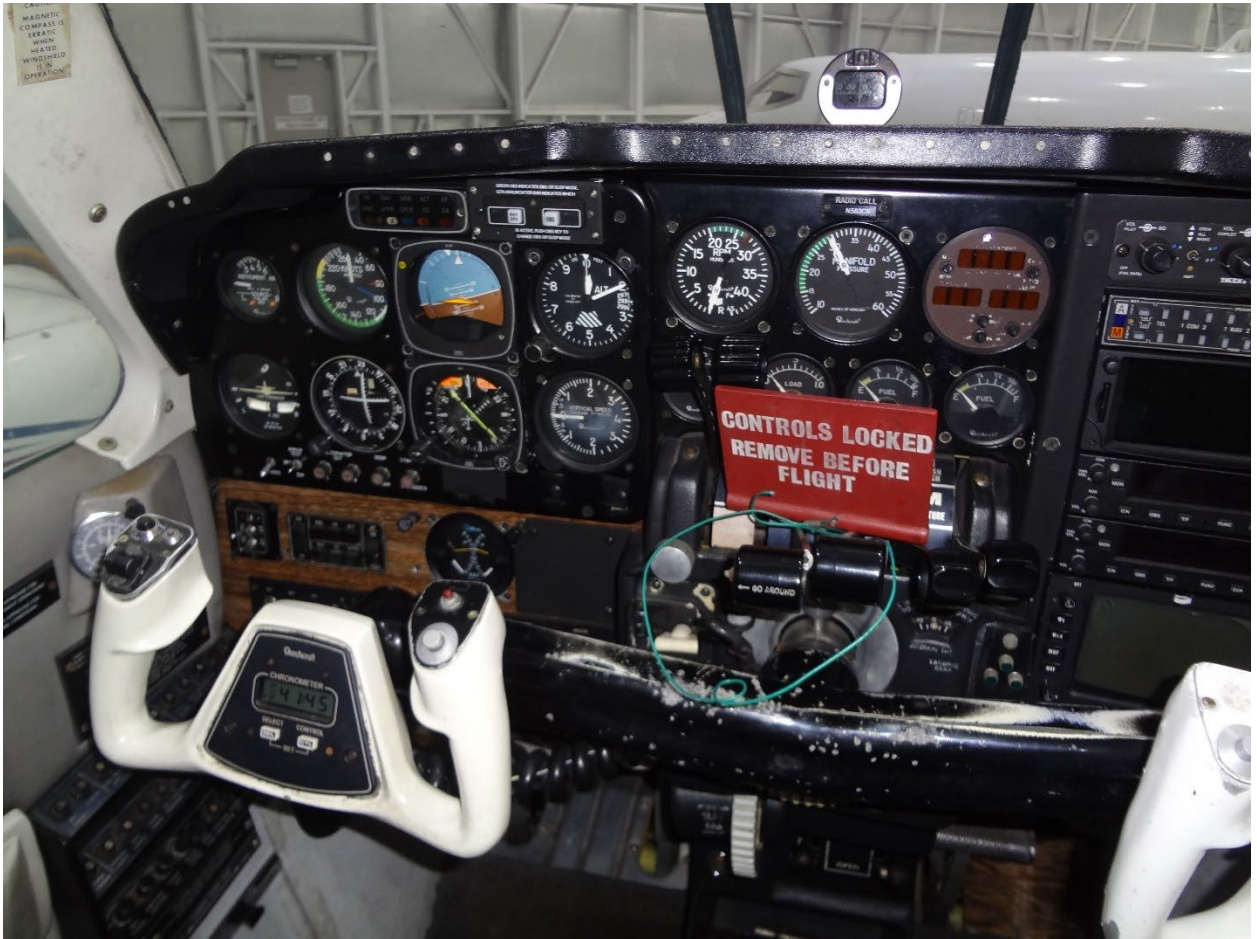
*The flight instruments are located on a floating panel directly in front of the pilot's seat. Standard flight instrumentation includes attitude and directional gyros, airspeed, altimeter, vertical speed, turn coordinator, and a clock. A magnetic compass is mounted above the instrument panel and an outside air temperature indicator is located on the left*

side panel. Located on the right side of the instrument panel is the standard pressure gage for the instrument air system.

Photo 6: Instrument Panel of N583CK - Similar as the Accident Airplane  
(Note: Dual yoke was not on the accident airplane)
