This letter serves as an addendum to my statement for the accident on October 20, 2021 at Dallas Executive airport.

# Continuous Flow Fuel Injection Systems

By Randy Knuteson

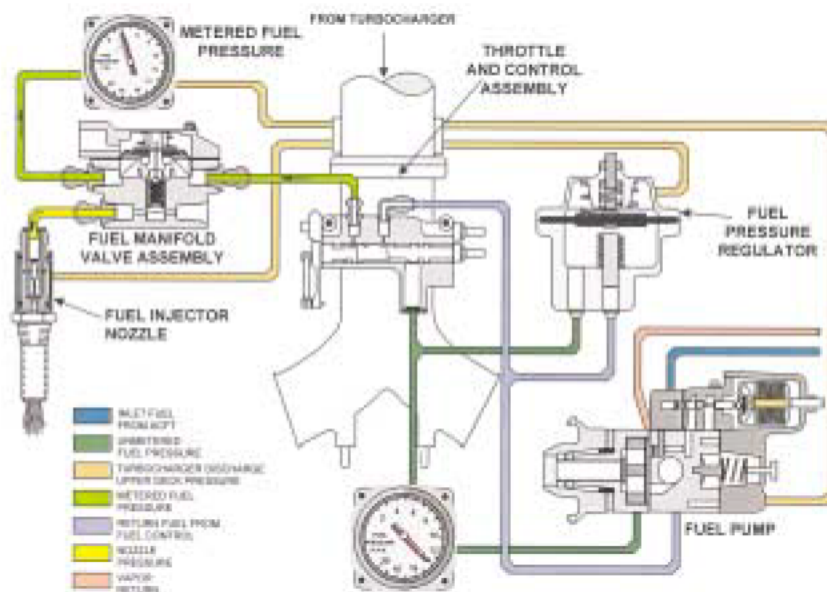
Typical Turbo-Charged Fuel System Schematic (With Regulator)

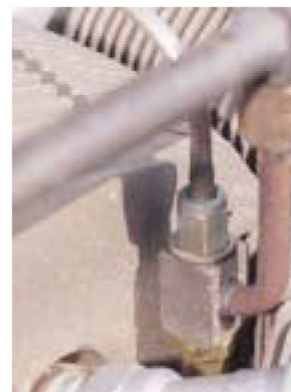
**Turbocharged engines reference upper-deck pressure to the injection nozzles. Always replace o-rings and packings when cleaning or replacing these nozzles.**

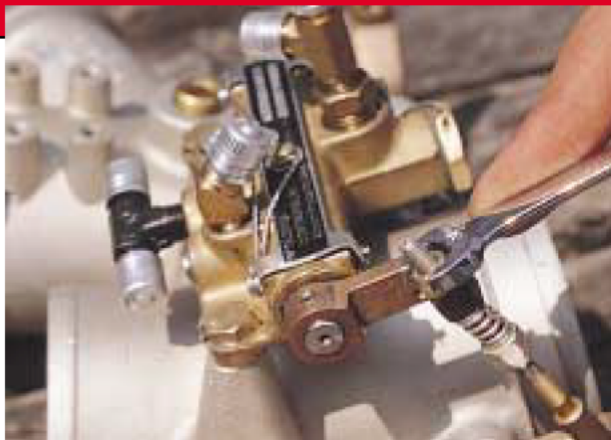
***This is a typical 470 and 520 mixture style adjustment. It requires a 3/8 wrench with a clockwise rotation to enrich the mixture.***

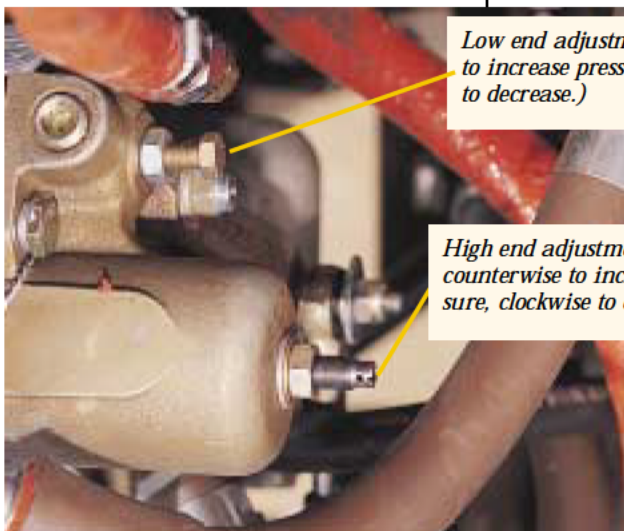
*Low end adjustment. (Turn clockwise to increase pressure, counterclockwise to decrease.)*

*High end adjustment. (Turn counterclockwise to increase pressure, clockwise to decrease.)*

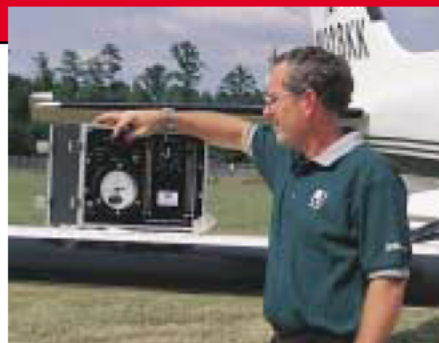
**Paul Cramer of Kelly Aerospace is using a Porta Test unit manufactured by Aero Test, Inc. to set fuel pressures on a Cessna 340.**

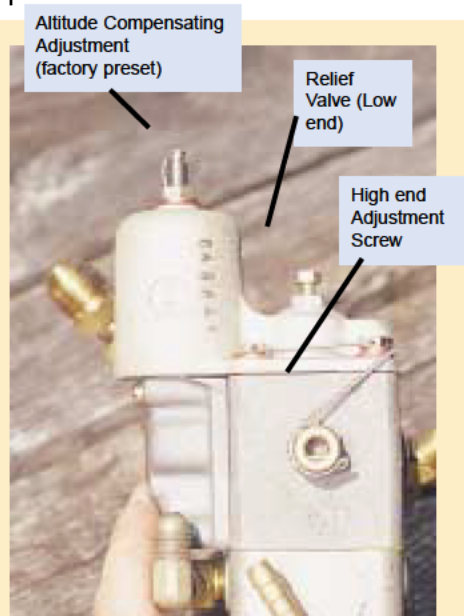
**The 550 style pump incorporates three adjustments. The aneroid adjustment is factory preset to compensate for altitude changes. The brass boss on the side of the pump is an adjustable orifice that once set, determines high-end fuel pressures output. Turning it clockwise (in) increases pressure. The 5/16-inch bolt with 3/8 jamnut is the relief valve adjustment that determines low-end pump pressure. A clockwise movement increases pump pressure.**
