Laura Abraham  
Air Safety Investigator  
Central Region

**Subject:** CEN25LA093 - Review of Maintenance Records

### **Synopsis of Aircraft Maintenance Records Review**

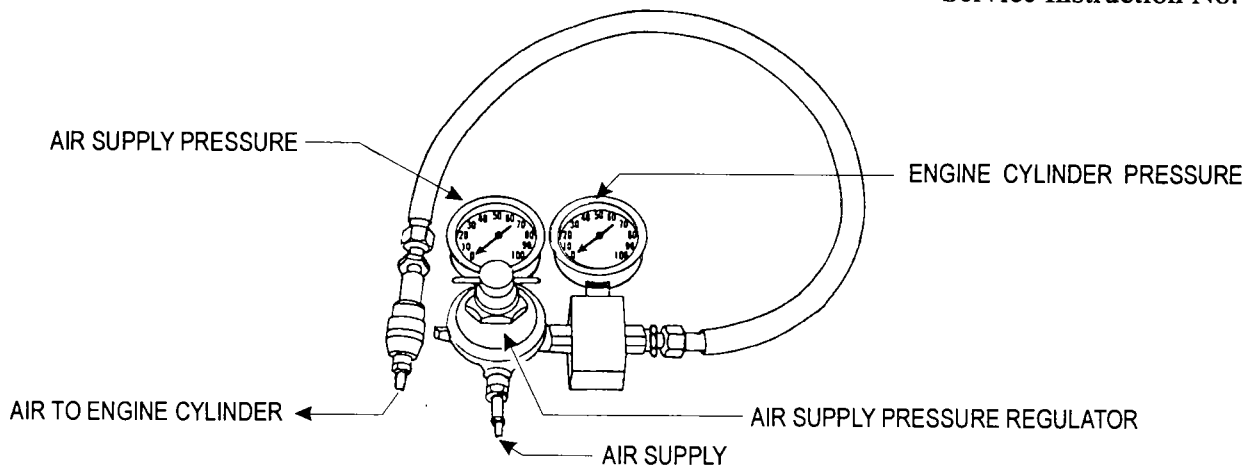
Typical Differential Compression Measuring Device

The condition of the working parts in the combustion chamber of a cylinder can be determined by measuring the static leak rate of the cylinder as compared to the leak rate through an orifice of specified size. This is accomplished by attaching a differential compression measuring device, which incorporates the orifice, to one spark plug hole of the cylinder while the piston is at top center of the compression stroke.

The orifice size of the differential compression measuring device is critical if consistent and meaningful cylinder analysis are to be obtained; the larger the orifice the less chance of detecting potential problems. Therefore, a specific orifice size that provides an acceptable leak rate has been selected for all Textron Lycoming engines; the instructions described herein are based on this orifice which is .040 in. dia. (No. 60 drill) x .250 in long, with entrance angle of 59°/60°.
