## **NATIONAL TRANSPORTATION SAFETY BOARD**

### **Group Chairman's Factual Report**

# **OPERATIONAL FACTORS**

**DCA16IA200**

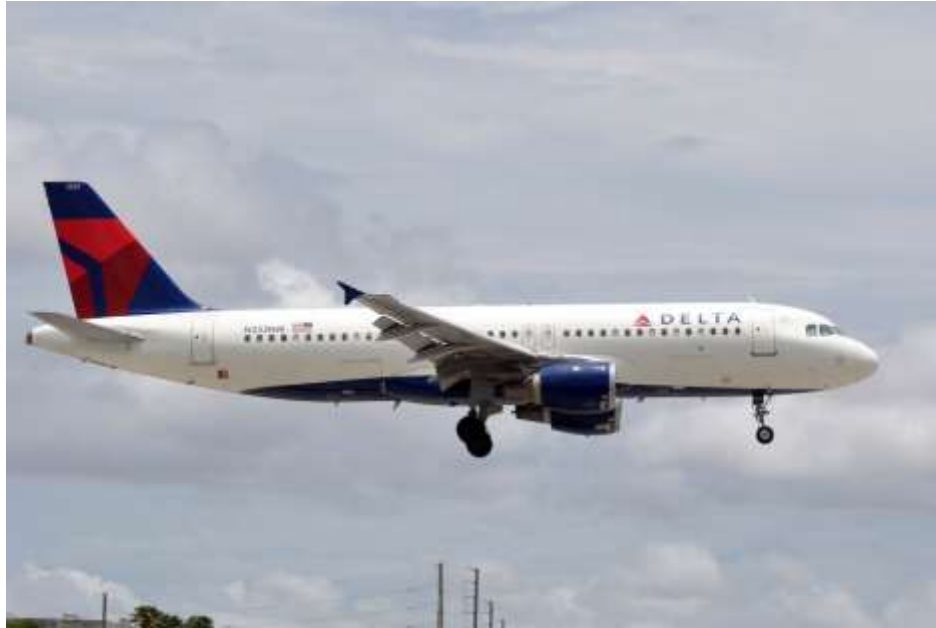
**Photo 1: Incident Airplane (Registration N333NW)**

The incident airplane was an Airbus A320-211 (Registration N333NW), Serial No. 0329, and was manufactured in 1992. The registered owner was Delta Air Lines, Inc., and it held a transport category airworthiness certificate dated July 10, 1992. The airplane had a maximum ramp weight of 170,635 pounds, and had a total passenger seating capacity of 160, and contained 4 flight crew seats and 5 cabin crew seats. A review of NTSB and FAA records found that the incident airplane had not been involved in any previous incidents that merited a formal investigation or accidents.<sup>33</sup>

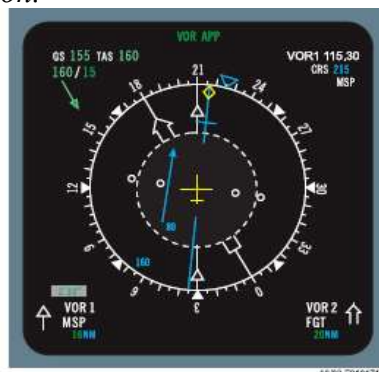
Figure 11: ROSE VOR Mode<sup>62</sup>

*The ROSE VOR mode provides a VOR display similar to a conventional HSI<sup>61</sup> as well as additional VOR information.*
